Docket No. 272 – Development and Management Plan Inspection

Segment 4a Underground Line

Date: April 19, 2007

Location: Singer Substation to Fairfield/Westport Town Line

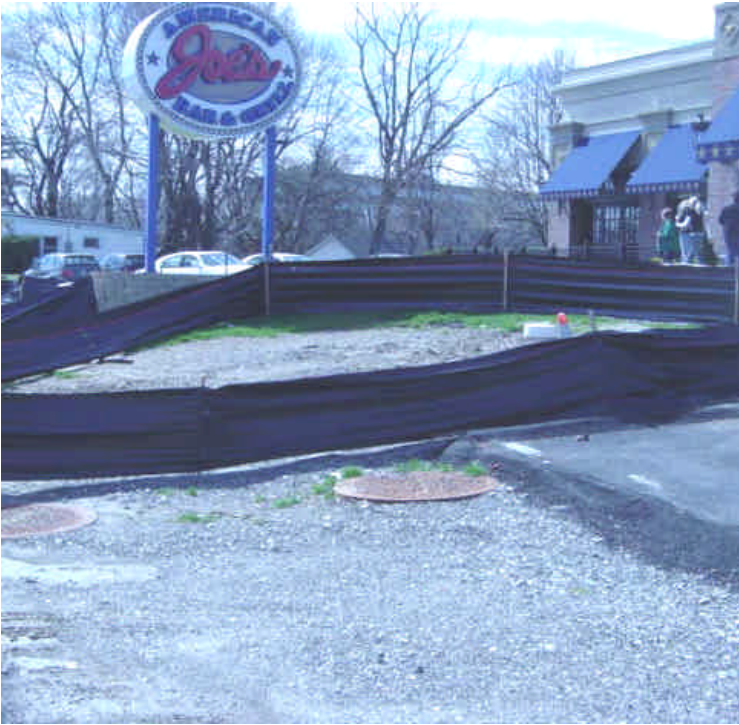
Well installation at vault #36 caused additional soil disturbance. Silt fence has not been toed-in, leaving it ineffective. The silt fence should be toed-in to provide the intended control.

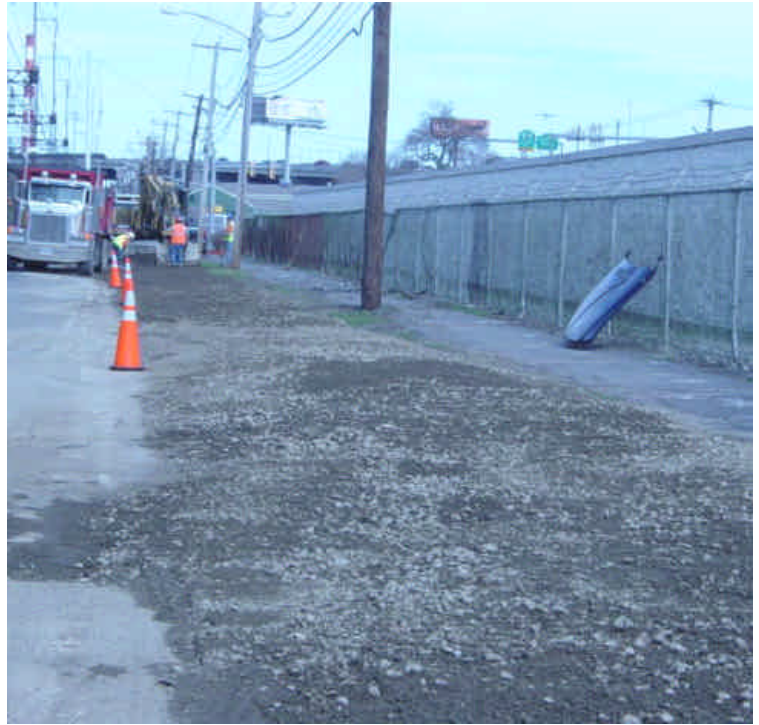
Stone is being applied to the ruts in the shoulder of Railroad Ave., and to prevent additional tracking.

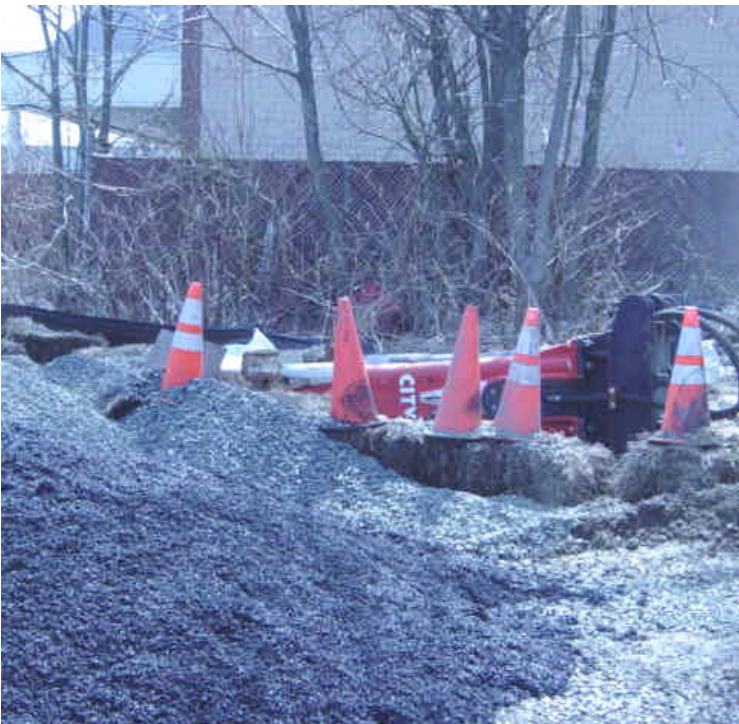
Both photos are of the King's Highway lay-down yard. Left: The fluid filled equipment is being adequately and proactively contained within the yard. Right: General overview of the yard, no issues were noted.
