Docket No. 272 – Development and Management Plan Inspection

Segment 4a Underground Line

Date: April 25, 2007

Location: Singer Substation to Fairfield/Westport Town Line

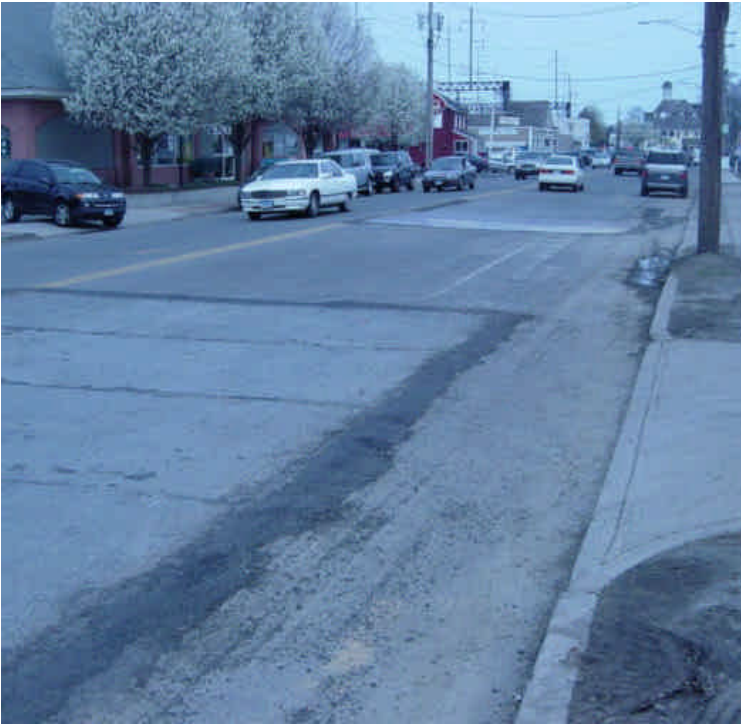
Photo of vault #32, minor sediment/material accumulation was noted along the shoulder of the roadway. Provide regular sweeping along the roadway, including the gutters.

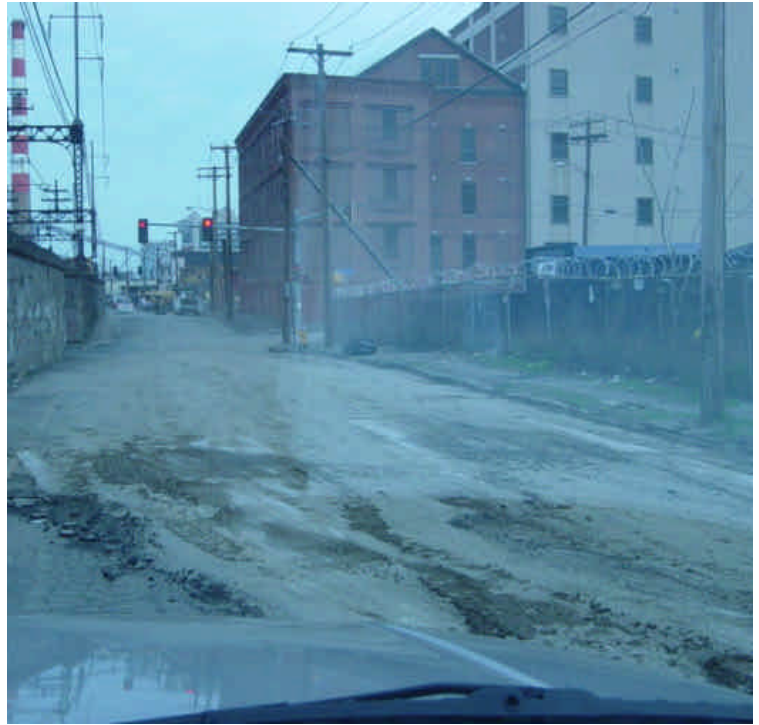
Areas of Inspection	Observation	Recommended Action	Corrected Action
Bridgeport	but it was not toed-in. 4/25/07 Significant sediment tracking was again observed at the Railroad and Myrtle Ave. intersection and was originating from a stockpile yard identified as being associated with the Glenbrook Cable project. This is not covered under this D&M plan. 4/25/07	Noted for the record since contractors stated the sediment is not related to this project. 4/25/07	NA
Kings Highway Lay-down Yard (Off Kings Highway, near Rt. 1 rotary)	Airborne dust migration was not noted within the Kings Highway lay-down yard at the time of inspection, but has been noted during past inspections. 4/25/07	Prevent dust migration by implementing the dust control specifications within the 2002 CT Guidelines for Soil Erosion and Sediment Control. 4/25/07	Needs regular attention.
Inland Wetland and Watercourse encroachment and mitigation	The Kings Highway lay-down yard is located adjacent to potential resource areas and a concrete lined waterway. 4/25/07	See erosion control section. 4/25/07	NA

Photo of Railroad Ave. at its intersection with Myrtle Ave. Significant sediment tracking was noted but is due to a storage yard for a project not covered under this D&M plan.

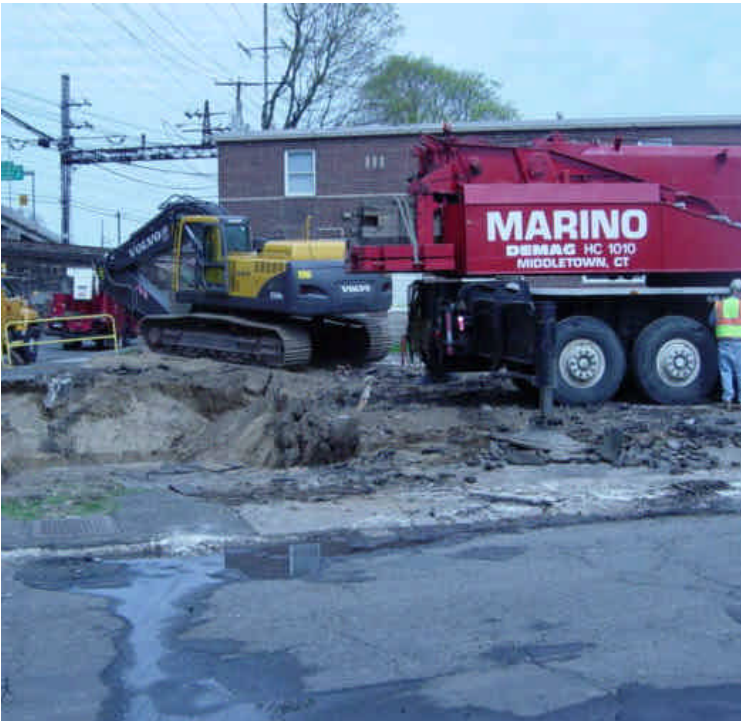
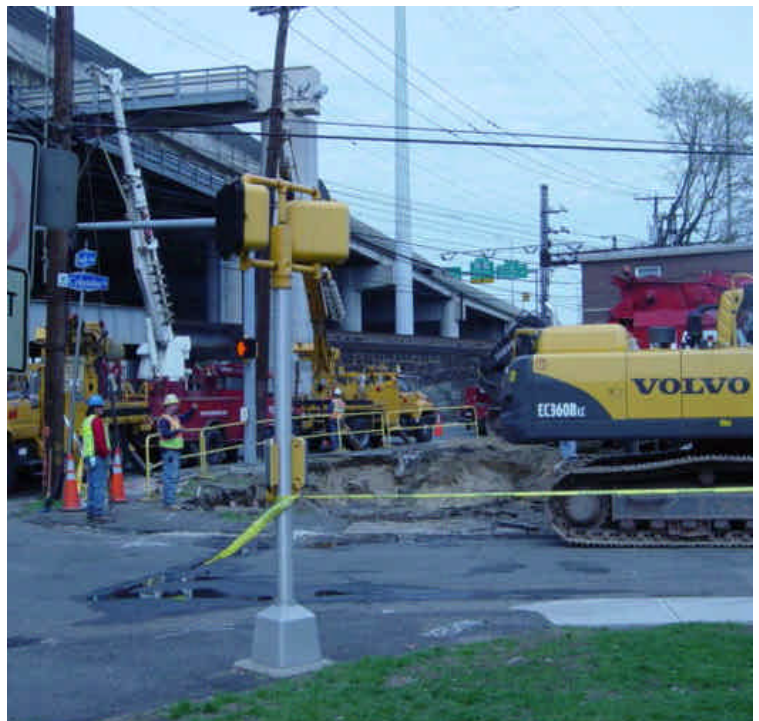
Installation activities were being conducted at Vault #47. 4/25/07	None. 4/25/07	NA

Both photo show the construction activities at vault #47. No issues were noted.
