Docket No. 272 – Development and Management Plan Inspection

Segment 4b Underground Line

Date: April 3, 2007 (night inspection)

Location: Fairfield/Westport Town Line to Westport Avenue in Norwalk

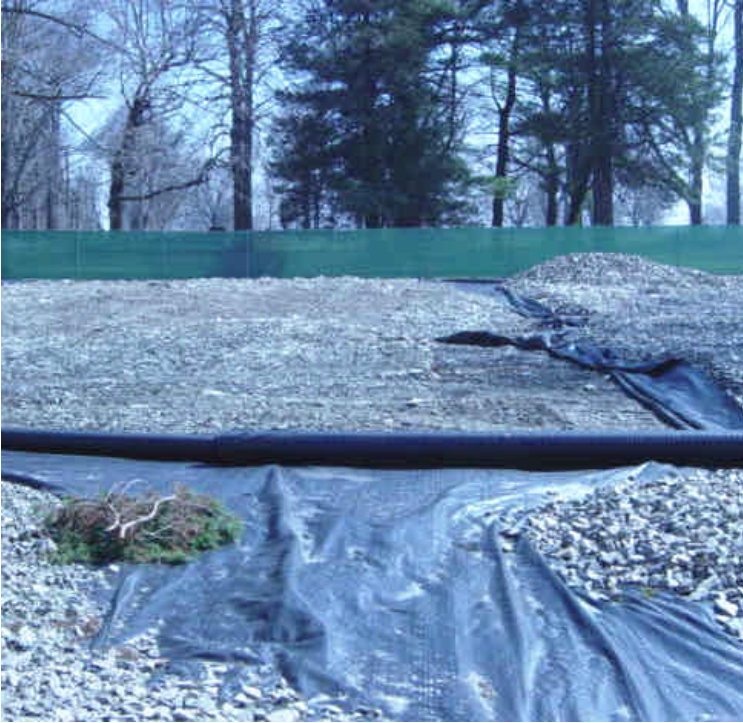
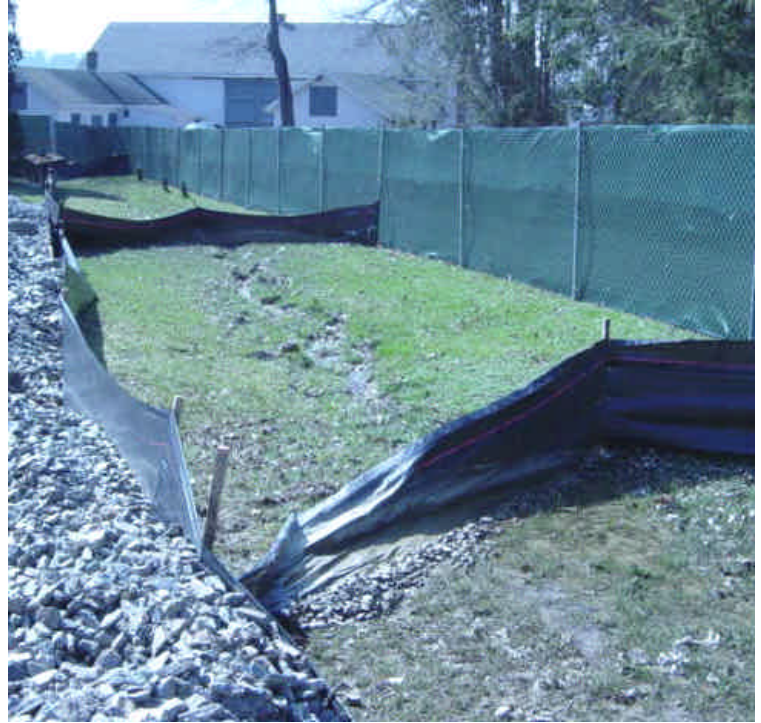
Areas of Inspection	Observation	Recommended Action	Corrected Action
<p>Kings Highway Lay-down Yard (Fairfield) (Currently being used for Segment 4a and 4b operations.)</p> <p>Sherwood Island lay-down yard</p>	<p>activities has the potential to enter catch basins. Dry slurry/material was visible along the gutter of the roadway near sta. #407. 4/3/07</p> <p>Airborne dust migration was not noted within the Kings Highway lay-down yard at the time of inspection, but has been noted during past inspections. 4/3/07</p> <p>The entire yard was being lined with fabric, and covered with a layer of soil and stone. A second liner is installed and then covered with a final layer of stone This will aid in reducing mud and tracking and lead to simplified restoration at the end of the project. 4/3/07</p> <p>The only stormwater discharge point has been adequately controlled with haybale and silt fence barriers. One corner of a section of silt fence was in disrepair. 4/3/07</p>	<p>slurry from entering catch basins and sensitive areas, by quickly attending to it as it is generated during cutting. Clean/sweep the accumulated slurry noted in this location. 4/3/07</p> <p>Prevent dust migration by implementing the dust control specifications within the 2002 CT Guidelines for Soil Erosion and Sediment Control. 4/3/07</p> <p>None. 4/3/07</p> <p>Re-establish the silt fence check dam and reinforce if necessary. 4/3/07</p>	<p>Needs regular attention.</p> <p>Yard was lined with fabric and stone prior to use.</p> <p>Needs minor repair.</p>

Both photos show the Sherwood Island lay-down yard. Left: View of an area in the process of being set-up for use by the contractors. The area is lined with fabric and a mixture of stone/soil is applied. Another layer of fabric is placed, and finally the area is covered with stone. Right: Good erosion controls are in place to protect the only stormwater outlet from the site. The section of silt fence in the foreground of the photo is in need of repair.

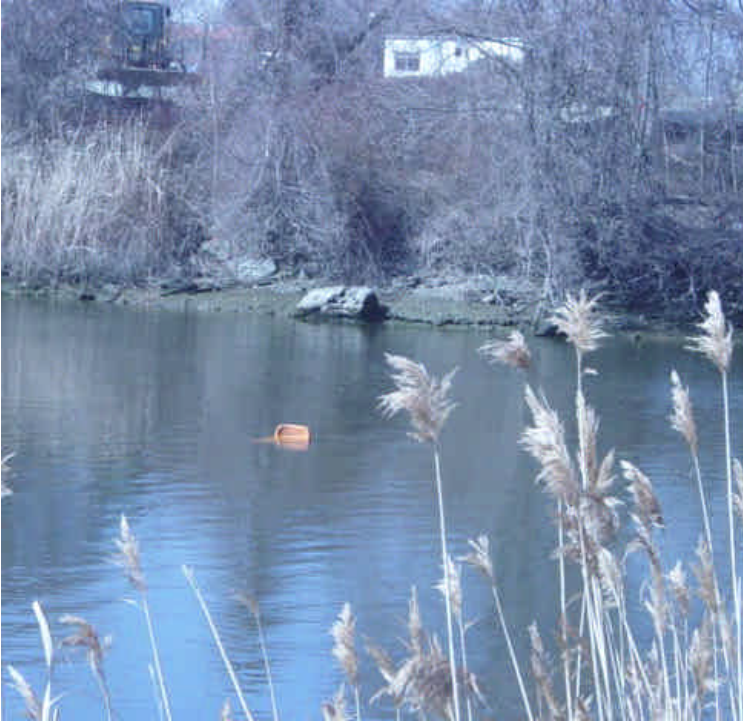
Areas of Inspection	Observation	Recommended Action	Corrected Action
	<p>nearby resource areas by an earthen berm. 4/3/07</p> <p>An orange object (resembling construction materials) was observed within the waterway directly to the west of the Imperial Ave. yard. It is unclear whether this object is project related. 4/3/07</p>	<p>If at all feasible, determine if the object came from the yard and remove if necessary. 4/3/07</p>	<p>Needs evaluation. The contractor rep stated they would try to check during low tide.</p>
Staging, Storage, and Parking Areas	<p>A contractor lay-down yard is located off of Kings Highway near the Rt. 1 rotary. This is being used for both 4a and 4b activities. 4/3/07</p> <p>A contractor lay-down yard is located off of Imperial Ave. in Westport. 4/3/07</p> <p>Stockpiles of materials remain in the lay-down yard off Imperial Ave. Piles remain contained to the yard at this time. 4/3/07</p> <p>A contractor lay-down yard is located within Sherwood Island State Park. Multiple controls were used to stabilize the yard from the beginning. 4/3/07</p>	<p>See Erosion Control section and Spills and Material Storage section for more detail. 4/3/07</p> <p>See erosion control section. 4/3/07</p> <p>Continue to monitor piles for stability and containment. 4/3/07</p> <p>See Erosion Control section for more details. Continue to monitor the one stormwater discharge point. 4/3/07</p>	<p>NA</p> <p>NA</p> <p>NA</p> <p>NA</p>

An object was noted within the water immediately to the west of the Imperial Ave. lay-down yard. If at all feasible, determine if the object was something that came from the yard. Remove if necessary.

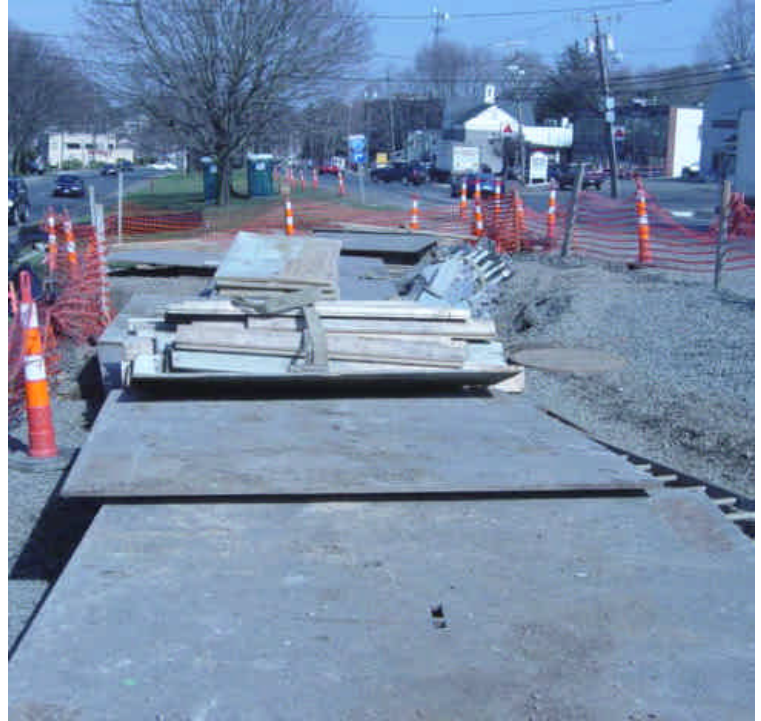
Photo of vault #18 construction activities.

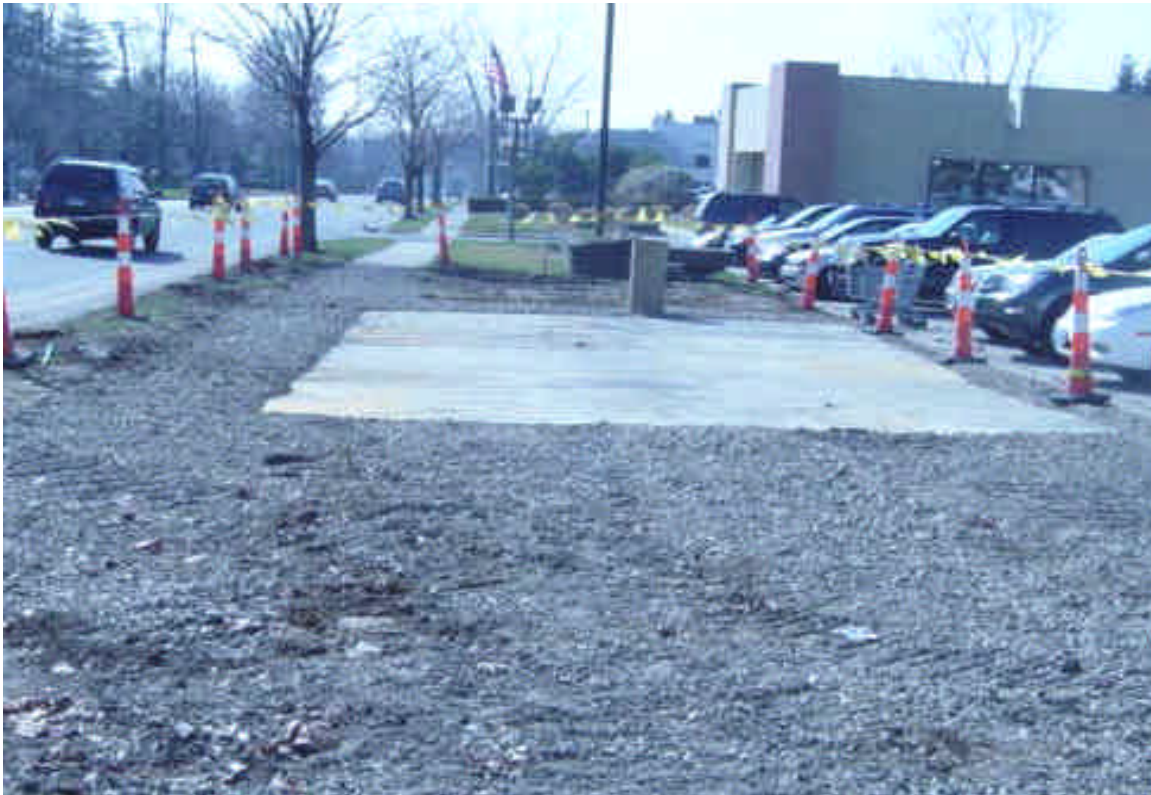
Photo of vault #21 construction activities.

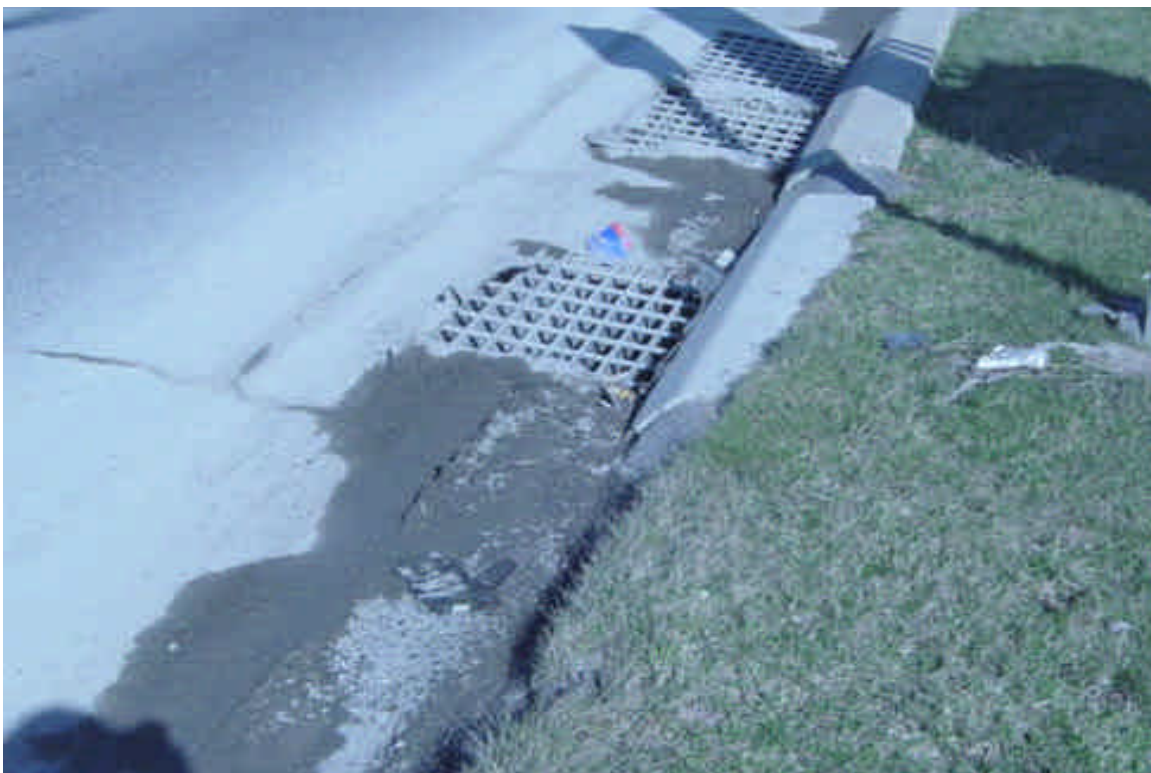
Two of the three catch basin inlets near Sta #407 had liners but the third still needed controls. 4/3/07	Install controls in any catch basins where slurry or run-off from the project can enter. 4/3/07	Some liners were in place but additional attention is needed.
	Slurry from saw cutting	Continue to prevent	Needs attention

Saw cutting slurry was noted along the gutter of the roadway, south of sta. #407. Two of three catch basins were protected with a silt liner. The gutter should be swept by hand if the street sweeper cannot reach. Continue to attend to slurry as soon as it is generated.
