Docket No. 272 – Development and Management Plan Inspection

Segment 4b Underground Line

Date: April 13, 2007

Location: Fairfield/Westport Town Line to Westport Avenue in Norwalk

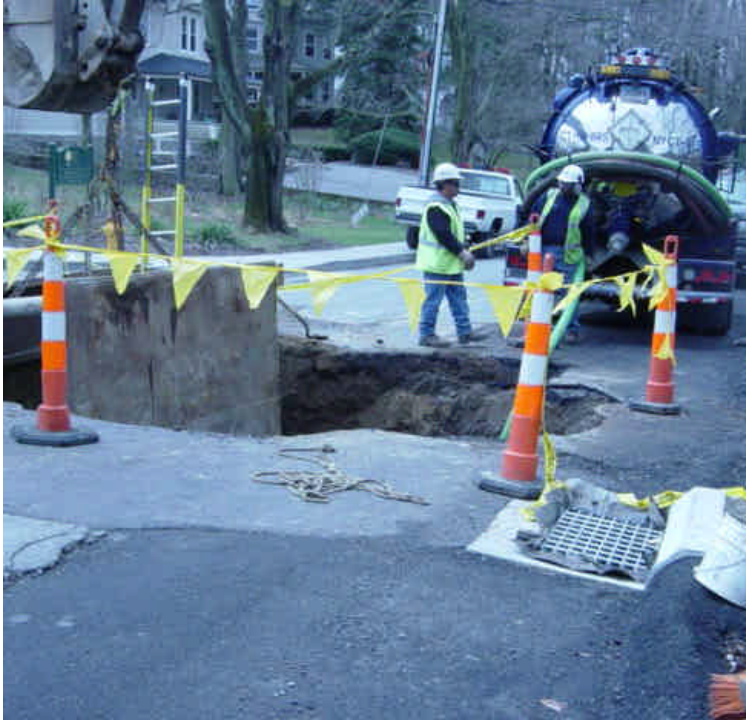
Construction activities located within Imperial Ave. adjacent to Dead Man's Creek. Adjacent catch basins have been protected.

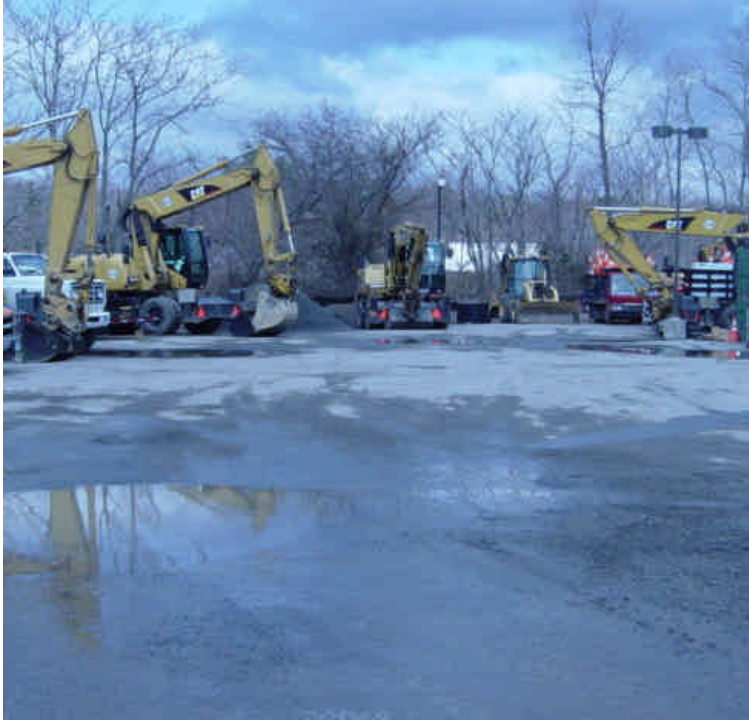
Photo of the Imperial Ave. lay-down yard. No issues were noted.

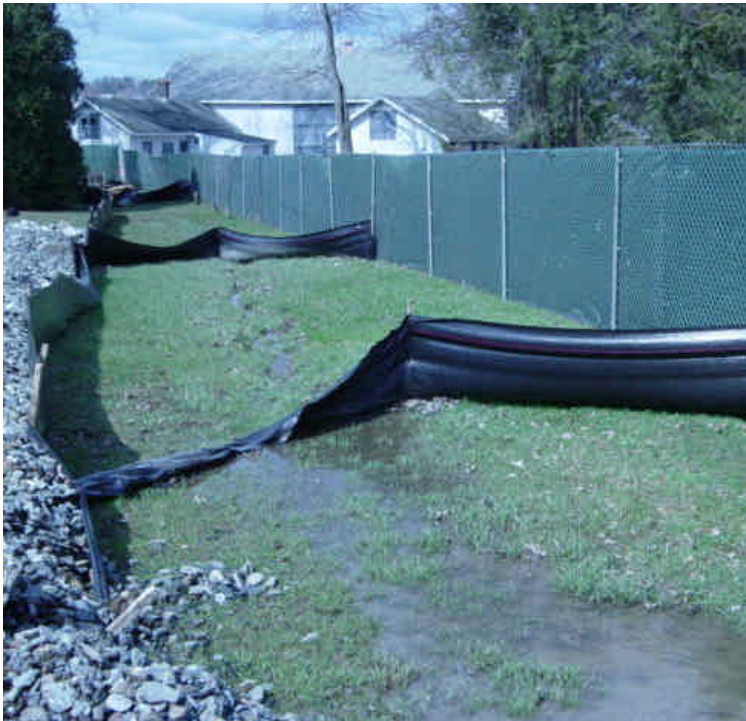
Both photo taken within the Sherwood Island lay-down yard. Left: Silt fence check dam leading to stormwater outlet has been compromised and is in need of repair. Right: Fluid filled equipment being stored on grassed area. No leaks were observed but equipment could be stored on a liner or otherwise contained proactively.

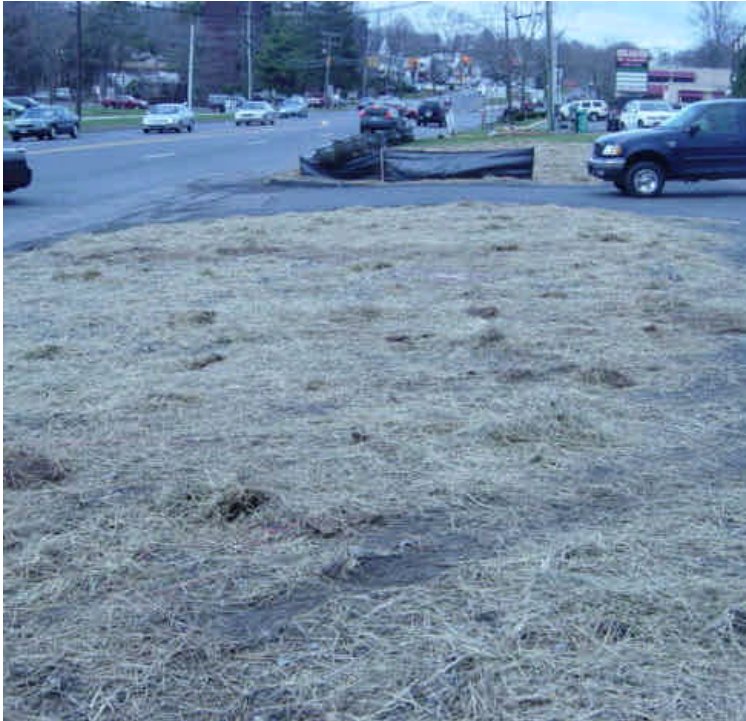
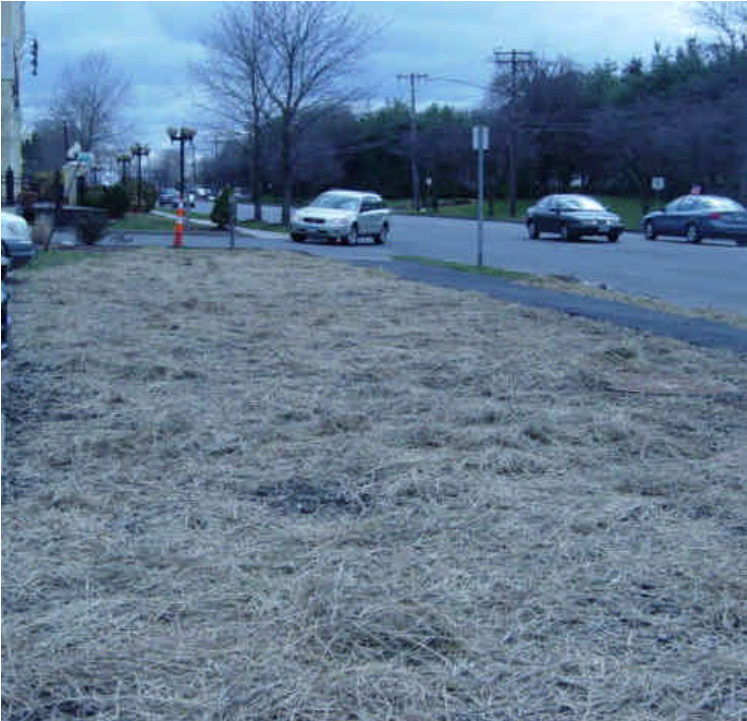
Both photo of temporary stabilization measures (mulch) on exposed soils at completed vault locations.  
Left: Vault #20. Right: Vault #23.

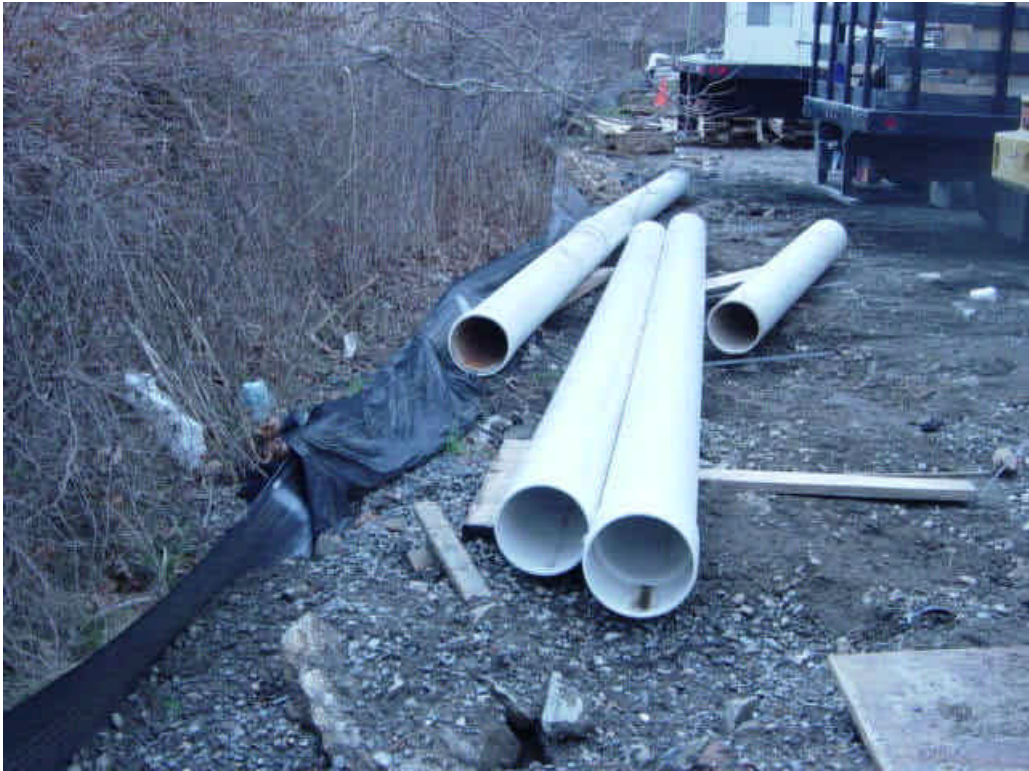
Materials within the King's Highway lay-down yard were piled against the controls, compromising them. The fence should be re-established. Continue to store materials in a way that does not strain the controls.
