**Docket No. 272 – Development and Management Plan Inspection**

**Beseck Switching Station Inspection**

**Date:** August 7, 2007

**Location:** Beseck Switching Station

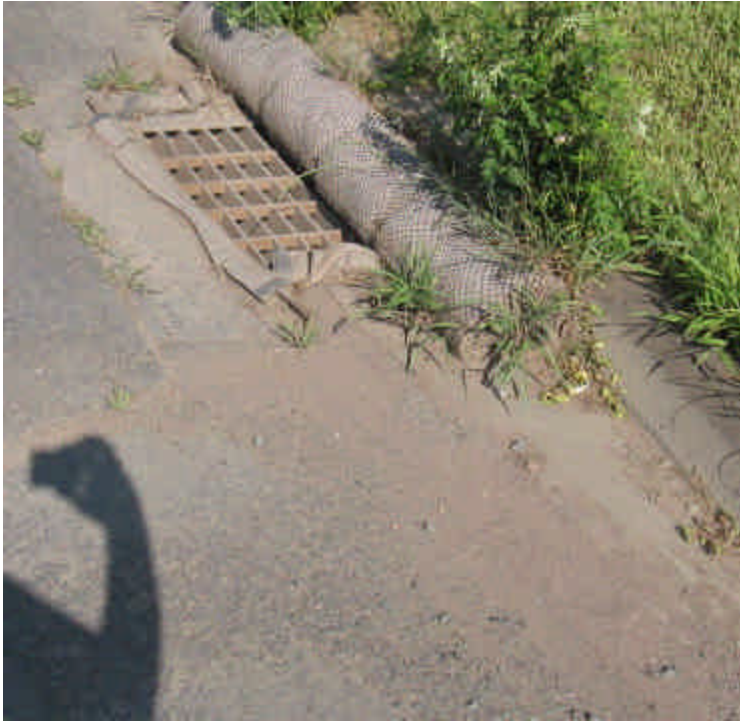
**Some sediment accumulation remains around the catch basins along Carpenter Rd.**

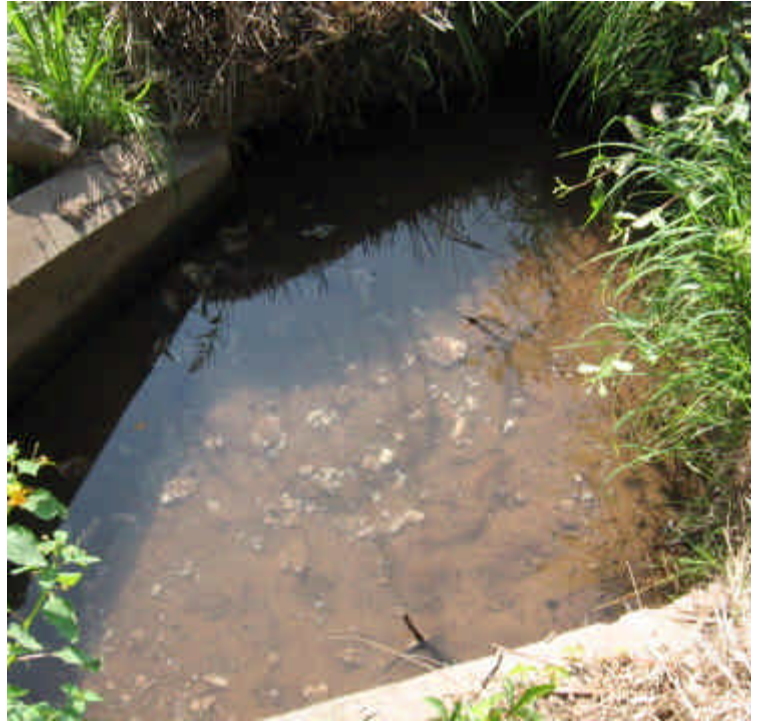
**Sediment has settled out of the standing water and accumulated at the culvert outlet south of Carpenter Rd.**

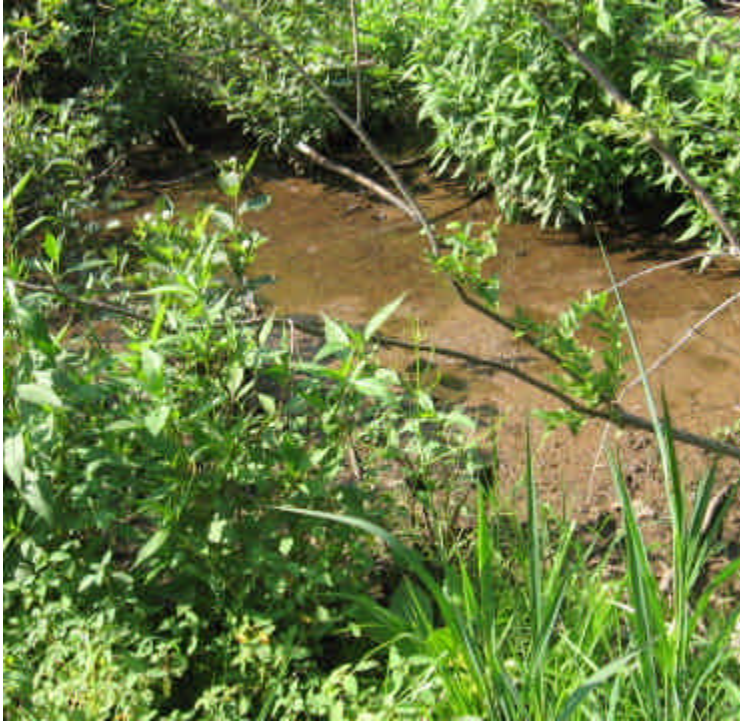
**View of the sediment accumulation in the wetland south of Carpenter Rd.**

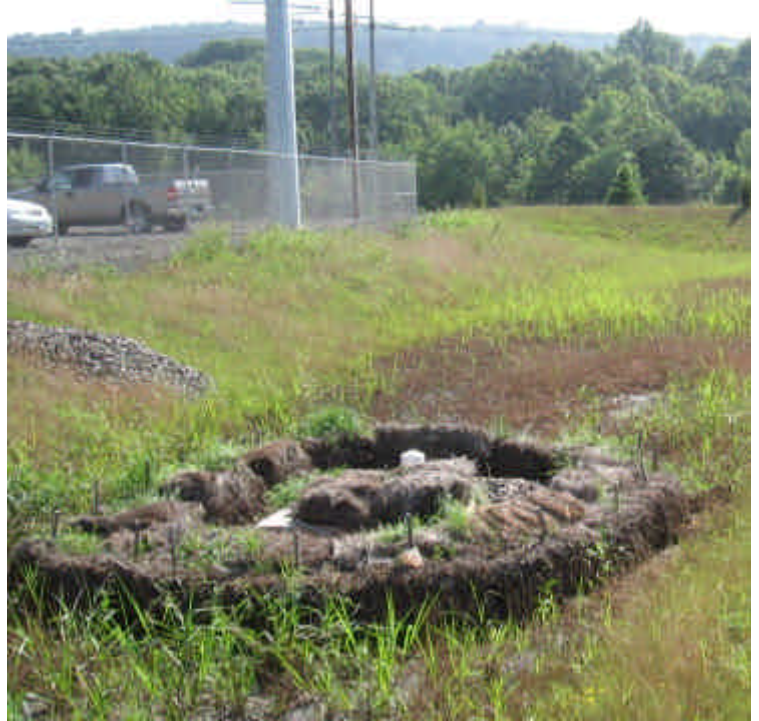
**Standing water was no longer present in the detention basin. Filtering controls remain in place.**
