Docket No. 272 – Development and Management Plan Inspection

East Devon Substation Inspection

Date: August 7, 2007

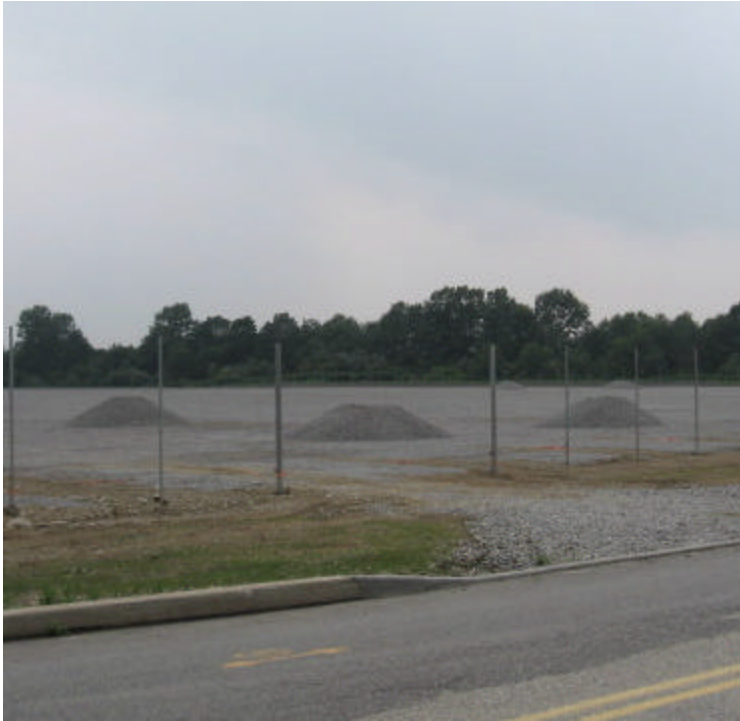
Foundation and site construction	Perimeter fence installation and site grading continues. Additional gravel was stockpiled on site this week. 8/7/07	None at this time. 8/7/07	NA

Additional gravel was delivered to the substation site this week.

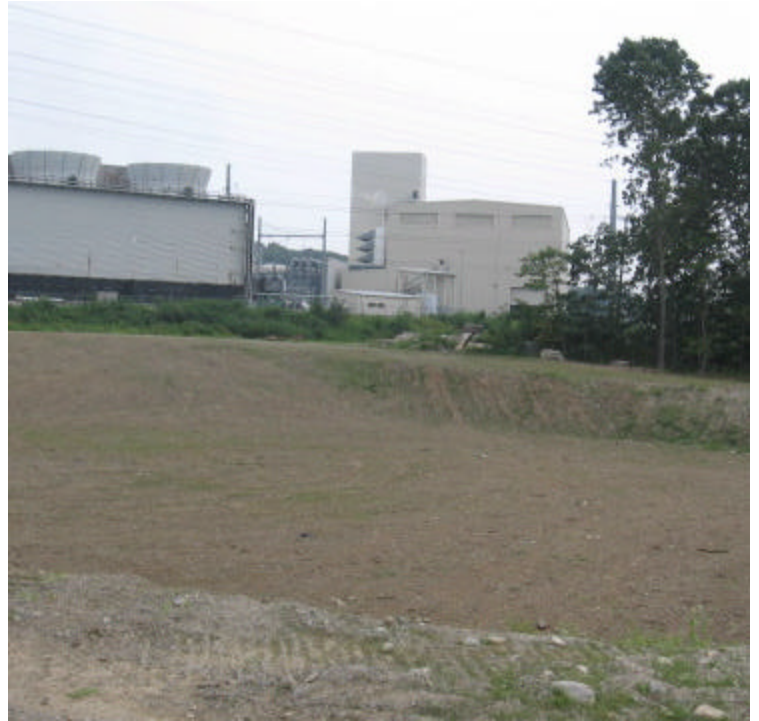
Grass growth was noted in the retention basin.

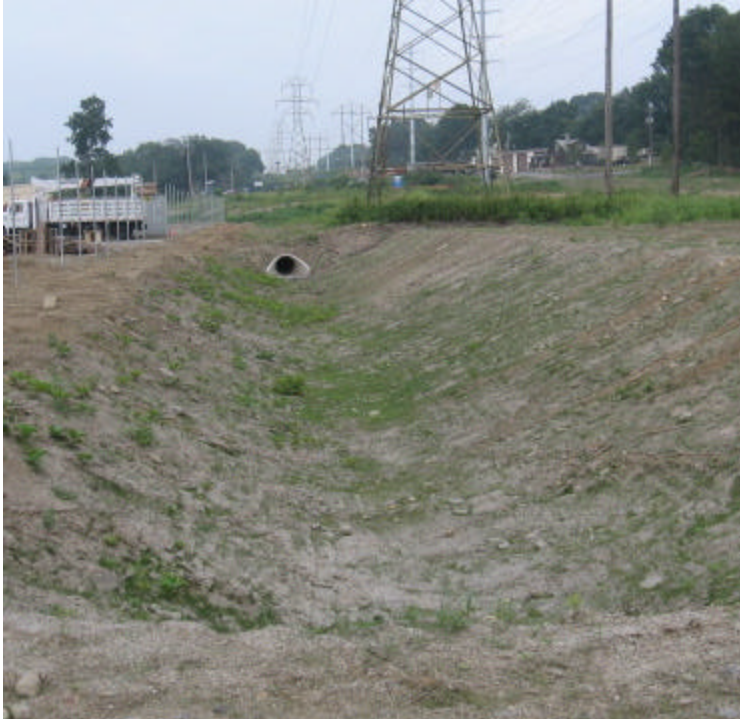
Grass growth was noted in the drainage swale.

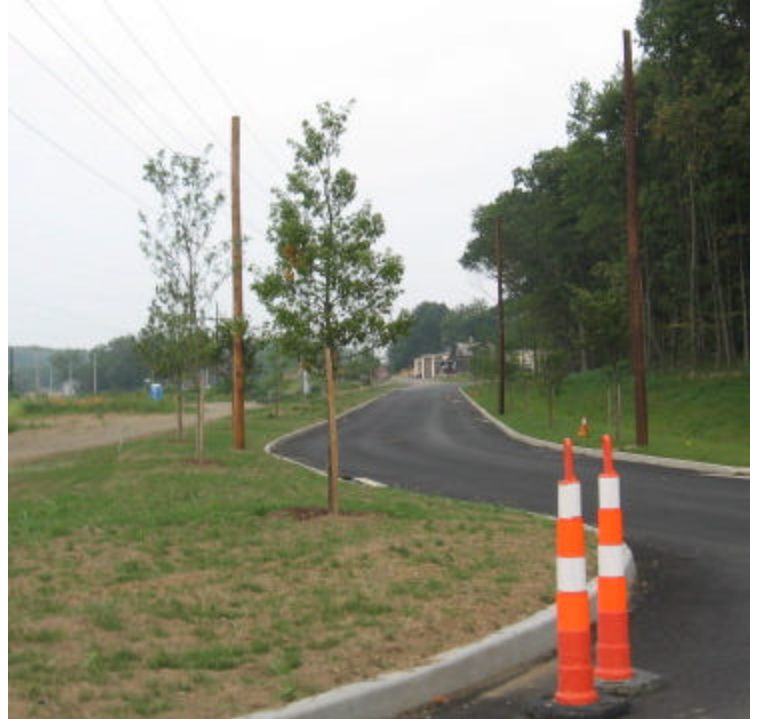
View of the recently completed Shelland Street.
