Docket No. 272 – Development and Management Plan Inspection

Segment 1a Inspection

Date: August 27, 2007

Location: Segment 1a – Scovill Rock Switching Station to Chestnut Junction, Oxbow Junction to Beseck Switching Station (excluding Royal Oak Bypass), and Black Pond Junction to Beseck Switching Station

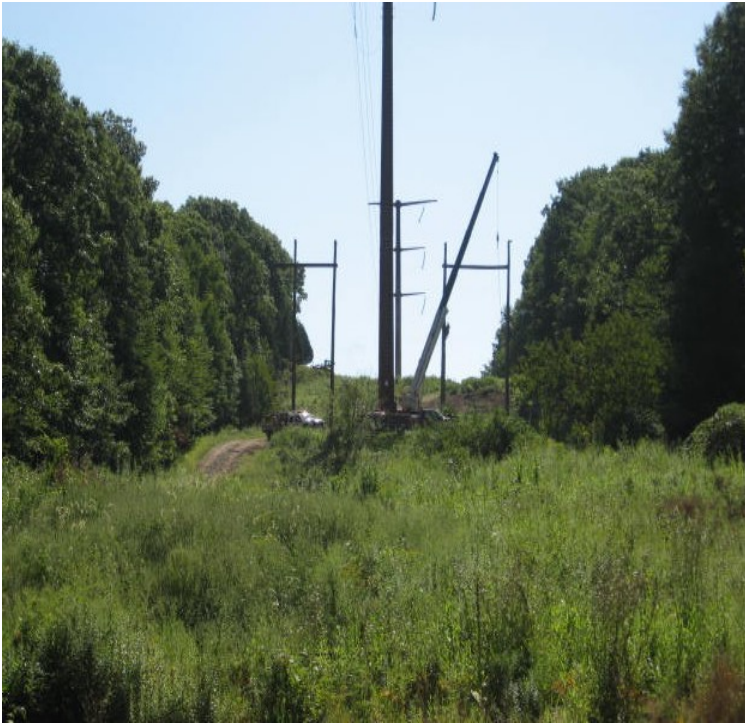
Shunpike Rd: View of pole installation.

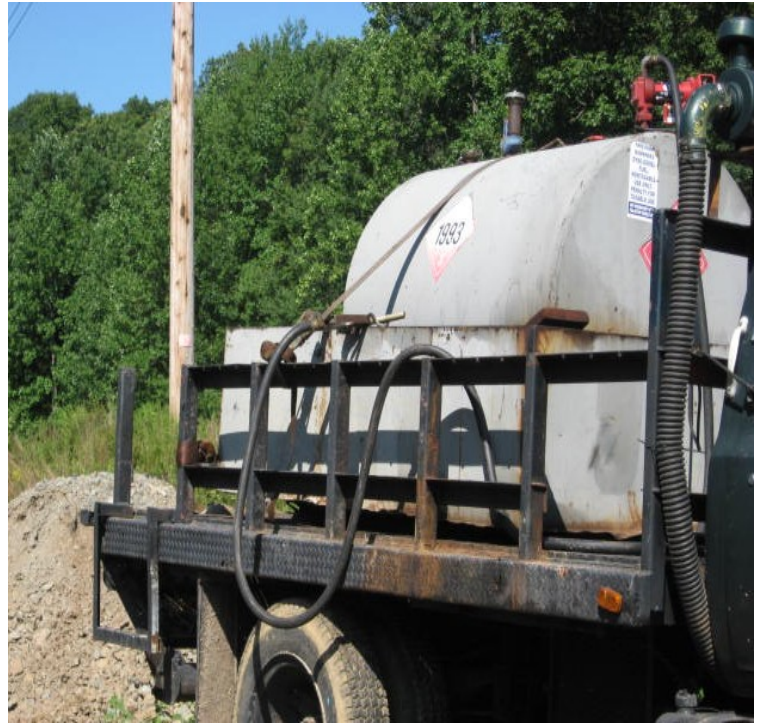
Shunpike Rd: Refueling tank with unsecured nozzle dripping.

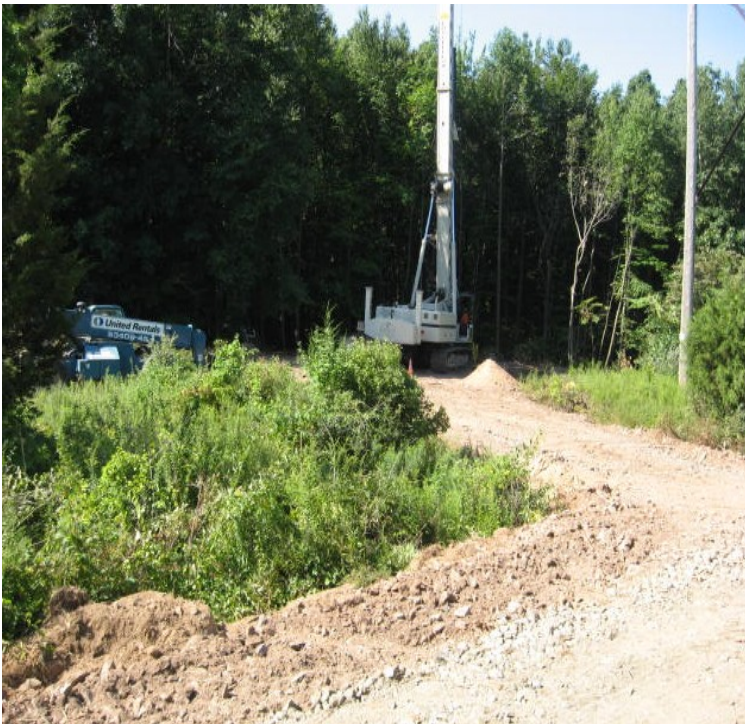
Bartholomew Rd: View of foundation drilling.

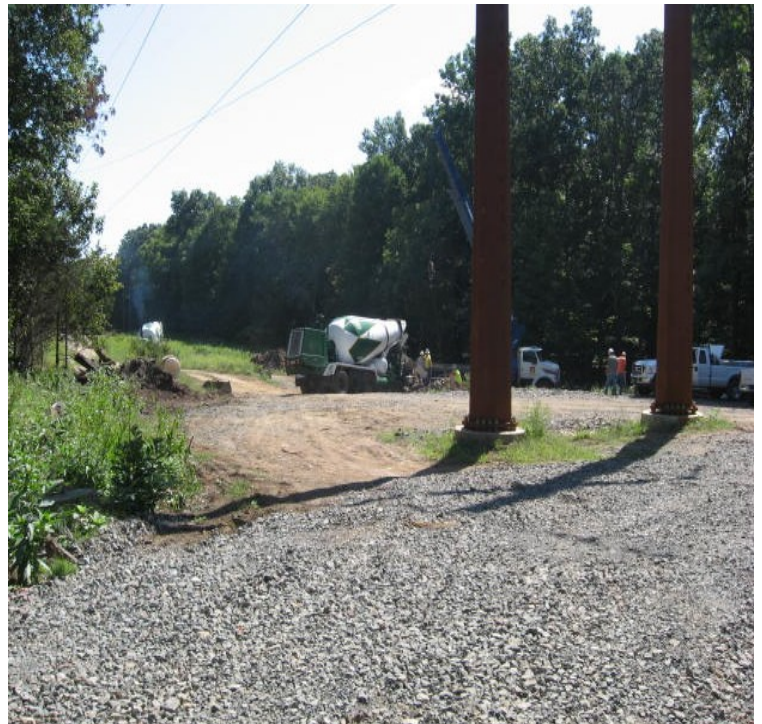
Black Walnut: Foundation pouring underway.

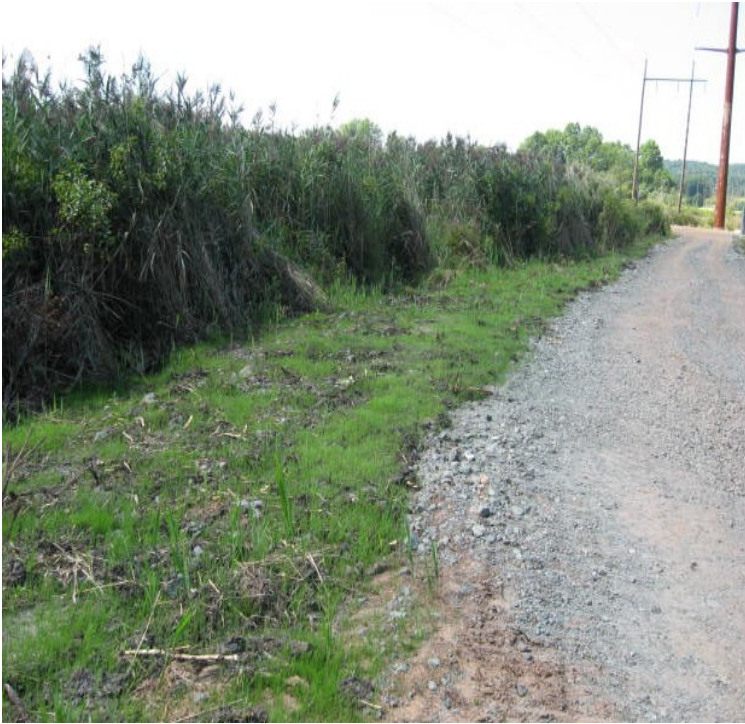
Durham Rd: Soil pile removed, disturbed areas seeded.

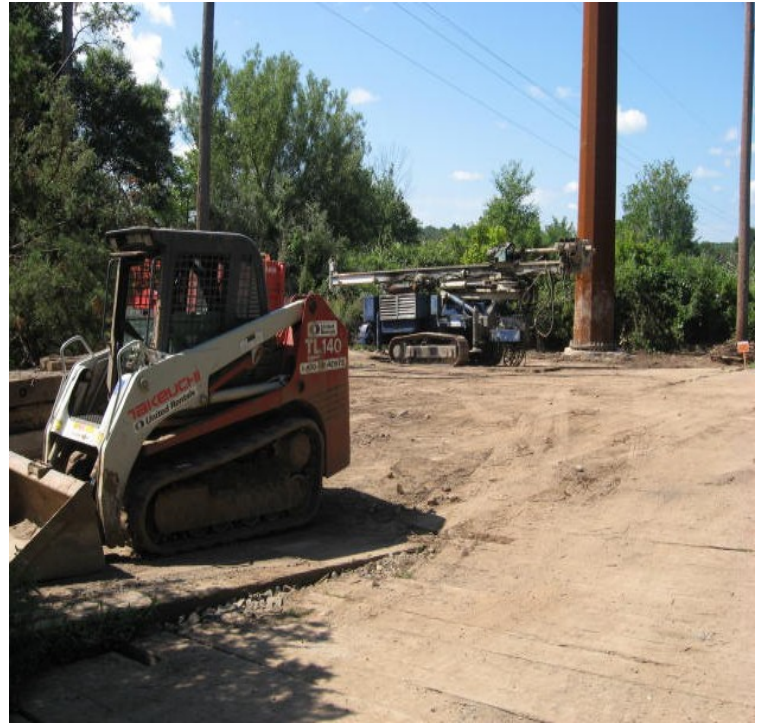
Durham Rd: Equipment stored within the wetland area.

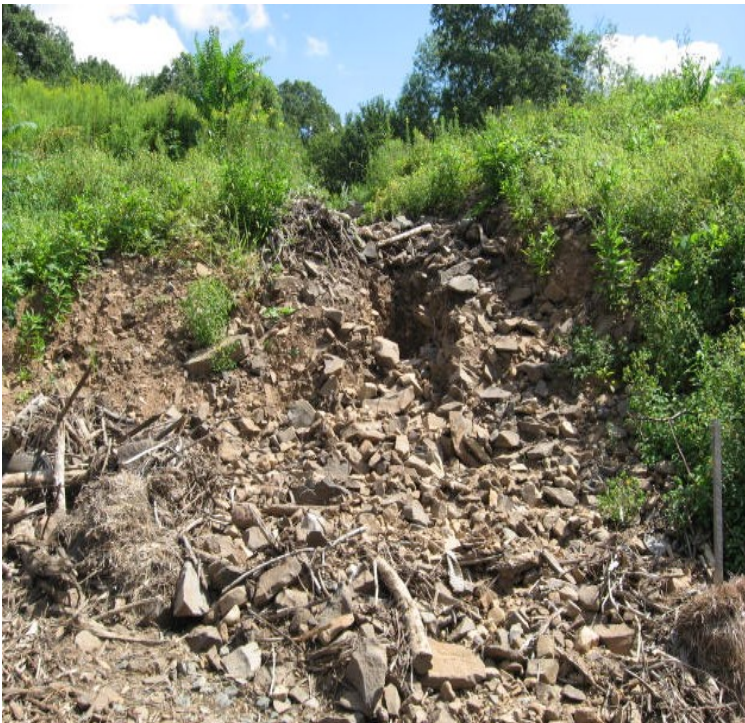
East Meriden SS: Run-off from substation is eroding the slope here.

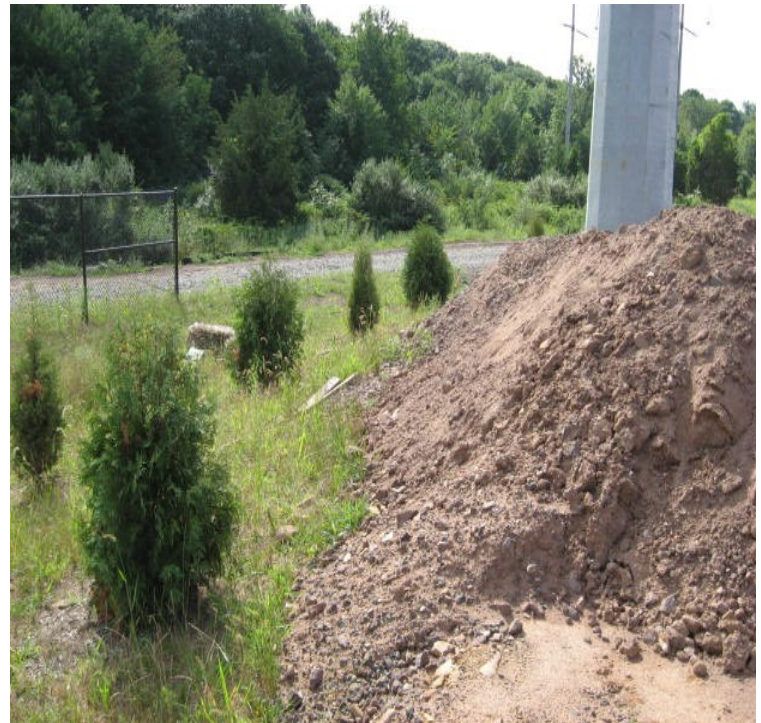
Carpenter Ln: Soil stockpile located upgradient of drainage ditch east of Besock SS.
