Docket No. 272 – Development and Management Plan Inspection

Segment 1b (Royal Oaks Bypass) Inspection

Date: August 6, 2007

Location: Segment 1b (Royal Oaks Bypass)

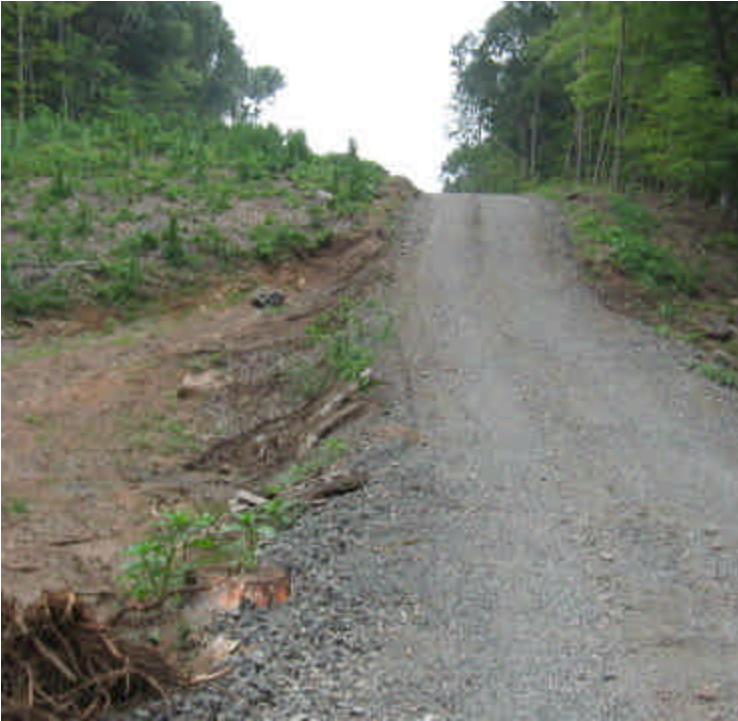
Ruts/washouts have been regraded along a steep slope in the access road off Black Walnut Drive.

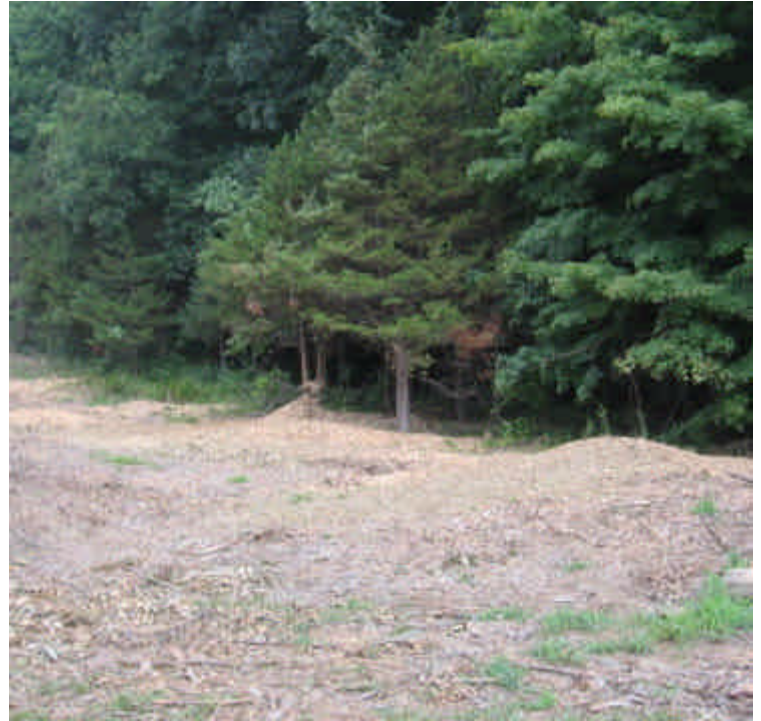
Black Walnut Dr: Wood chip piles, greater than three inches deep remain in the ROW at the 1A/1B intersection. Spread chips out in upland areas or remove from the ROW.

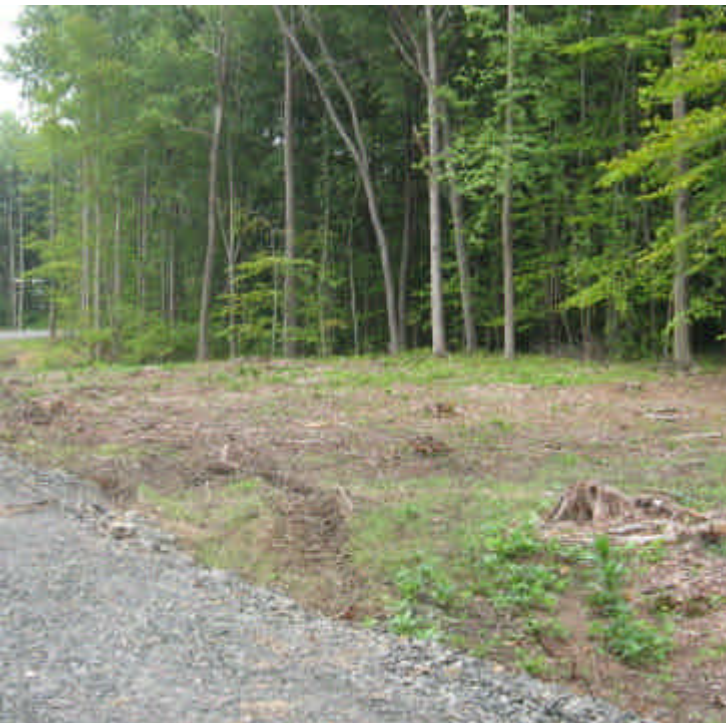
Equipment ruts were noted in a wetland west of Route 17. Continue to limit equipment to designated access roads.

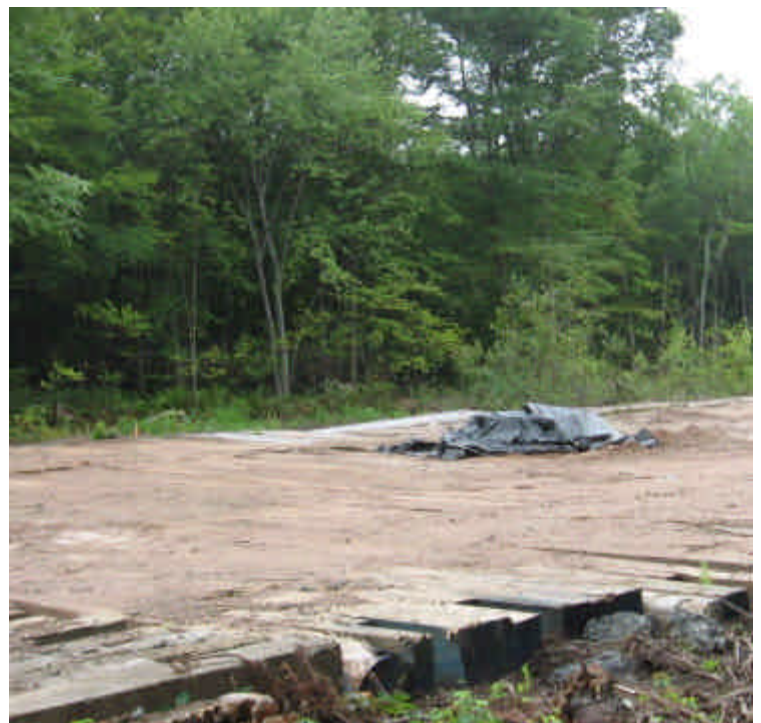
Some accumulated sediment remains on the timber mat crane pad west of Route 17. Remove if feasible to avoid run-off to the wetland
