Docket No. 272 – Development and Management Plan Inspection

Segment 2a Inspection

Date: August 2, 2007

Location: Segment 2a – Beseck Switching Station to Cheshire/Hamden Town Line

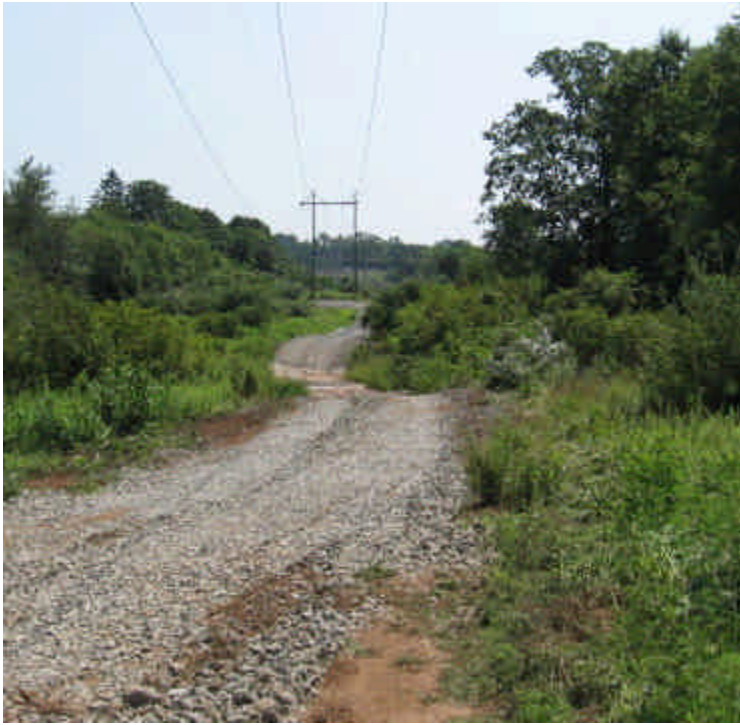
Pond Hill Rd: A view of the access road being installed here.

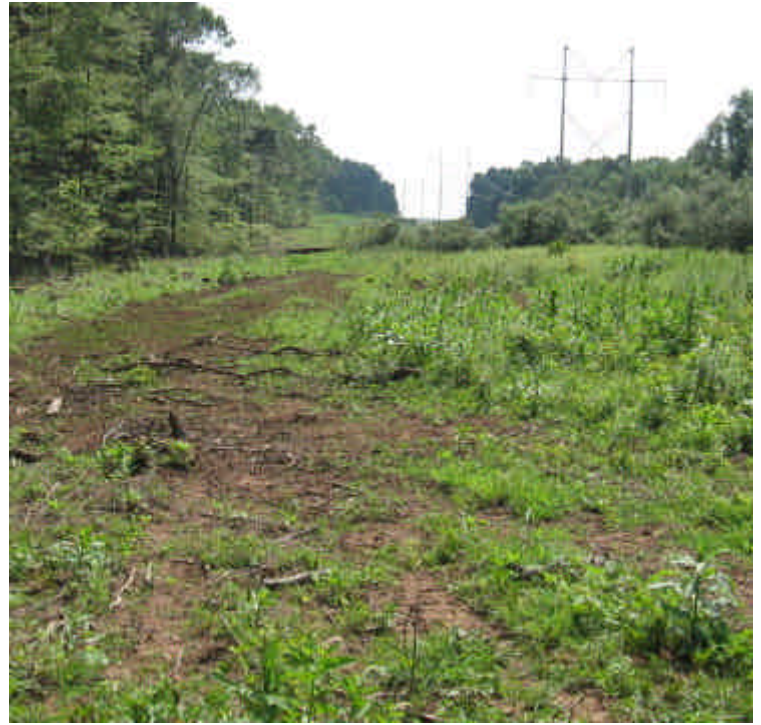
Williams Rd.: Areas disturbed by clearing activities are beginning to re-vegetate.

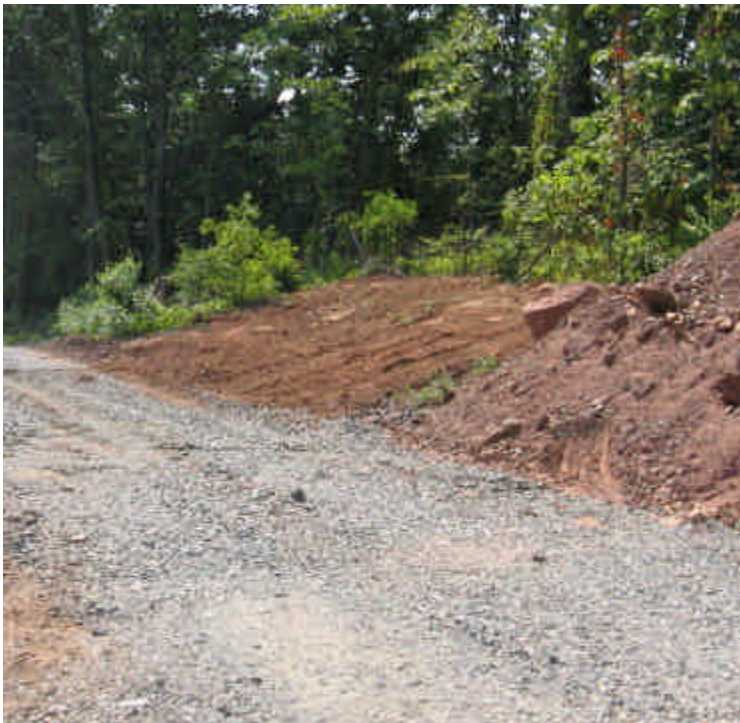
Williams Rd: Exposed soils remain near a wetland after access road construction. Seed the slopes or temporarily stabilize to prevent run-off.

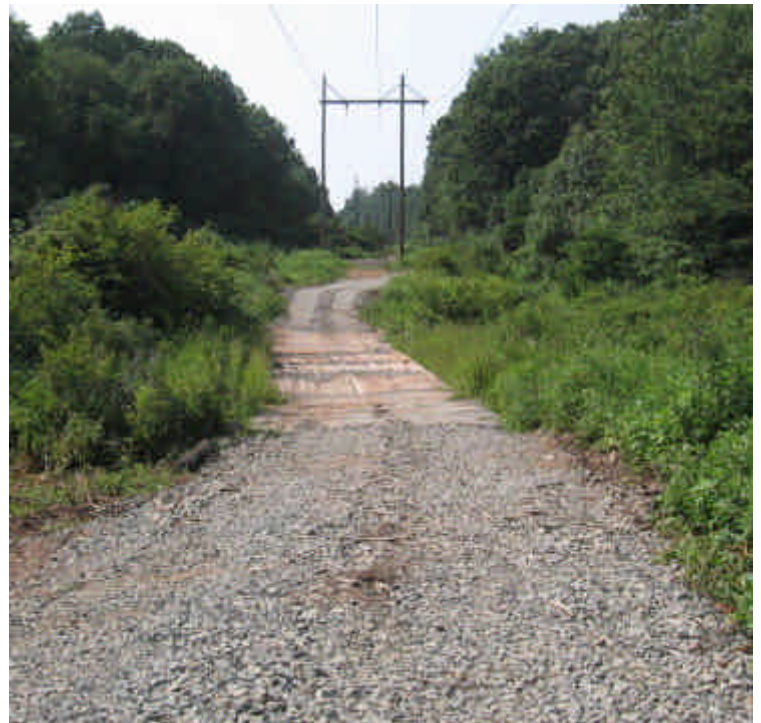
Pond Hill Rd: View of the timber mats in place at the wetland crossing.
