Docket No. 272 – Development and Management Plan Inspection

Segment 2b Inspection

Date: August 2, 2007

Location: Segment 2b – Cheshire/Hamden Town Line to East Devon Substation

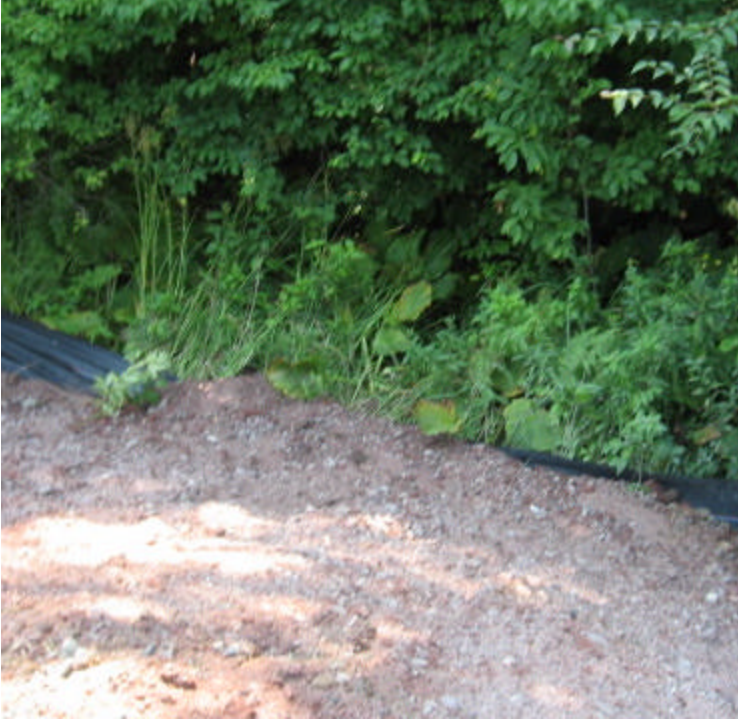
West Todd NE (Hamden): Spoils from foundation work have overwhelmed the silt fence and are now in the wetland here.

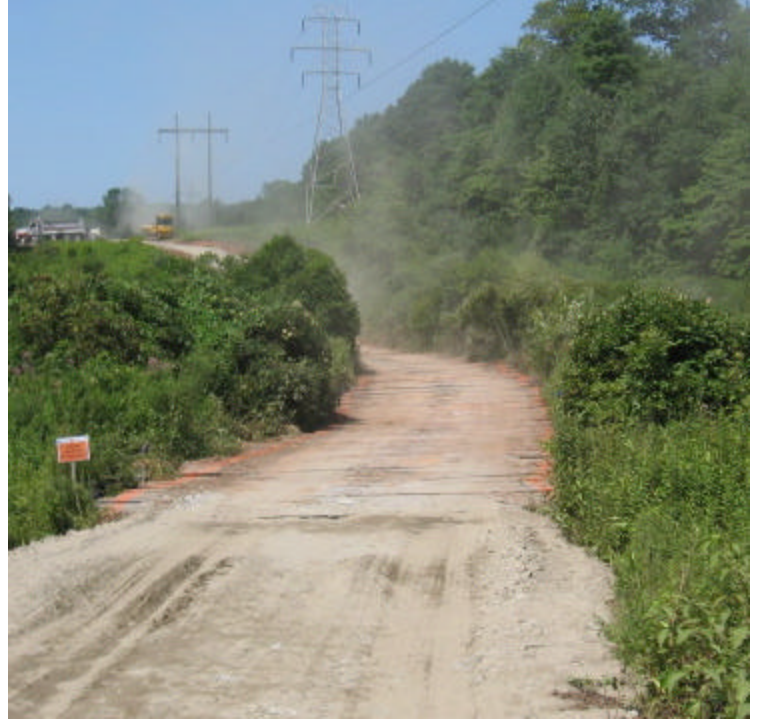
Brooksvale west (Hamden): Timber mats are in place at the wetland crossings. Erosion controls are being installed as work progresses. Dust control was not provided on site.

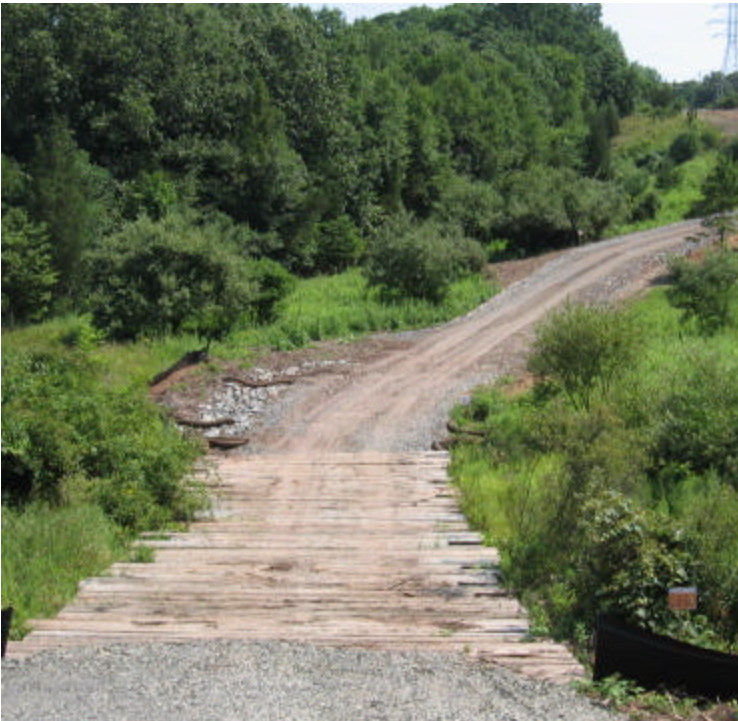
Brooksvale west: Timber mats are in place at the second wetland crossing. Silt fence is in place and controls will continue to be added as work progresses.

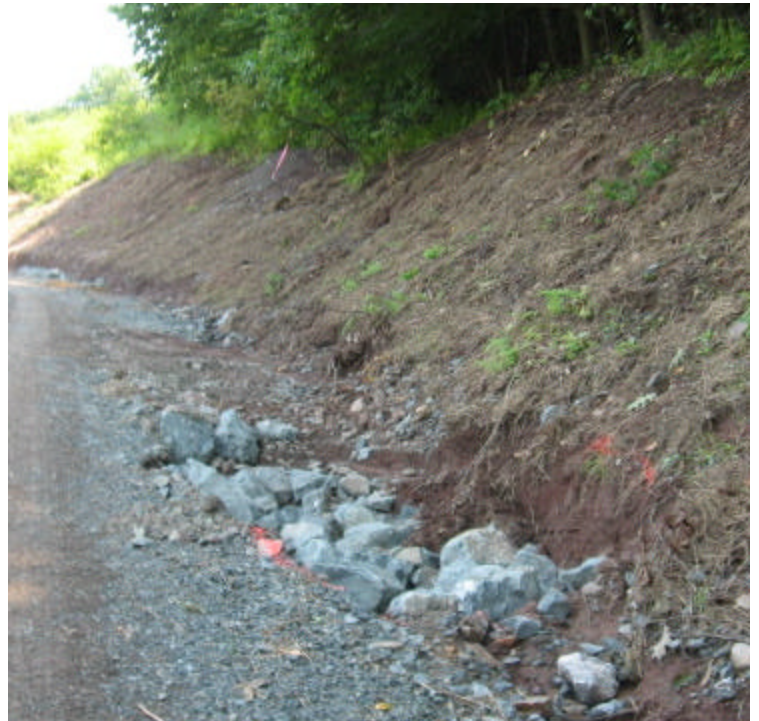
Old Lane Rd (Hamden): Washouts have been stabilized with stone, but some sediment remains within the wetland here.
