Docket No. 272 – Development and Management Plan Inspection

Segment 2b Inspection

Date: August 7, 2007

Location: Segment 2b – Cheshire/Hamden Town Line to East Devon Substation

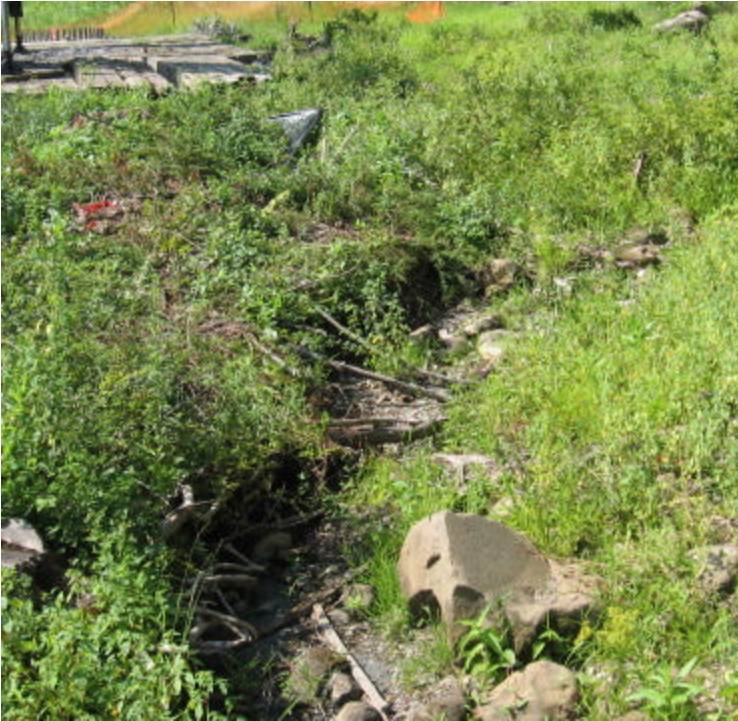
Areas of Inspection	Observation	Recommended Action	Corrected Action
JCC	<p>along the access road here. Silt fence located along the access road is in need of repair. 8/7/07</p> <p>Silt fence is in need of repair near structure #241 19. Sediment was noted in the dry stream channel here. 8/7/07</p>	<p>proper function. Stormwater will not be filtered properly if traps become overwhelmed with sediment. Repair silt fence when feasible. 8/7/07</p> <p>Continue to monitor and repair and maintain as necessary. Evaluate sediment accumulation within the stream channel. Carefully remove sediment during the dry season if it is greater than 2" in depth. 8/7/07</p>	<p>Needs attention</p>
Bethany, CT Morris to Hatfield	<p>Uncontained spoil piles were noted upgradient from the wetland in this section. 8/7/07</p> <p>Due to heavy rains (in previous weeks), washouts have occurred near the first wetland crossing here. Sediment has overwhelmed the controls in some locations. 8/7/07</p>	<p>Spoil piles should be contained within silt fence and/or haybales or covered with plastic until removed from site. 8/7/07</p> <p>Washouts/gullies should be filled with a stabilizing material. Remove sediment from controls and adjust as needed. 8/7/07</p>	<p>Needs proactive attention</p> <p>Needs attention</p>

JCC (Woodbridge): The silt fence is in need of repair near proposed structure #24119. Also, sediment from foundation work was noted in the dry stream channel.

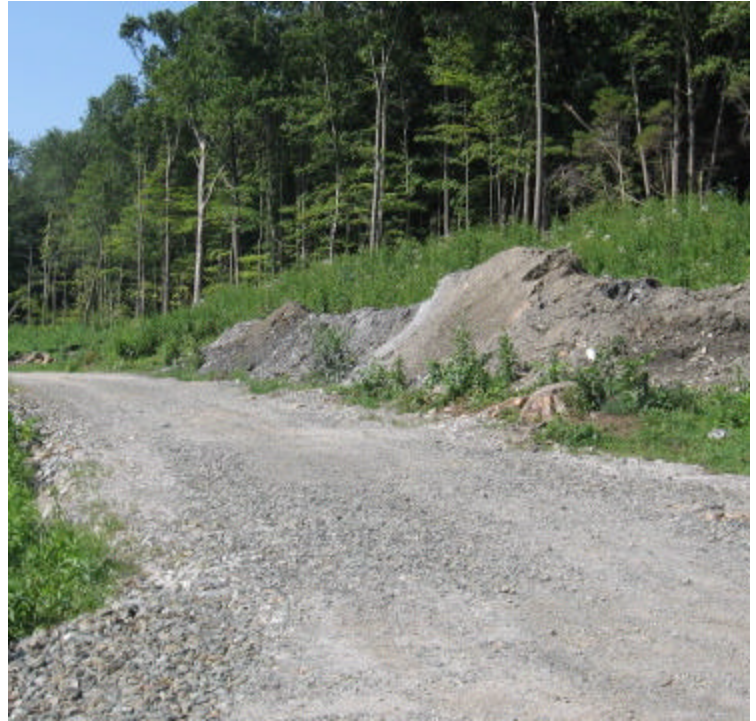
JCC (Woodbridge): Uncontained spoil piles were noted upgradient from the wetland here.

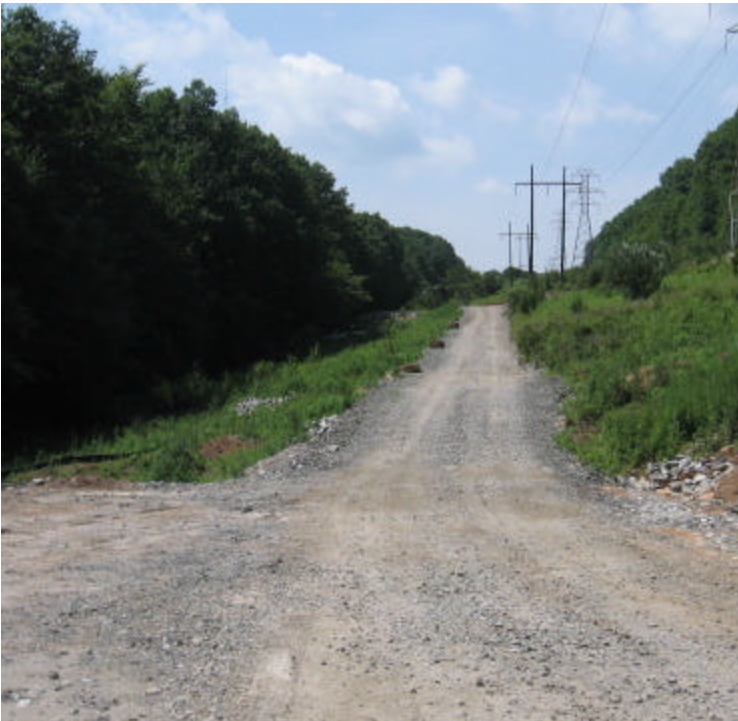
Downs Road	<p>Hay bale check dams were added to the water bar outlets along the access road here. 8/7/07</p>	<p>Continue to monitor and add controls as necessary. 8/7/07</p>	<p>Hay bale check dams were added to the water bar outlets for sediment filtration</p>
Hamden, CT Tom Swamp Rd/Arrow Rd	<p>Temporary culverts are in place within the access roads here. Stone sediment traps and haybale check dams remain at the outlets. Sediment accumulation was removed from the stone trap at the 2nd culvert outlet off Tom</p>	<p>Continue to monitor and add/maintain controls as necessary and avoid piling sediment on top of the stone sediment trap. 8/2/07</p>	<p>Proper controls are in place but still needs proactive attention when feasible</p>

Downs Rd. (Bethany): Haybale check dams have been added at the water bar outlets for sediment filtration.

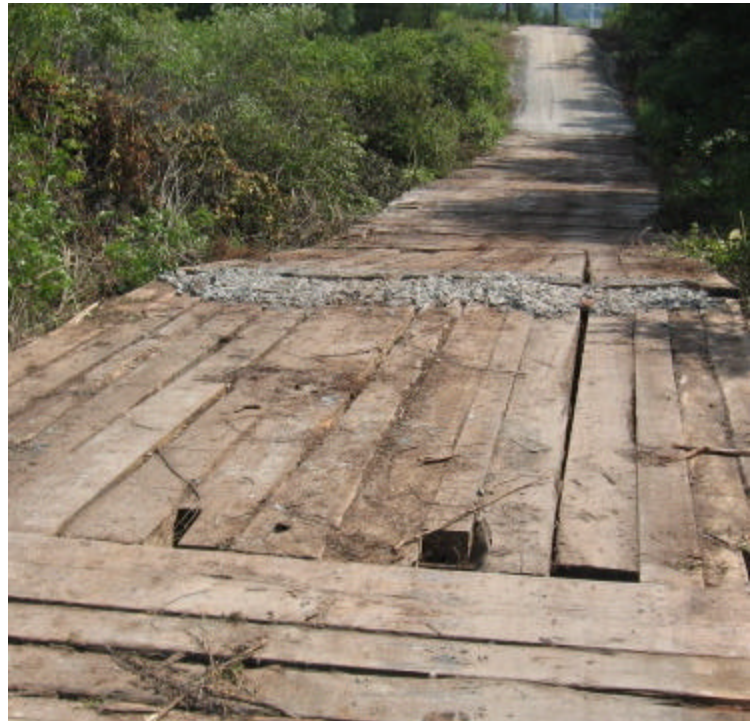
Brooksvale east (Hamden): Timber mats have been installed at the wetland crossing here.
