Docket No. 272 – Development and Management Plan Inspection

Segment 2b Inspection

Date: August 24, 2007

Location: Segment 2b – Cheshire/Hamden Town Line to East Devon Substation

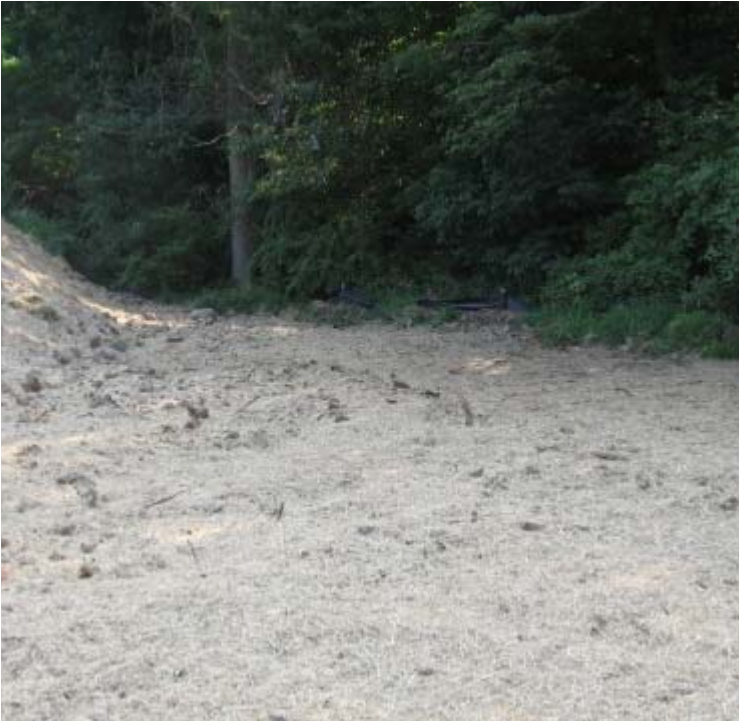
Lexington Lane (Milford): Rock has been pulled away from the silt fence as part of the pad reclamation work. Exposed soils have been mulched.

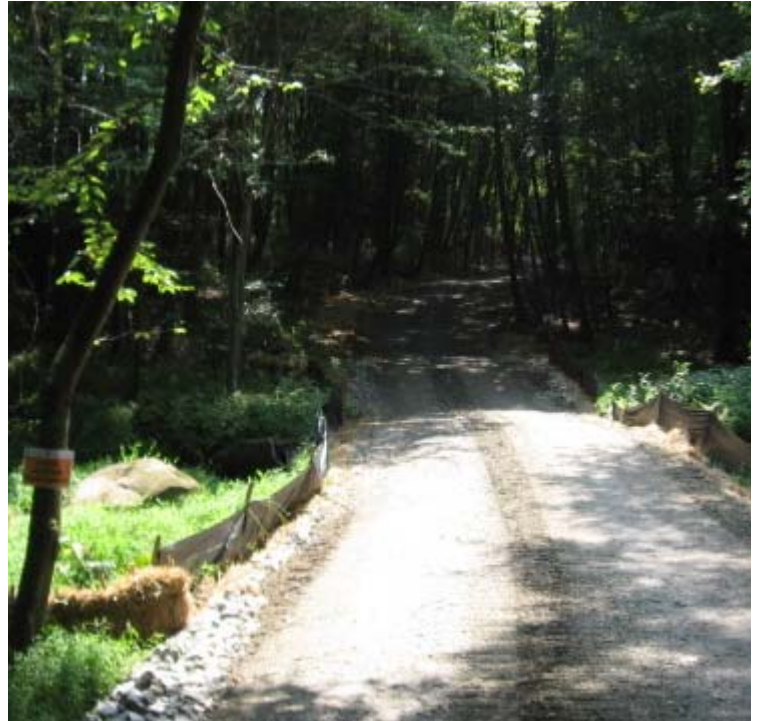
Clearview Ln. to Rte. 15 (Woodbridge): A view of the access road at the stream crossing. Proper controls are in place.

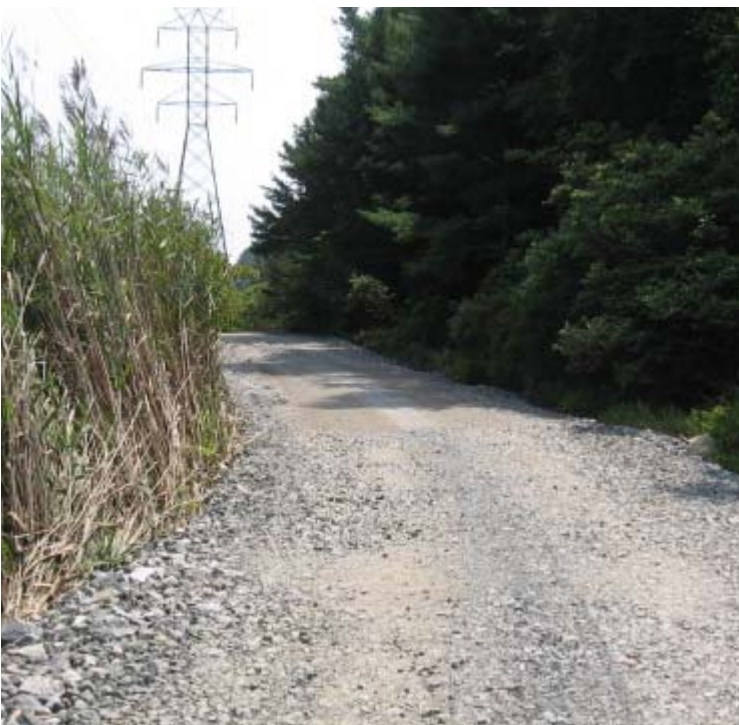
Clearview Ln. to Rte. 15: A view of access road construction through the wetland near structure #3899.

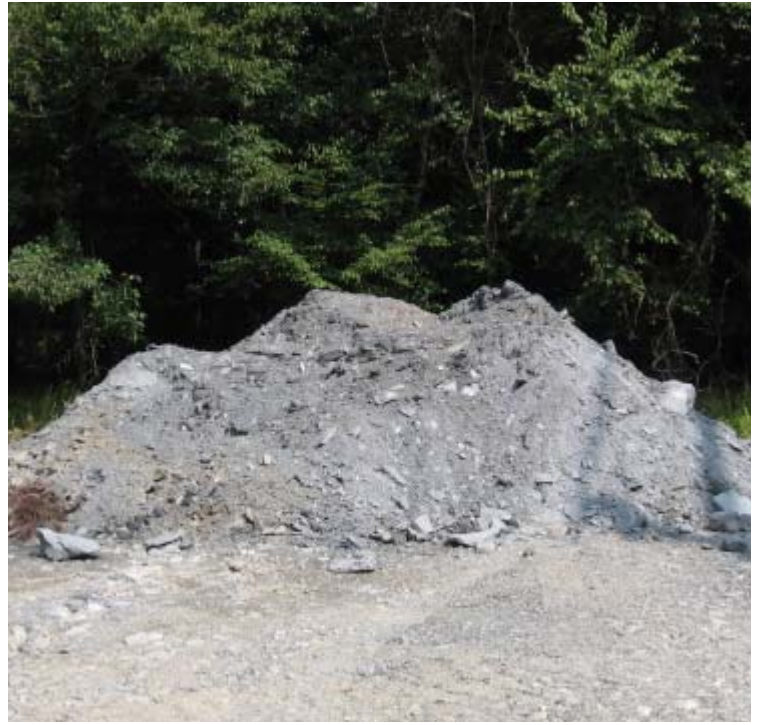
Clearview Ln. to Rte. 15: Spoils remain on the stone pad in the the wetland near structure #3899.

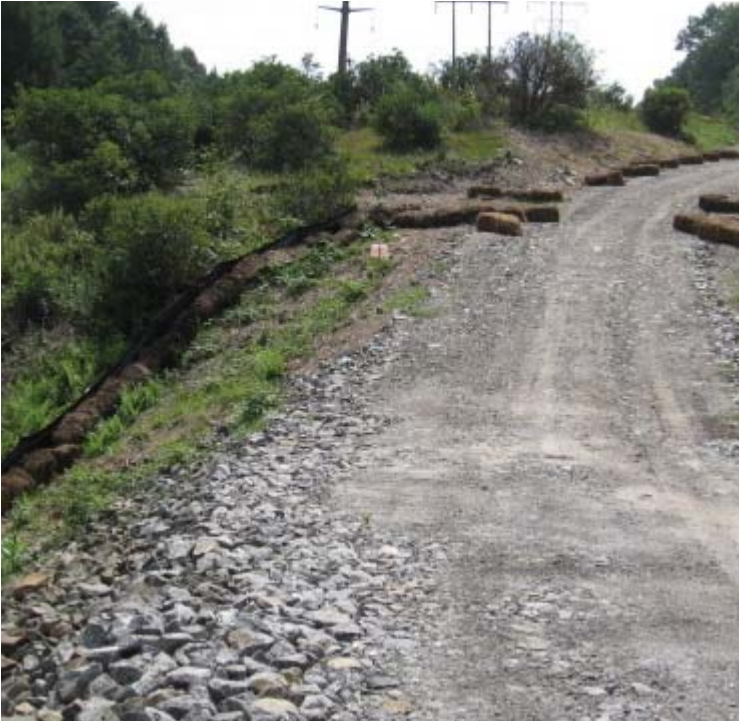
Litchfield Turnpike (Bethany): Haybale check dams have been added along the access road where washouts have occurred in the past.

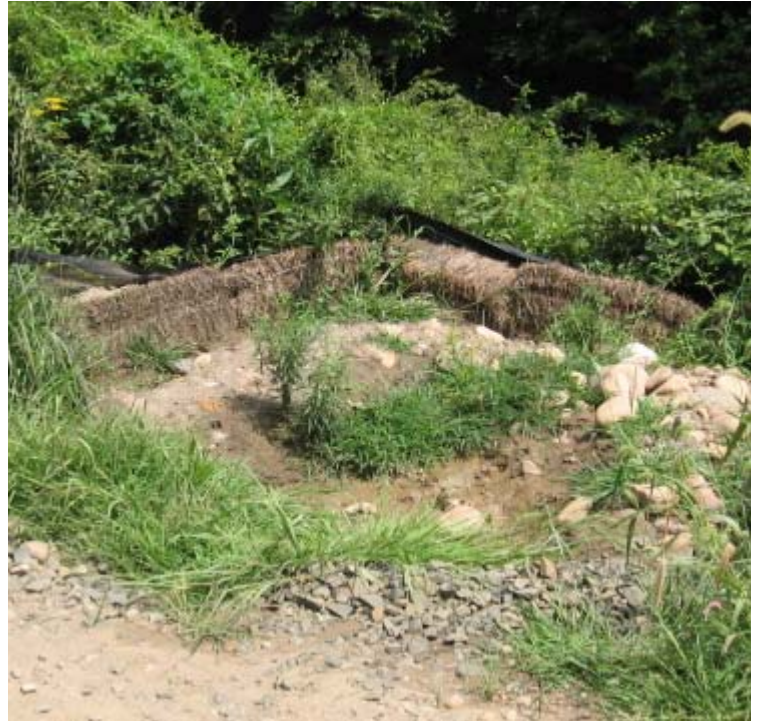
Glen Dam (Woodbridge): Sediment has accumulated in the stone lined sediment trap here.

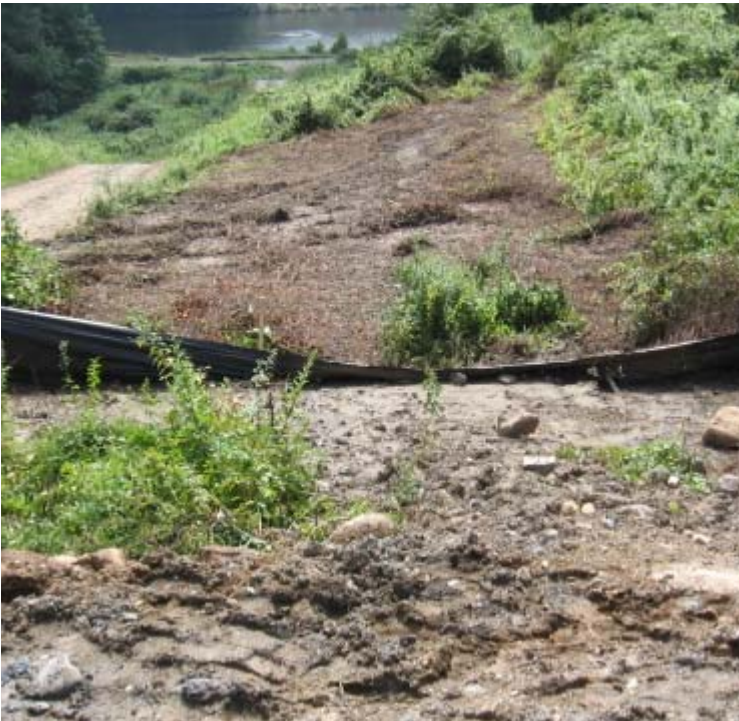
<p>JCC</p>	<p>Exposed soils remain on the slope adjacent to structure #3950. 8/24/07</p>	<p>Exposed soils should be seeded and mulched when feasible. 8/24/07</p>	<p>Needs proactive attention</p>
<p>JCC</p>	<p>Silt fence is in need of repair near structure #24119. Sediment was noted in the dry stream channel here. 8/24/07</p>	<p>Continue to monitor and repair and maintain as necessary. Evaluate sediment accumulation within the stream channel. Carefully remove sediment during the dry season if it is greater than 2” in depth. 8/24/07</p>	<p>Needs attention</p>
<p>JCC</p>	<p>Uncontained spoil piles were noted upgradient from the wetland in this section. 8/24/07</p>	<p>Spoil piles should be contained within silt fence and/or haybales or covered with plastic until removed from the site. 8/24/07</p>	<p>Needs proactive attention</p>

Glen Dam: Silt fence is in need of repair here and soils remain exposed adjacent to structure #3950.

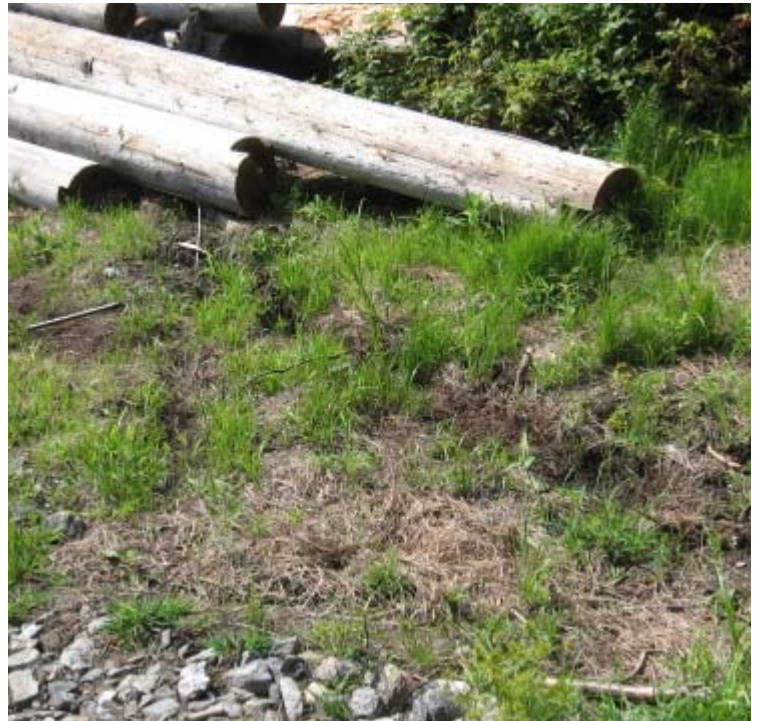
<p>Bethany, CT (Morris to Hatfield)</p>	<p>A stone access road and timber mats have been constructed/installed in the wetland areas in this section. 8/24/07</p>	<p>Continue to monitor. 8/24/07</p>	<p>NA at this time</p>
<p>Hatfield (south)</p>	<p>Ruts from foundation work and a dissembled H-frame structure were observed in the wetland here. 8/24/07</p>	<p>Repair ruts and restore wetland area. Remove poles from wetland as soon as possible. 8/24/07</p>	<p>Needs attention</p>
<p>Hamden,CT West Todd St, Tom Swamp/Arrow Rd, Willow Street, Brooksvale Ave, and Old Lane Rd</p>	<p>Temporary stone access roads and timber mats remain in some of the wetland areas in these sections. 8/24/07</p>	<p>Continue to monitor. 8/24/07.</p>	<p>NA at this time</p>
	<p>The overhead access road is stabilized. Turbid water was noted in the wetland during previous inspections. 8/24/07</p>	<p>Monitor during next large rain event. Evaluate sediment accumulation within the adjacent wetland. Carefully remove sediment from</p>	<p>Needs evaluation</p>

Hatfield Rd (Bethany): Ruts from foundation work and a disassembled H-frame structure remain in the wetland here.
