**Docket No. 272 – Development and Management Plan Inspection**

**Segment 2b Inspection**

**Date:** August 30, 2007

**Location:** Segment 2b – Cheshire/Hamden Town Line to East Devon Substation

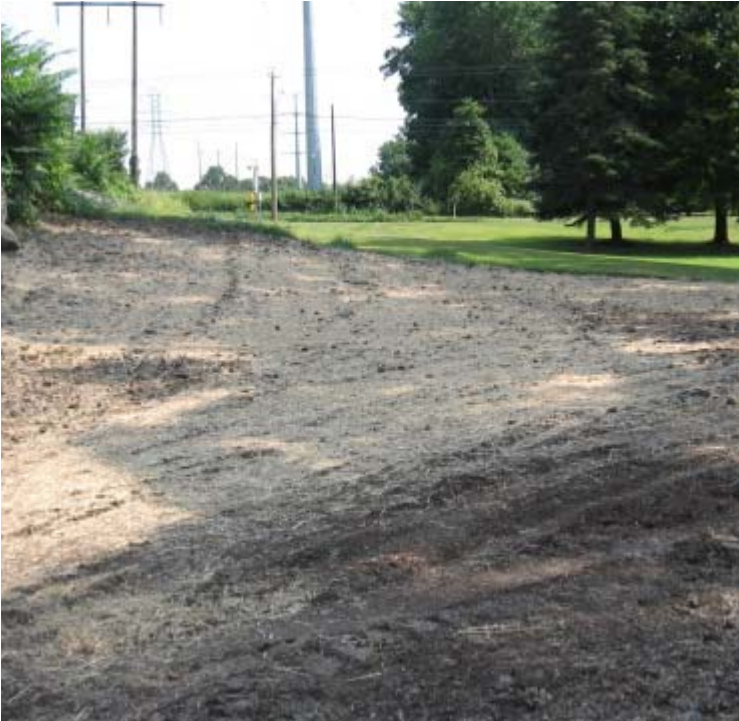
Wheelers Farms Rd (Milford): Exposed soils from pad reclamation activities have been temporarily stabilized with mulch.

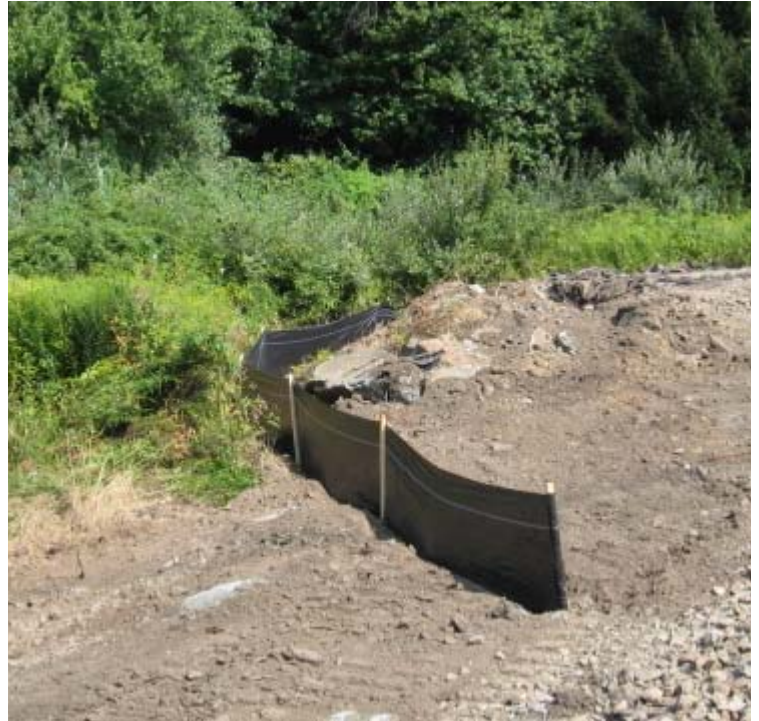
Wheelers Farms Rd: Additional silt fence is being installed as needed during pad reclamation activities.

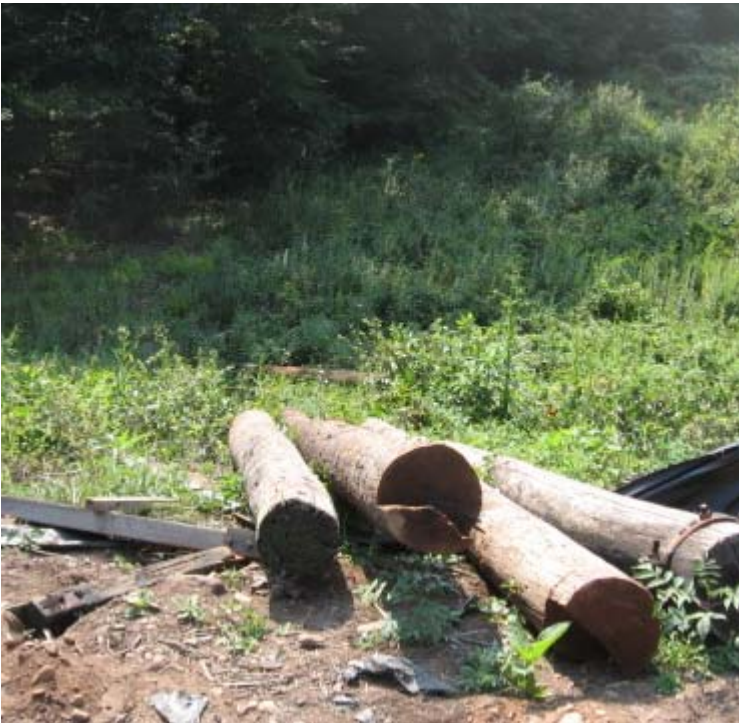
Willow St. (Hamden): Disassembled H-frame structures were noted on top of the silt fence and in a wetland buffer near structure #4010.
