Docket No. 272 – Development and Management Plan Inspection

Segment 3 Underground Line

Date: August 2, 2007

Location: East Devon Substation to the Housatonic River Crossing

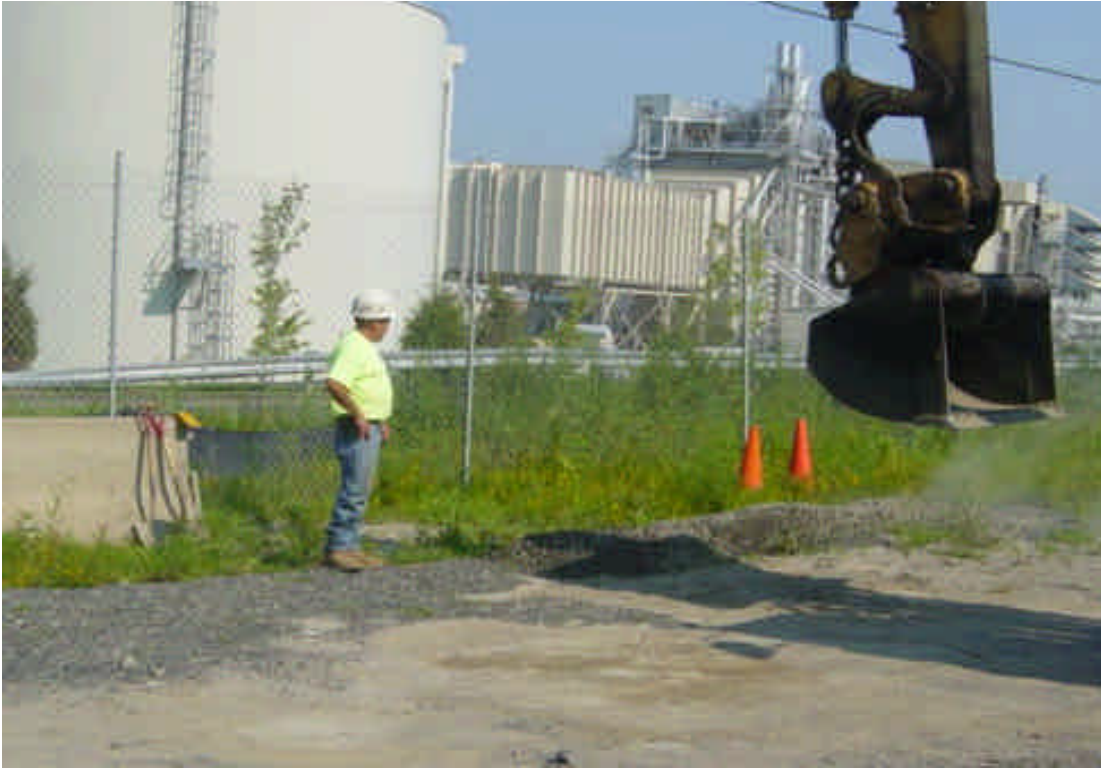
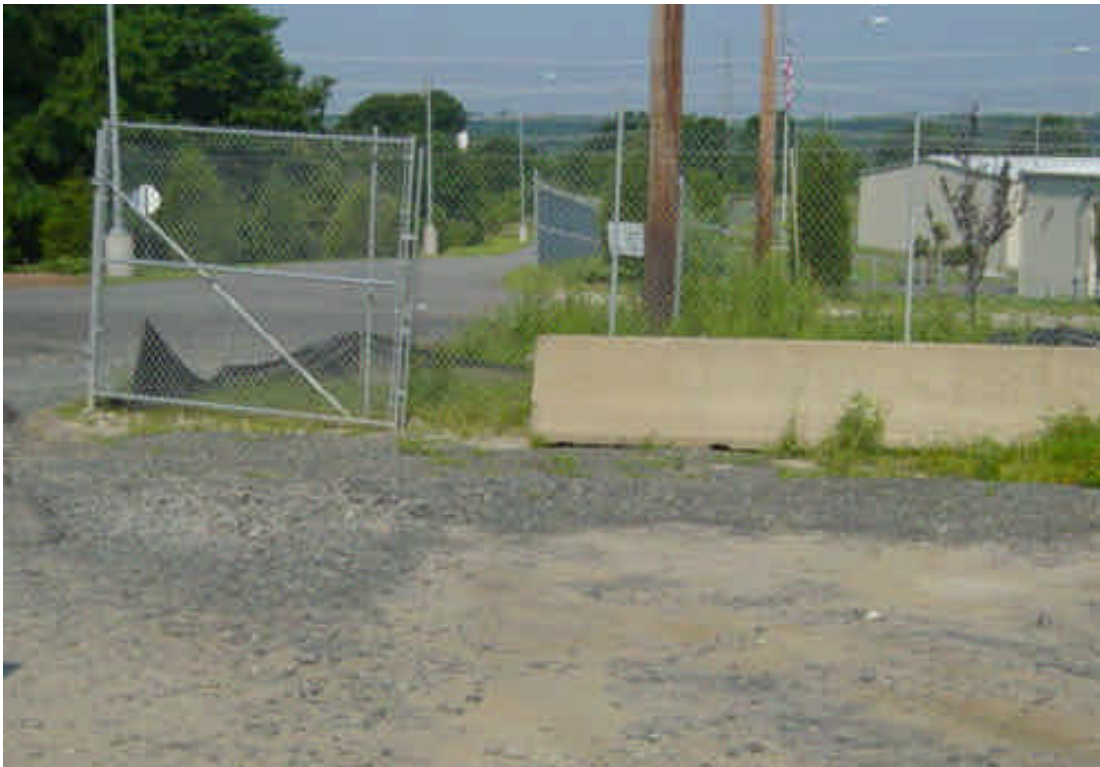
Areas of Inspection	Observation	Recommended Action	Corrected Action
Milford lay-down yard	<p>M/N work is stable. Other non-M/N contractors have also been noted using this location as a staging area. 7/25 – 8/02/07</p> <p>A stone berm was being installed during the inspection in an effort to reduce the accumulation of fine sediment noted at the entrance to the yard (since 7/5). Sediment had been traveling to the grassed area and catch basin (protected with silt sack and some silt fence). 8/02/07</p>	<p>remove the silt fence. 7/25-8/02/07</p> <p>Continue to monitor barrier controls and the new berm for effectiveness. 8/02/07</p>	<p>A stone berm was being installed as an additional barrier.</p>
Inland Wetland and Watercourse encroachment and mitigation	<p>Inland Wetland resource areas are located near station # 1053, 1051, and from #1012 to 1021. Stations #1117 to 1118 are located in a resource area. 8/02/07</p> <p>Wetland flagging was also noted along the trench work between station #1049-51. Portions of the vegetation in this area have been cleared due to other activity. 8/02/07</p>	<p>Monitor resource areas to ensure that non-permitted encroachment or impacts do not occur 8/02/07</p> <p>None at this time. 8/02/07</p>	<p>NA</p> <p>NA</p>

Both photos were taken within the Milford lay-down yard and are depicting a the installation of a stone berm near the entrance to the yard. The berm is being added as a barrier control to reduce sedimentation to the grassed area and the catch basin outside of the perimeter fence.
