**Docket No. 272 – Development and Management Plan Inspection**

**Segment 3 Underground Line**

**Date:** August 15, 2007

**Location:** East Devon Substation to the Housatonic River Crossing

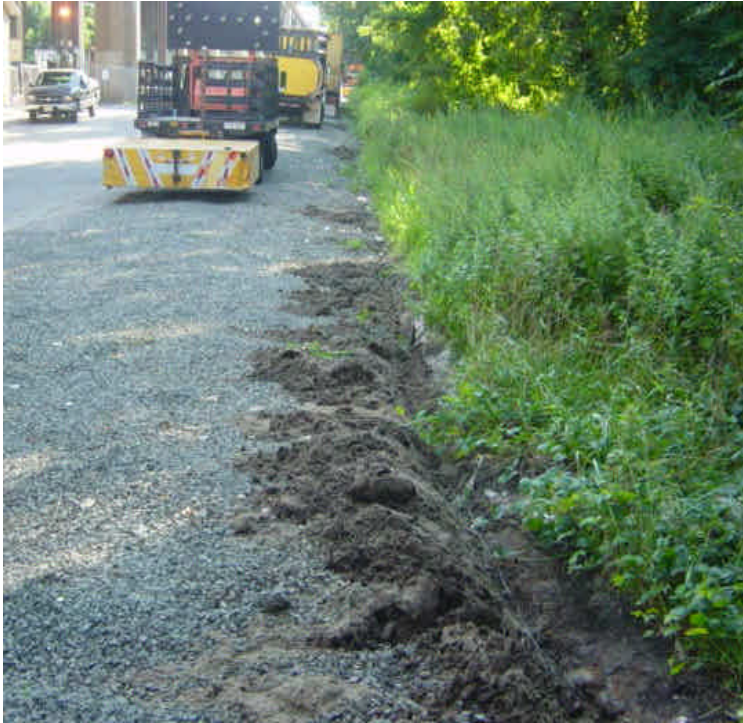
**Silt fence has been removed near sta. # 1017 as adjacent areas are stable. It would be beneficial to apply seed to the areas exposed by the removal of the fence.**

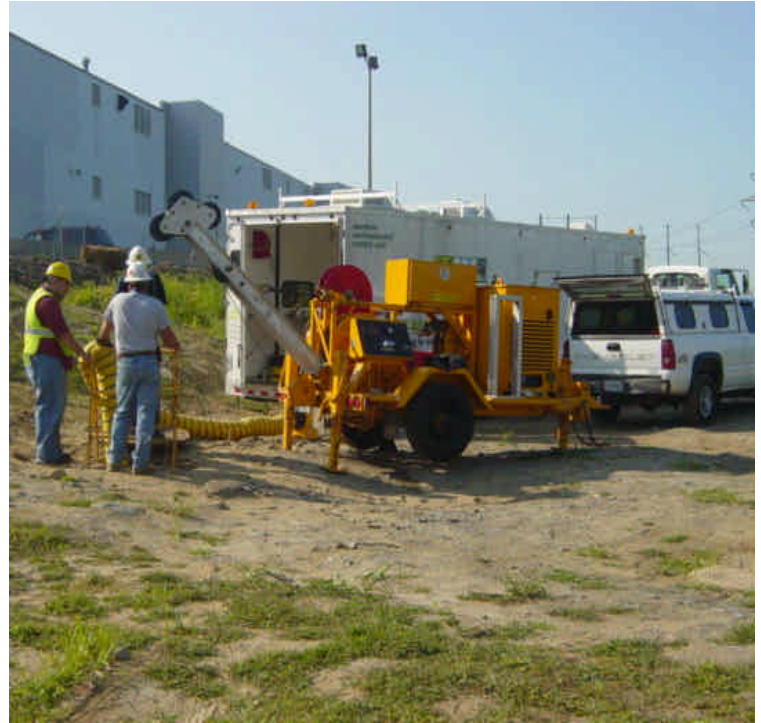
**Crews were working internal to vault #5 to vault #4 during the inspection.**

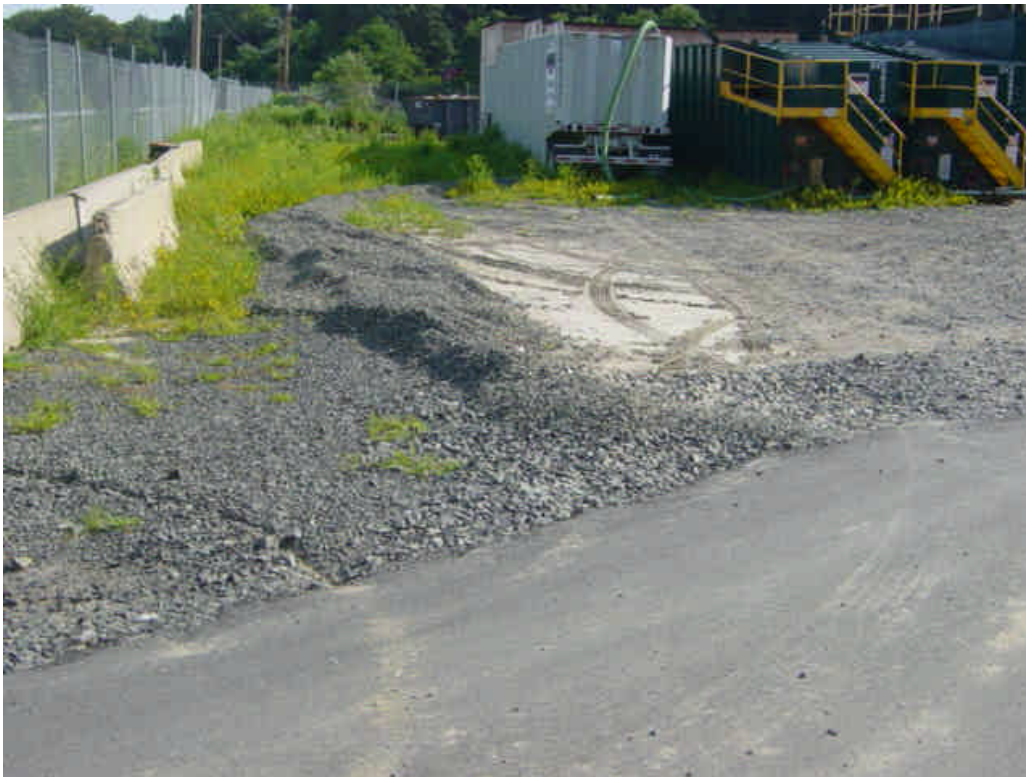
**The stone berm installed within the Milford lay-down is functioning well to control sediment migration beyond the limits of the yard.**
