**Docket No. 272 – Development and Management Plan Inspection**

**Segment 3 Underground Line**

**Date:** August 30, 2007

**Location:** East Devon Substation to the Housatonic River Crossing

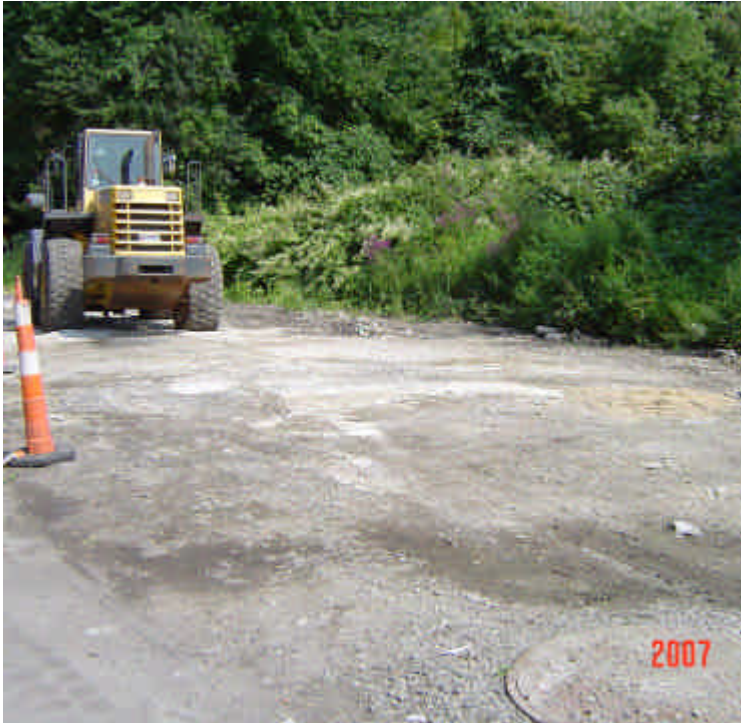
<b>Additional Observations</b>	<p><b>Construction activities that are not part of the M/N project have continued near vault #1 for several weeks. This continues to disturb soil in the area and concrete washouts are a regular occurrence. 8/30/07</b></p>	<p><b>Further stabilization on the part of M/N contractors would be difficult in this area. 8/30/07</b></p>	<p><b>Non-jurisdictional to this D&amp;M plan. Noted for the record.</b></p>

**View of the area near Vault #1. Construction activities that are not part of the Middletown/Norwalk continue here and impede any further stabilization efforts. These contractors also continue to have washouts here.**

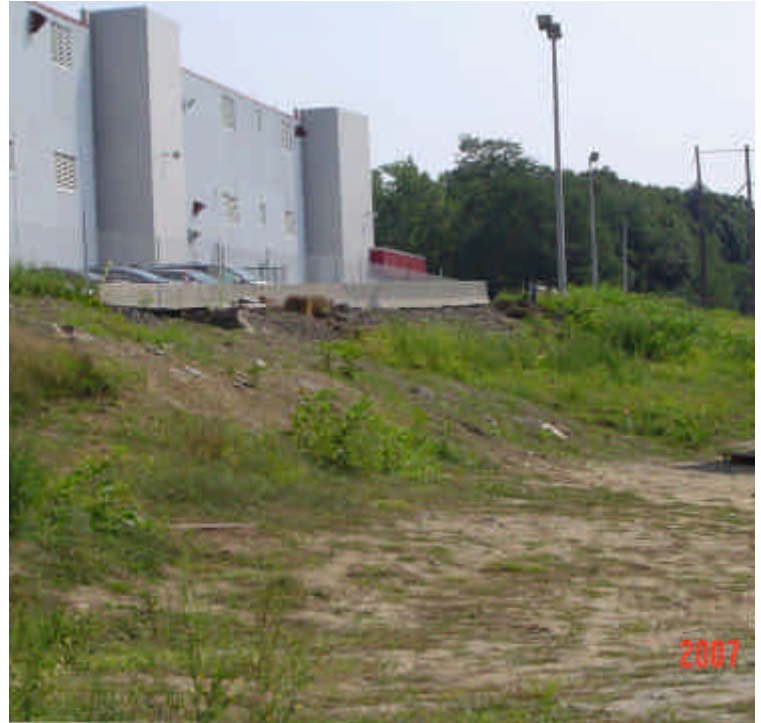
**View of the slope near Sta #1080 which is partially stabilized. Contractors are going to work out a final stabilization plan in the future.**

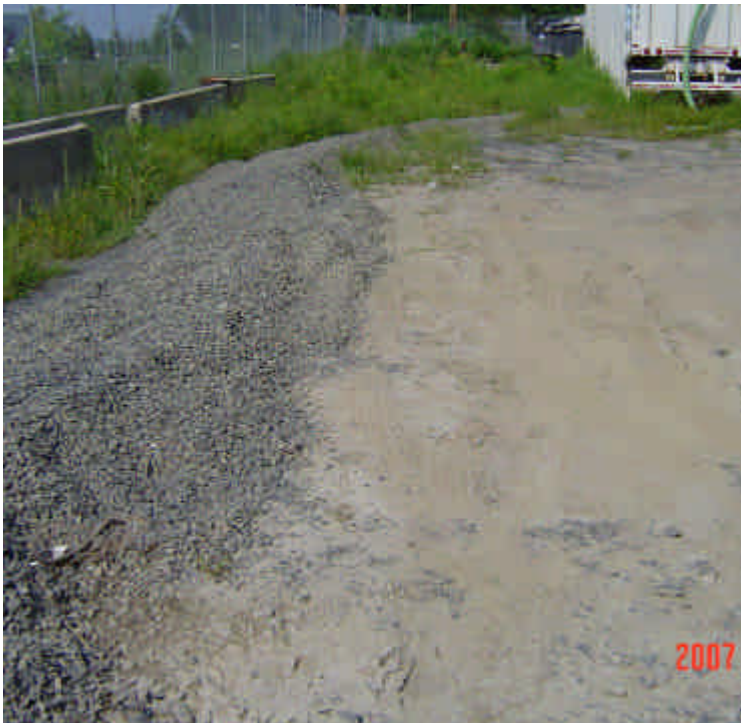
**The stone berm remains in place at the Milford lay-down yard and continues to prevent sedimentation outside of the yard.**

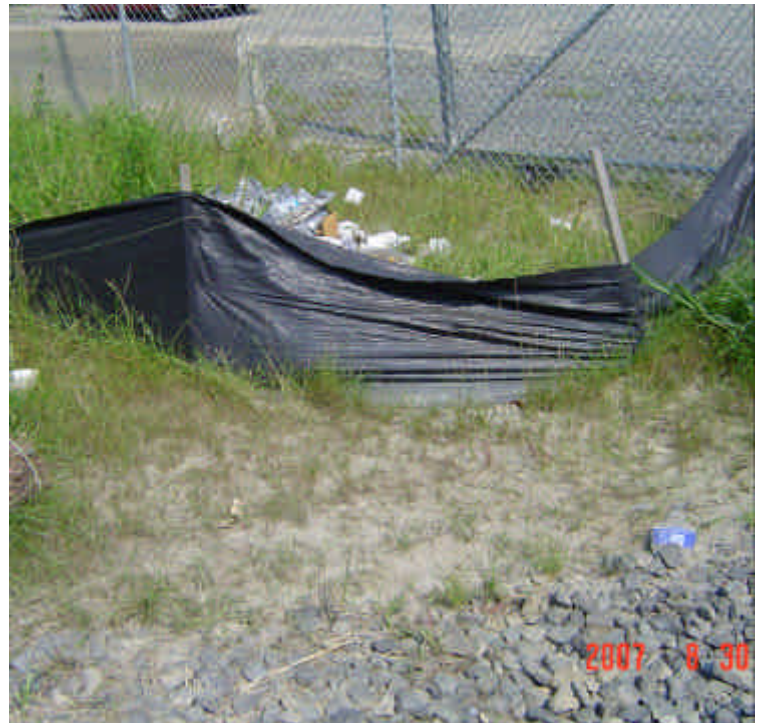
**Non-project related debris was noted dumped just outside the entrance to the Milford yard. Although this is not the contractors' responsibility, consider disposing of it for appearances/aesthetics.**
