Docket No. 272 – Development and Management Plan Inspection

Segment 4a Underground Line

Date: August 2, 2007

Location: Singer Substation to Fairfield/Westport Town Line

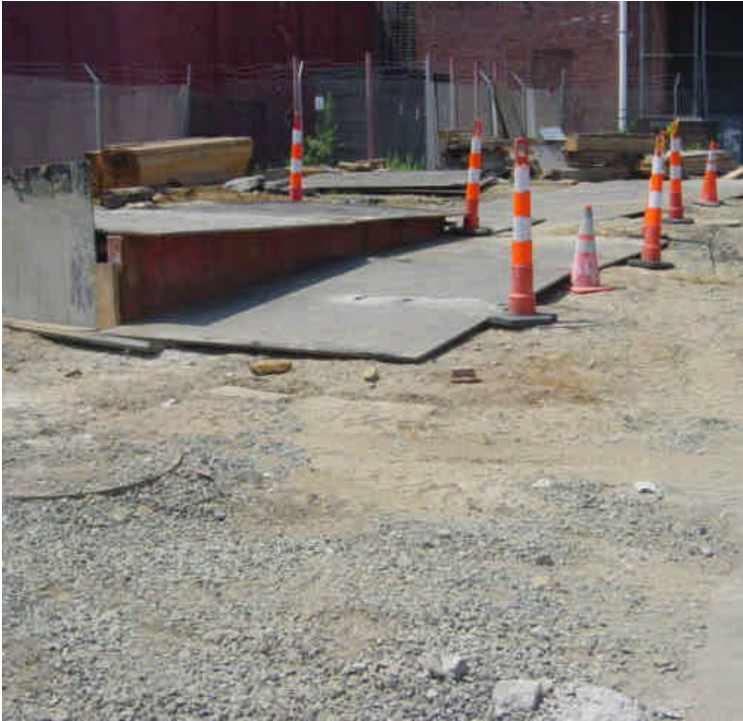
Photo of trenching activities at sta. #788 to #789.

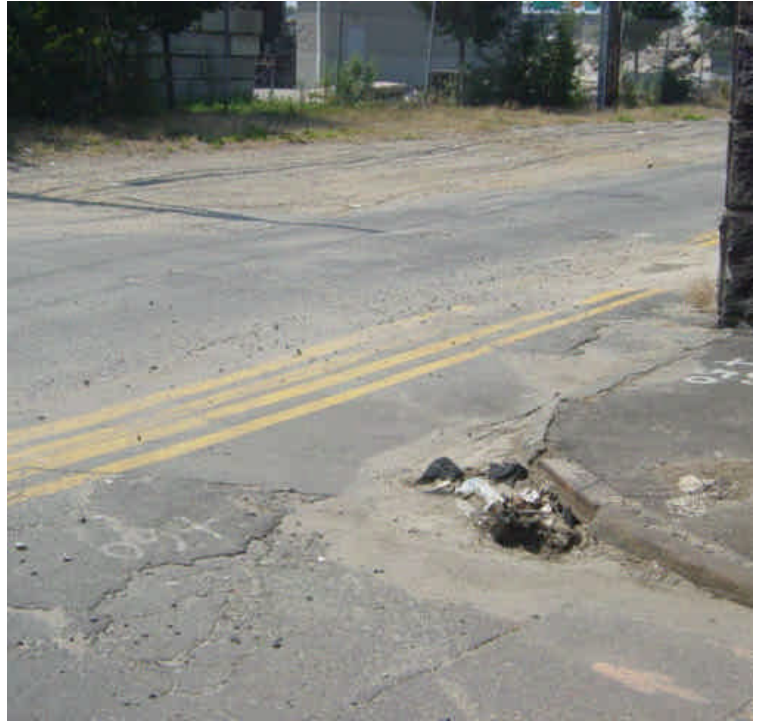
Catch basins located at the intersection of Railroad Ave. and Hancock Ave. are overwhelmed by sediment and debris. Some of the material appears to be from deteriorating patches or fill covering the trench.

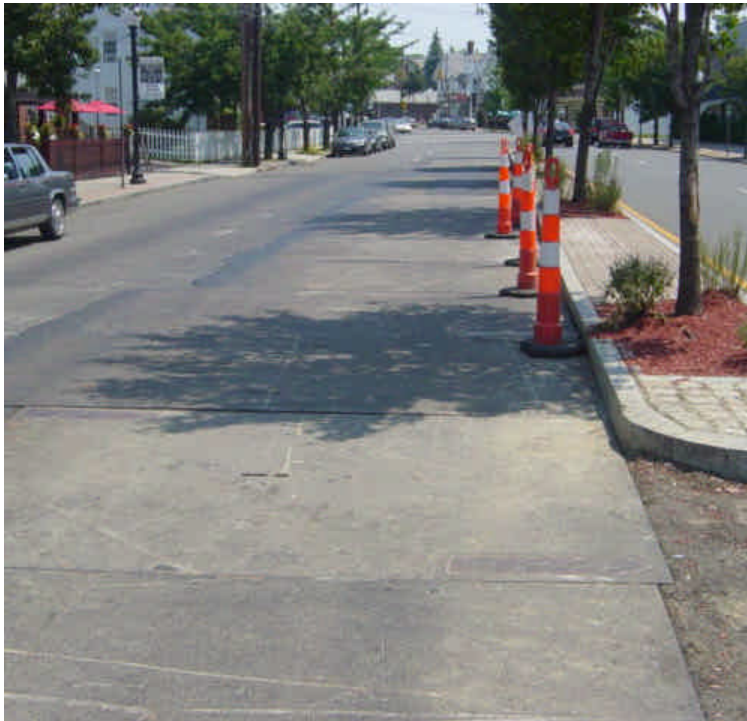
Photo of a typical active area of construction as it looks during the daytime, with trench covers in place.

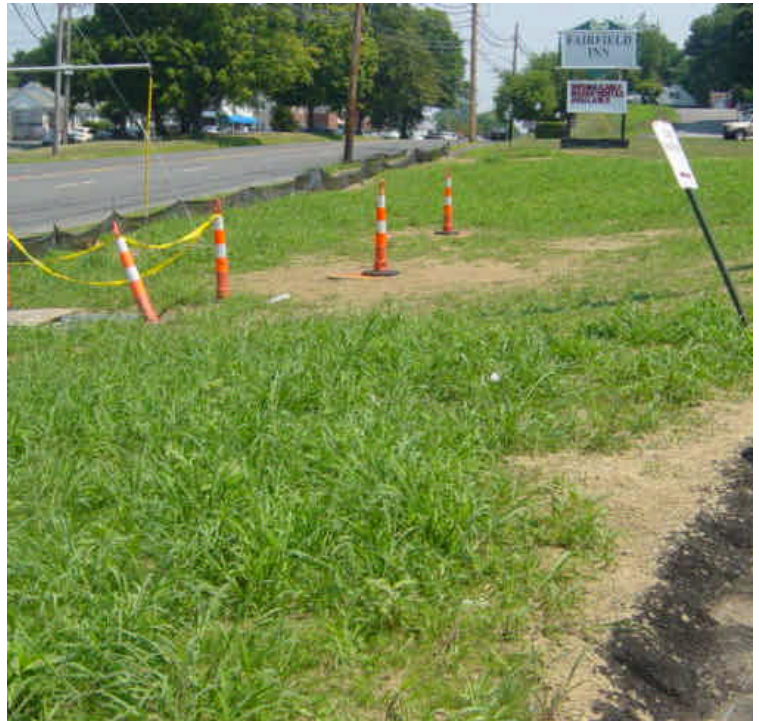
Photo of vegetative growth at vault #37. The majority of the area has greater than 75% vegetative cover.
