Docket No. 272 – Development and Management Plan Inspection

Segment 4a Underground Line

Date: August 15, 2007

Location: Singer Substation to Fairfield/Westport Town Line

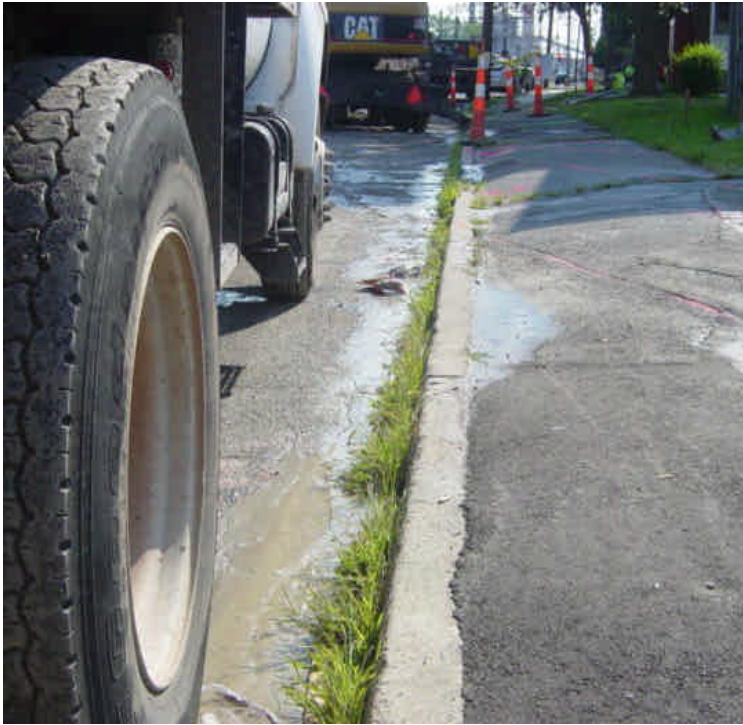
Dust/slurry was observed along on the edge of the roadway from recent sawcutting activities near sta. # 775. Continue to attend to cleaning up this material as soon as it is generated.

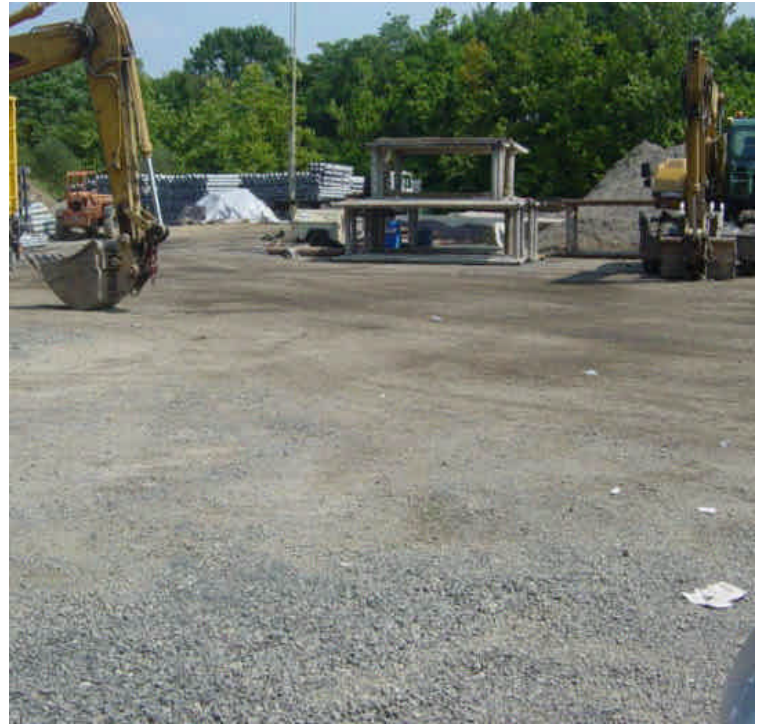
Calcium chloride has been spread throughout the King's Highway laydown yard to aid in reducing airborne dust generation.

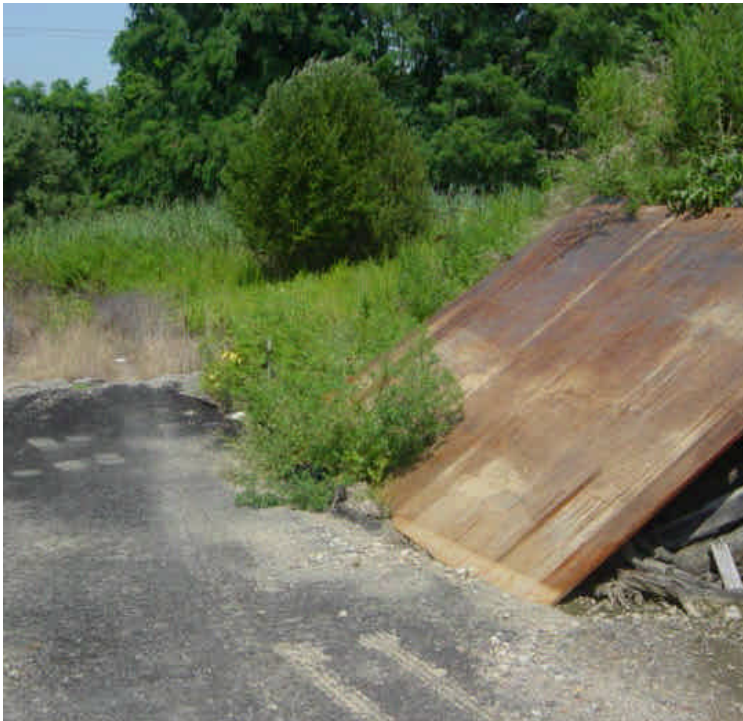
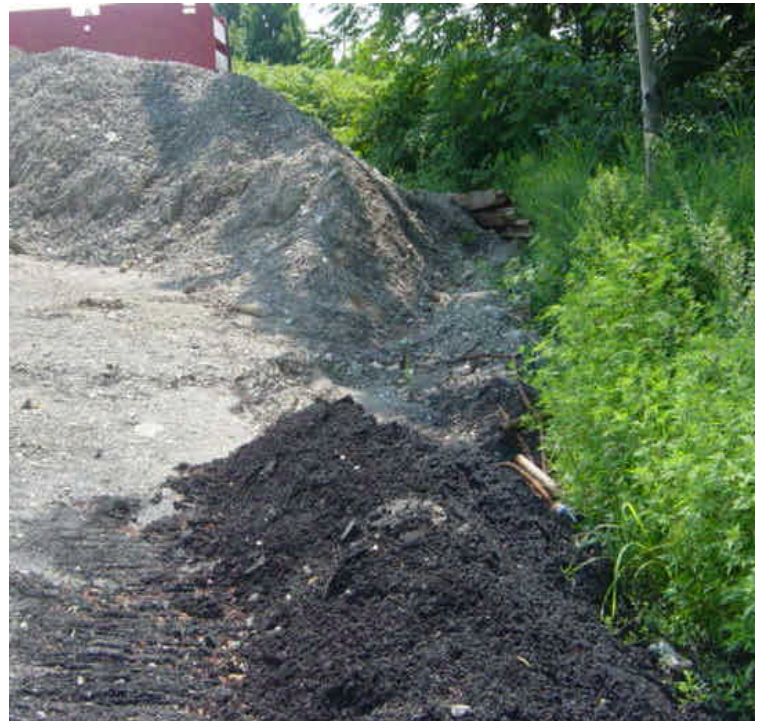
Both photos were taken within the King's Highway lay-down yard. Materials were observed overwhelming perimeter barrier controls in two locations.

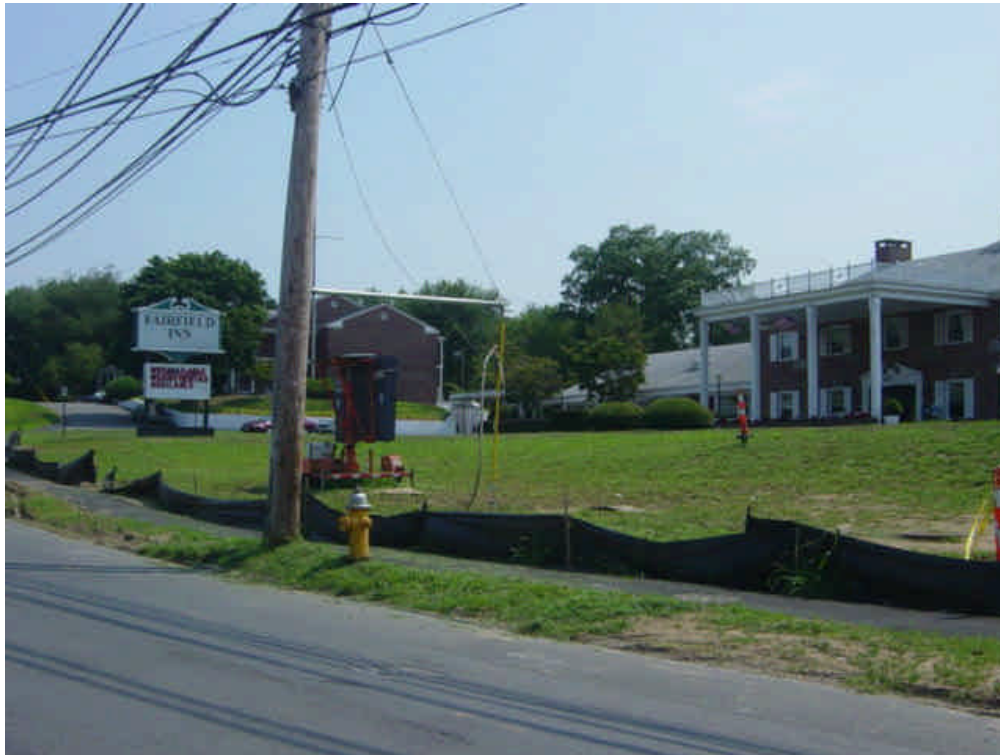
Erosion controls are in disrepair near vault #37. Either maintain the controls or remove them if the adjacent area is fully stabilized.

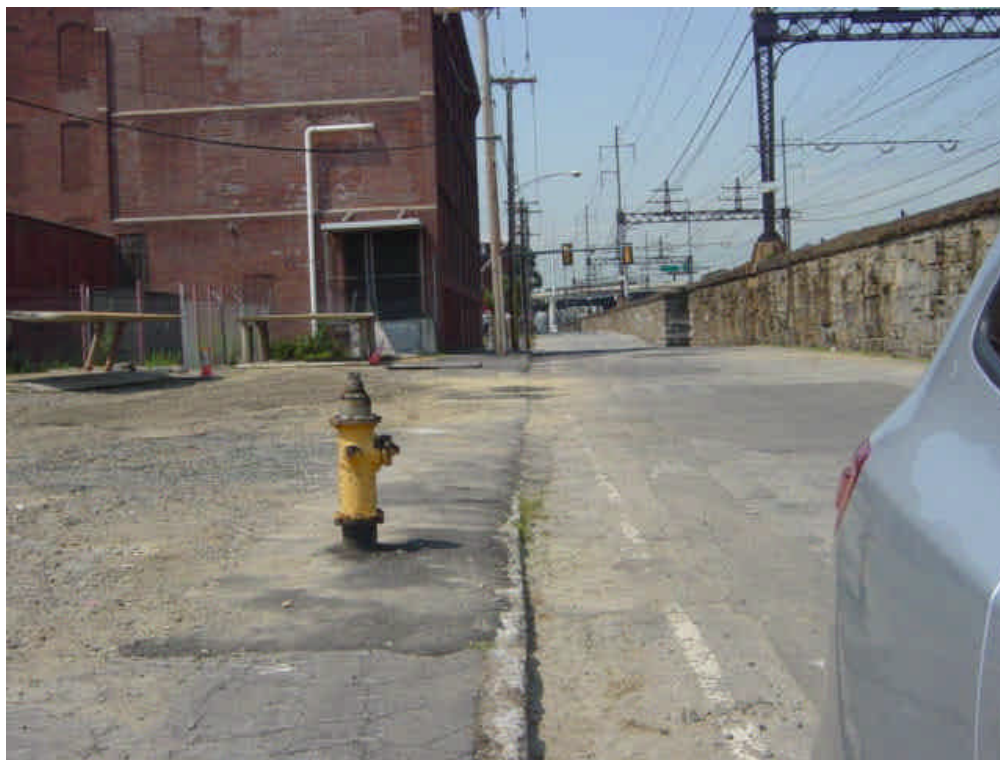
Soils from construction activities have migrated onto Railroad Ave. near sta. #789.
Sweep the roadway on a regular basis and contain any exposed soils.
