Docket No. 272 – Development and Management Plan Inspection

Segment 4a Underground Line

Date: August 21, 2007

Location: Singer Substation to Fairfield/Westport Town Line

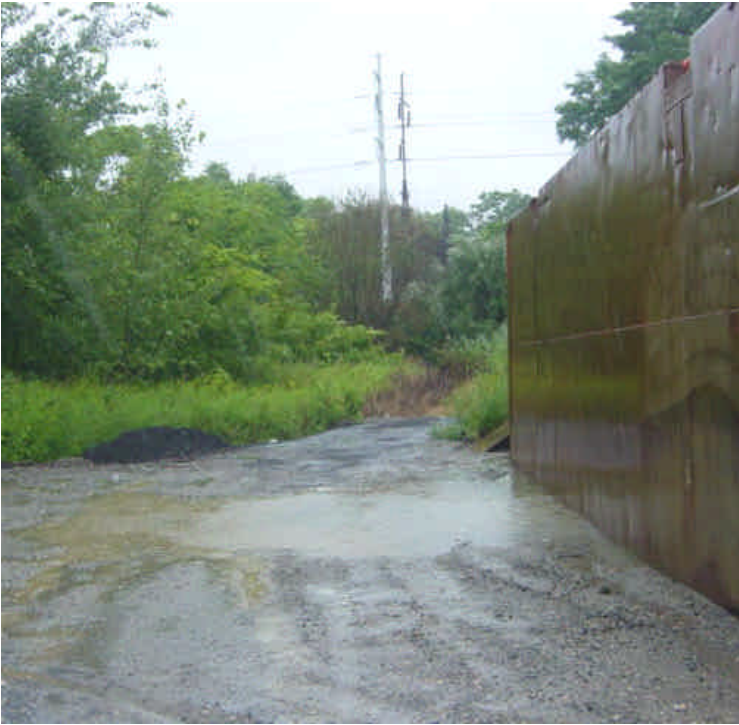
Areas of Inspection	Observation	Recommended Action	Corrected Action
Kings Highway Lay-down Yard (Off Kings Highway, near Rt. 1 rotary)	<p>covered under this D&M plan. This week, a significant amount of sediment-laden runoff was leaving the yard and entering a nearby unprotected catch basin. 8/21/07</p> <p>Sediment and debris was accumulating in the controls at the catch basins at the intersection of Railroad and Hancock Ave. The material appears to be a result of the deteriorating patch or fill on the trench. Minor amounts of sediment were noted within the roadway. 8/2-8/21/07</p> <p>Sediment from the construction activities was noted within Railroad Ave. near sta. #789. 8/15/07 Minimal sediment remains, rain may have washed some away. 8/21/07</p> <p>Perimeter erosion controls are overwhelmed by stored materials in two locations at the yard. 8/8-8/21/07</p>	<p>Remove sediment and debris from the catch basins, restoring their capacity. Sweep and properly dispose of any sediment/material within the roadway. 8/2-8/21/07</p> <p>Remove sediment from roadway and stabilize/contain any exposed soils that remain with the construction area. 8/21/07</p> <p>Re-establish the controls where necessary. 8/21/07</p>	<p>Needs attention</p> <p>Needs attention</p> <p>Needs attention</p>

Both photos were taken within the King's Highway lay-down yard. Left: Materials were still observed overwhelming perimeter barrier controls in two locations to the left and right of photo view. Right: A fluid filled bucket/attachment was being stored just outside of the containment area but still within the yard. Continue to store fluid filled equipment proactively within the containment area.

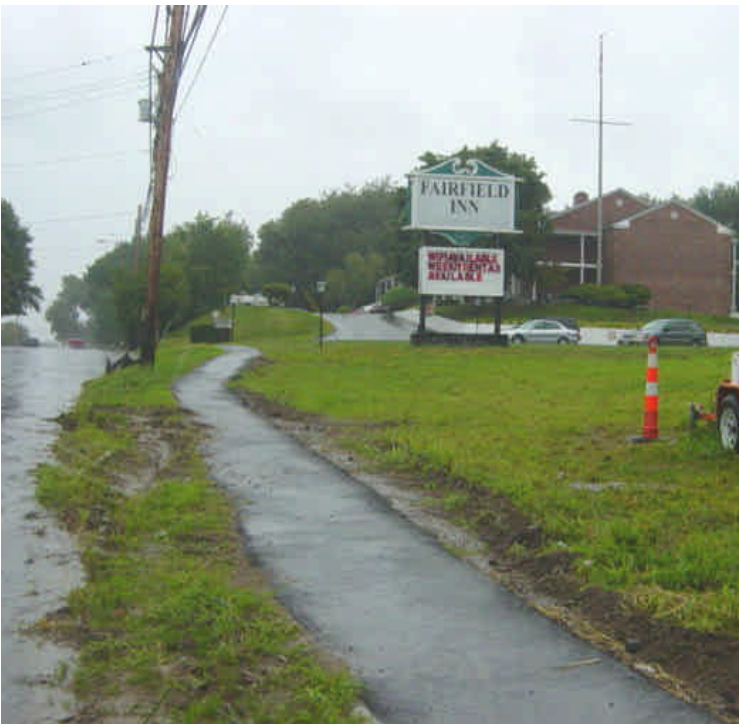
Erosion controls near vault #37 have been removed. Small amounts of exposed soil were noted as a result of removing the silt fence. Some ruts/exposed soil were also noted in the grass along the shoulder of the roadway. Mulch and seed these areas to reduce run-off.

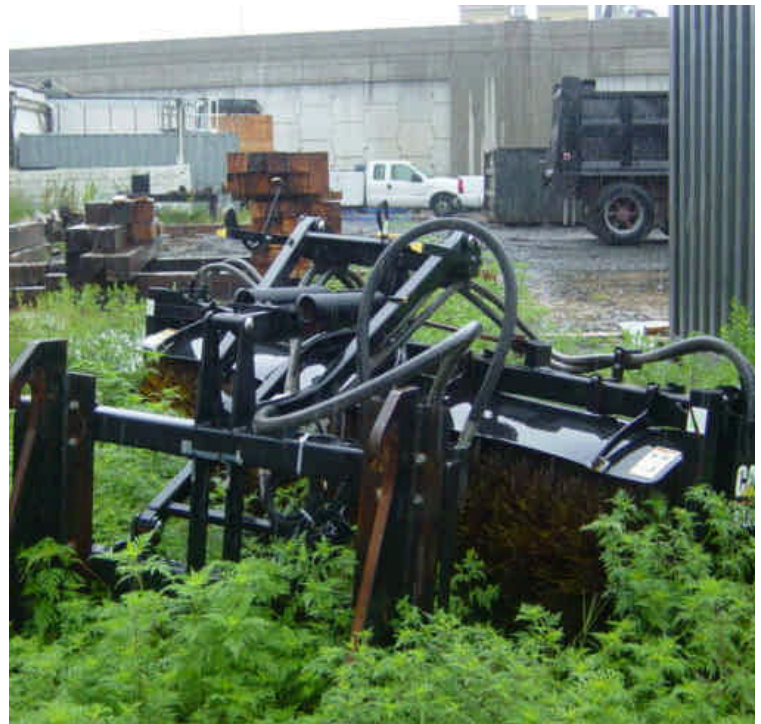
A fluid-filled sweeper was noted stored within the Bostwick Ave. lay-down yard. Continue to store all fluid filled equipment proactively in the proper containment.
