Docket No. 272 – Development and Management Plan Inspection

Beseck Switching Station

Date: May 17, 2006

Location: Beseck Switching Station

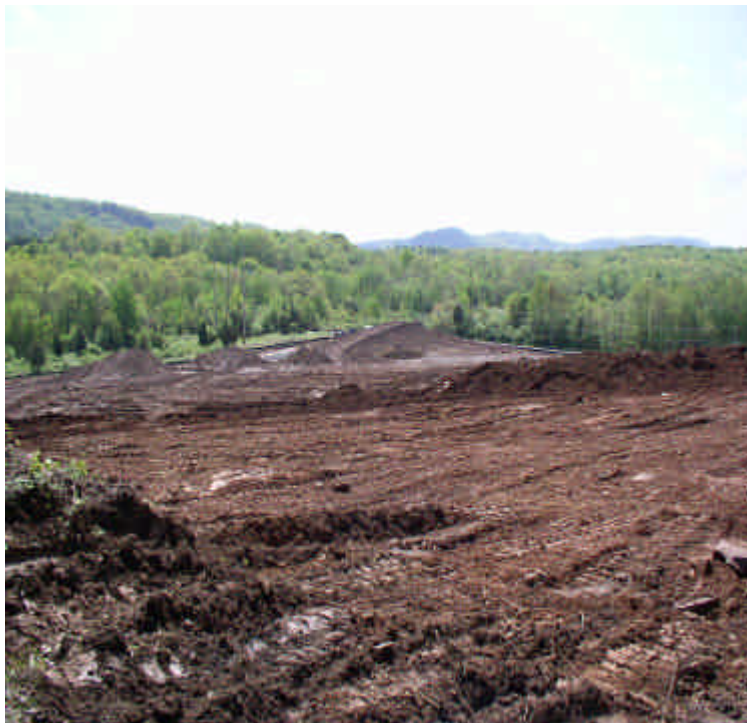
Entire site viewed from the northeast corner toward southeast.

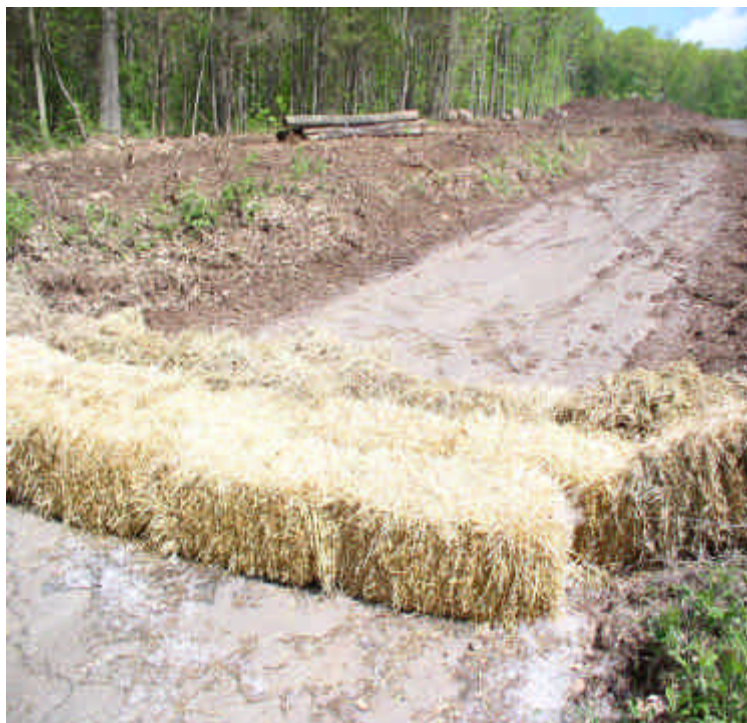
Additional haybales installed along the unused, western driveway

Areas of Inspection	Observation	Recommended Action	Corrected Action
Access Roads and Adjacent Roadways	<p>All vehicles are using the stone entrance pad on the east side of the site. Trucks are only allowed access via the stone entrance. No significant tracking of soil was present here. 5/17/06</p> <p>Rainwater run-off and sediment from the construction entrance on east side of site has deposited a very minor amount of sediment onto Carpenter Lane. 5/17/06</p> <p>Two additional rows of haybales and a soil berm were placed across the unused driveway on the west side of the site to control run-off. 5/17/06</p>	<p>Check stone construction entrance periodically to ensure it does not become filled/buried with soil; clean/refresh stone as needed. 5/17/06</p> <p>Street sweeping and silt sack replacement in the catch basins (CB) should continue to be performed as needed. 5/17/06</p> <p>Watch run-off and replace haybales as necessary. 5/17/06</p>	<p>Stone entrance has been extended further into the site. 5/17/06</p> <p>CB controls continue to be replaced proactively.</p> <p>Additional controls were installed across the driveway.</p>

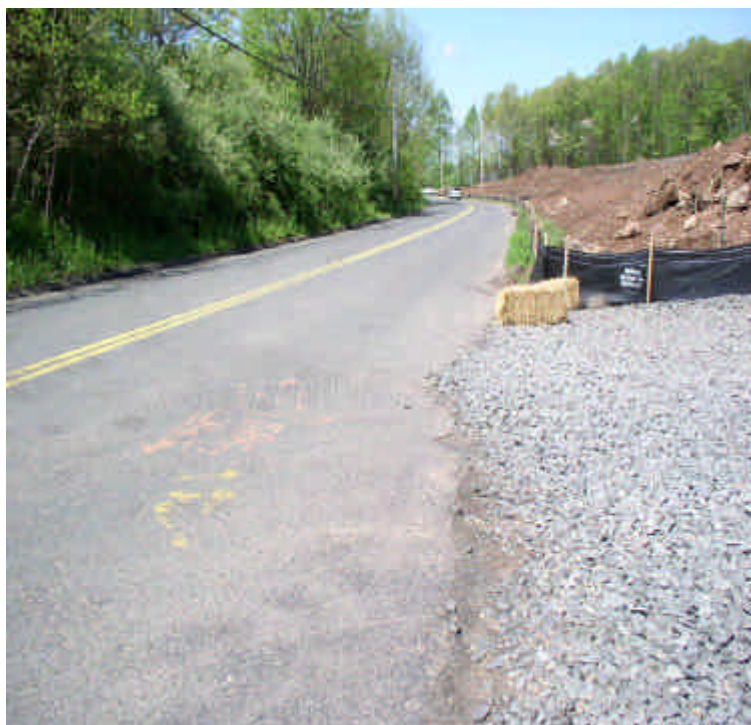
Carpenter Lane at the construction entrance. Sediment tracking was not observed.

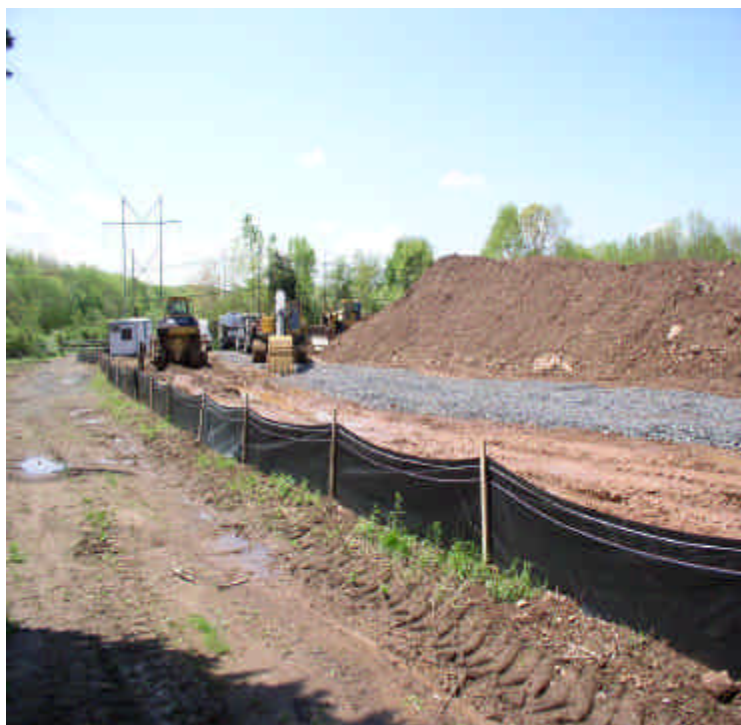
The crushed stone construction entrance was extended.

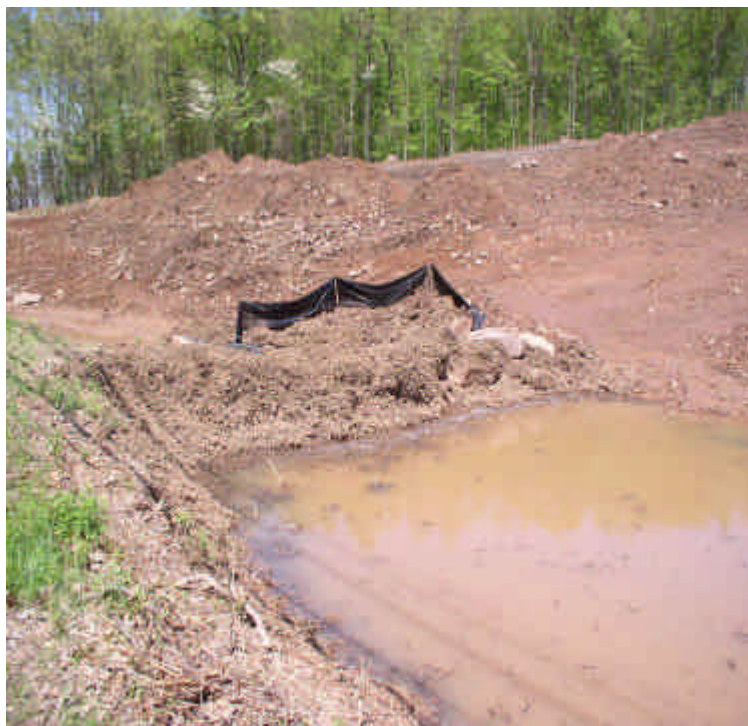
New settling basin installed adjacent to the storm drain inlet.

Areas of Inspection	Observation	Recommended Action	Corrected Action
Erosion and Sediment Controls	<p>Silt fence installed along the south and east sides of the site is in good condition. Soil has eroded from the toe of the silt fence in a few small areas along the east side. 5/17/06</p> <p>Due to recent rain events two temporary settling basins were installed on both sides of the storm drain inlet (onsite). They are separated from the storm drain by stone covered with wood chips. Although these measures are helping control sediment, storm water leaving the outlet pipe is still turbid. 5/17/06</p>	<p>Maintain/inspect silt fence throughout construction. Check the base of the silt fence for gaps and toe-in the area as needed. 5/17/06</p> <p>Additional measures to reduce water velocity and remove suspended sediment are being evaluated. e.g. install fabric liner and/or crushed stone within the settling basin, silt socks filled with wood chips, or possibly, approved flocculating agents. 5/17/06</p>	<p>NA</p> <p>Temporary settling basins were constructed. More stone and wood chips were placed inside the silt fence to the storm drain inlet for further protection.</p>

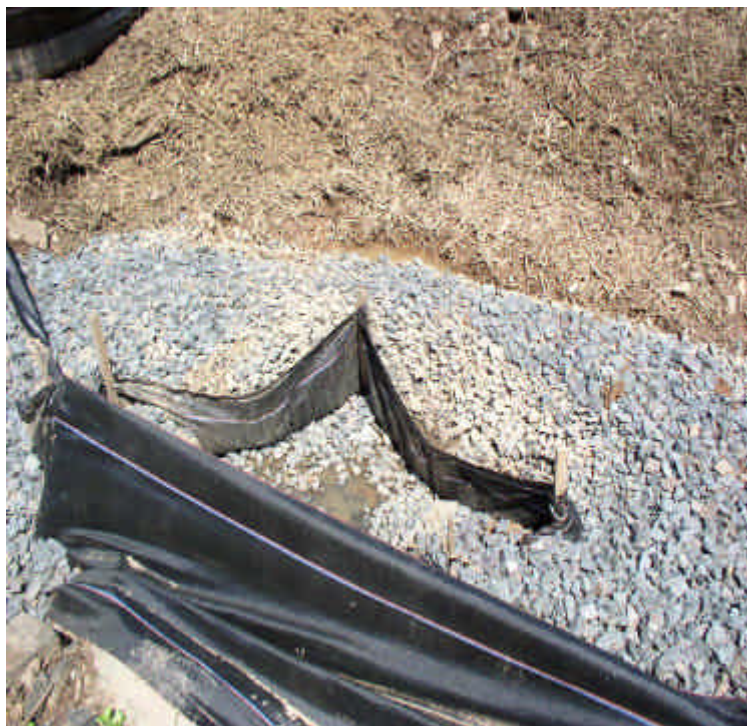
Storm drain inlet leading to wetland across Carpenter Lane. Even though a number of additional controls have been placed, water remains turbid leaving site.

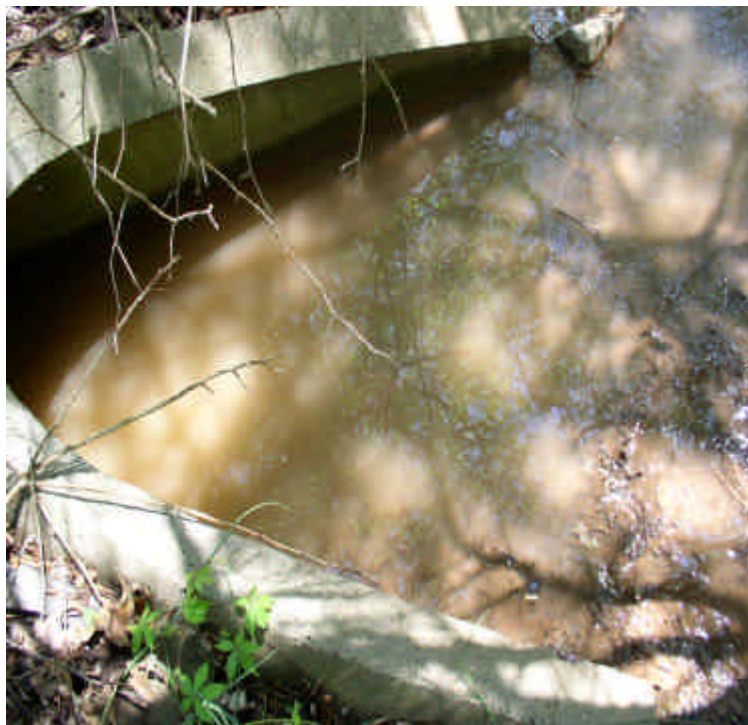
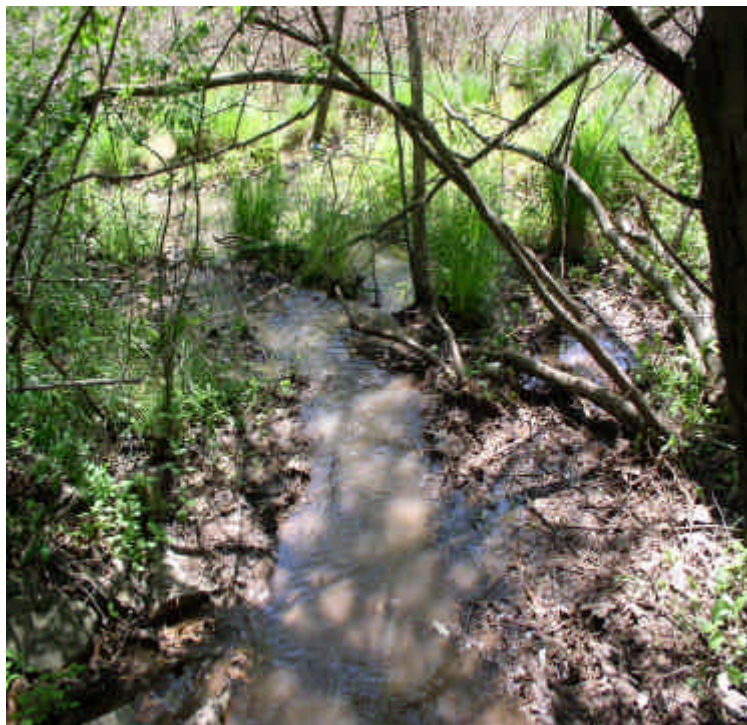
Inland Wetland and Watercourse encroachment and mitigation	<p>Wetland east of the site contains clear water. 5/17/06</p> <p>Wetland south of the site was receiving turbid water from the storm drain. See Erosion and Sediment Controls for more detail. 5/17/06</p>	<p>Continue to monitor wetlands during rain events. 5/17/06</p> <p>Additional control measures are being evaluated; continue to monitor wetlands during rain events. 5/17/06</p>	<p>NA</p> <p>Two settling basins were created around drain inlet.</p>
State species of concern, threatened and endangered species.	<p>According to the D&M plan, state-listed species are not located in this work area.</p>	<p>NA</p>	<p>NA</p>
Vegetative clearing limits (including trees to save or danger trees noted).	<p>All trees have been removed from the site and stumping is complete. 5/17/06</p>	<p>Stumps have been ground and their chips are being use as erosion controls. 5/17/06</p>	<p>NA</p>

Both photos show the area across (south of) Carpenter Lane where storm water entering the wetland remains turbid despite controls on site. Further controls are being evaluated.
