**Docket No. 272 – Development and Management Plan Inspection**

**Beseck Switching Station**

**Date:** May 24, 2006

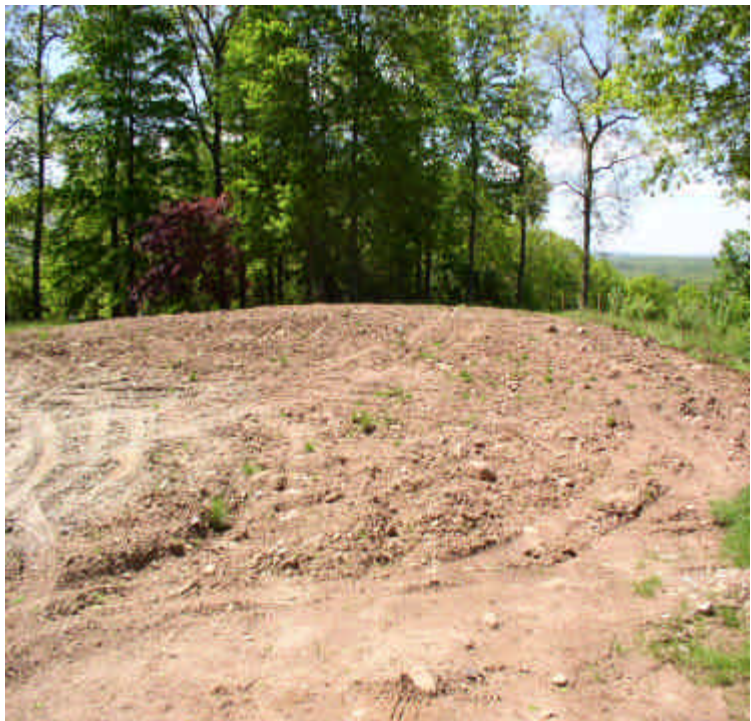
**New soil stockpile area located at the old Zolnik property. Silt fence was being installed in this location**

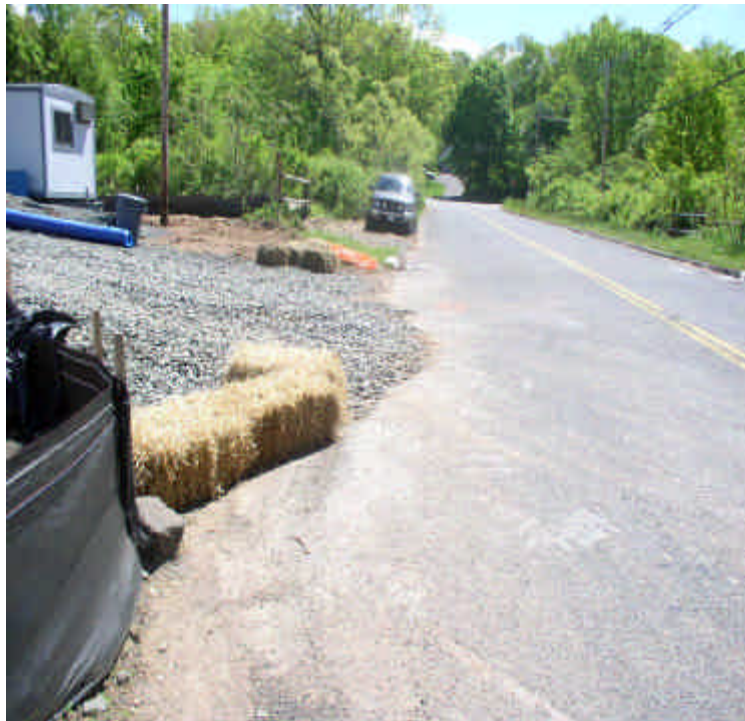
**Carpenter Lane at the construction entrance. No significant sediment tracking was noted.**

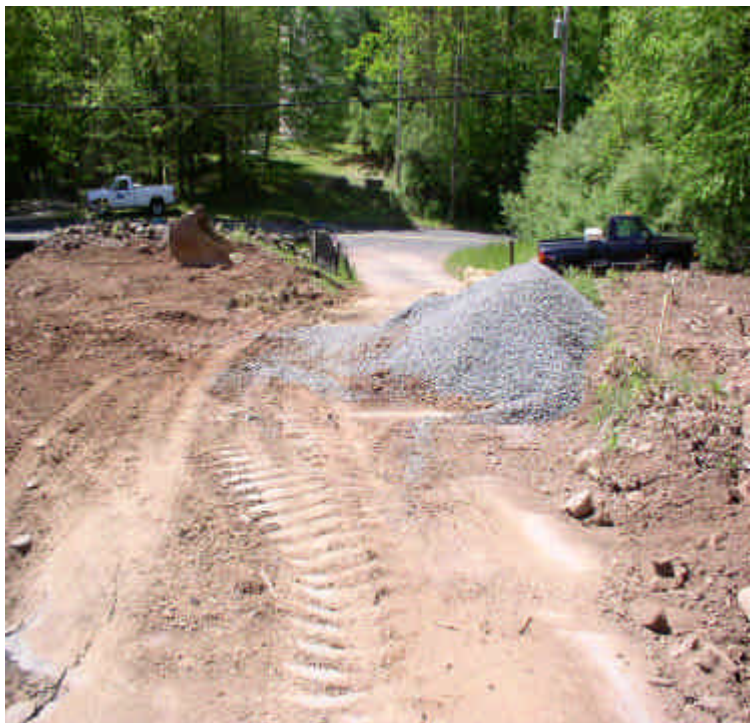
**Haybales will be replaced across the western driveway where they were moved for access to the new stockpile area.**

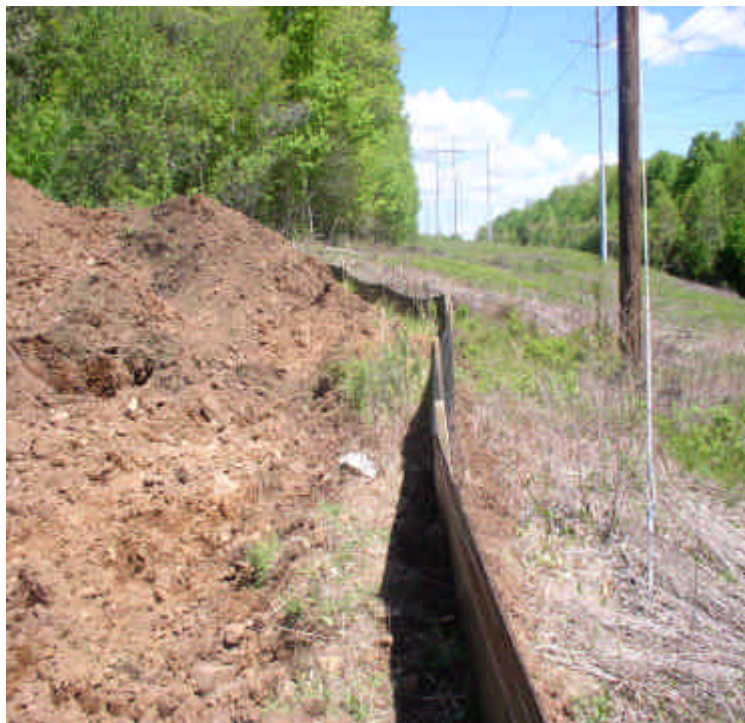
**New silt fence was extended along the northeast corner of the site to encompass the work limits.**

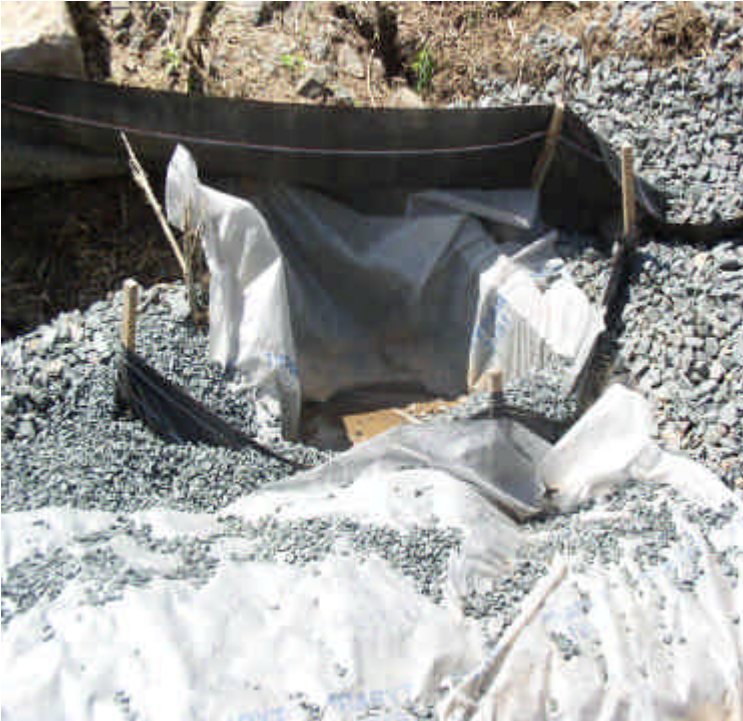
**New storm drain inlet leading to wetland across Carpenter Lane.  
stone.**

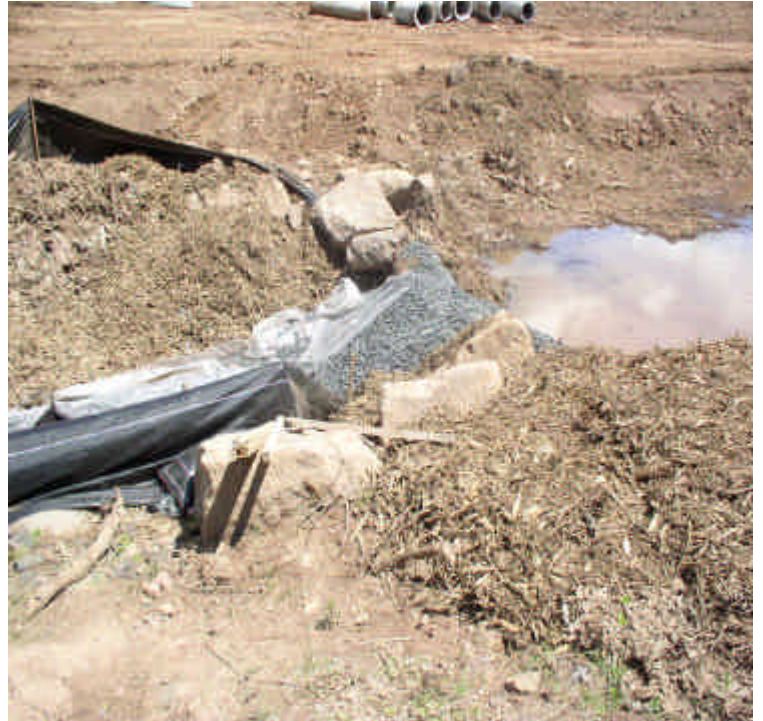
**New storm drain inlet protection consists of liners and**

Access Roads	Silt barrier liners in the catch basins (CB) should be replaced. 5/24/06 New fabric is being used	BSC was told the liners would be replaced by crews tomorrow 5/24/06 Watch the durability of the new fabric and make	CB controls should continue to be replaced proactively. New liners were installed to reduce

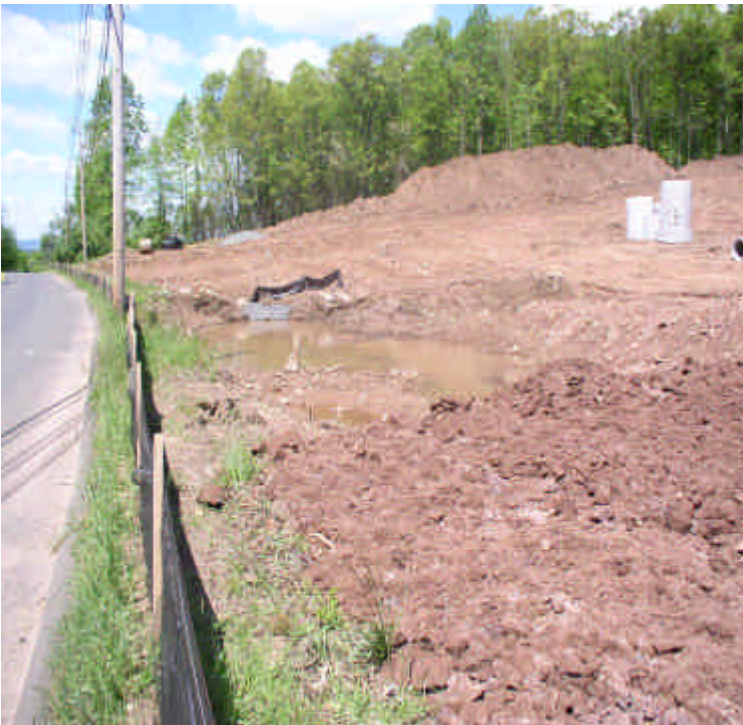
**Storm water settling basin adjacent to the storm drain inlet.**

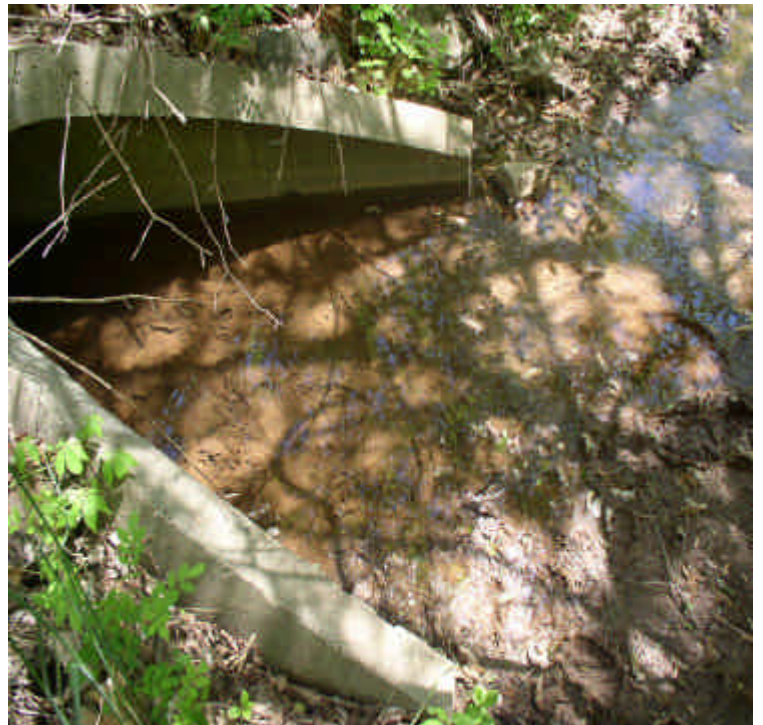
**Storm water outlet to the wetland across Carpenter Lane.  
Water entering the wetland was clear at this time.**
