Docket No. 272 – Development and Management Plan Inspection

Beseck Switching Station

Date: May 31, 2006

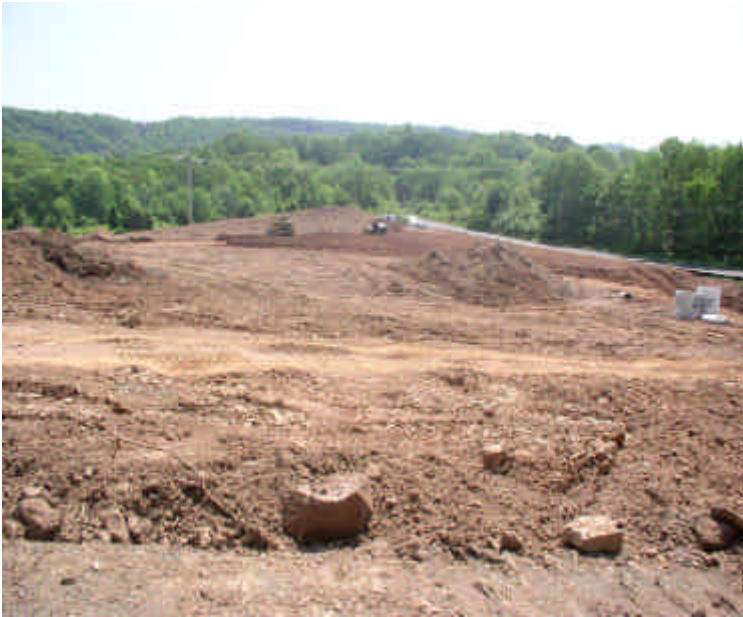
Entire site looking southeast at the major soil grading operation

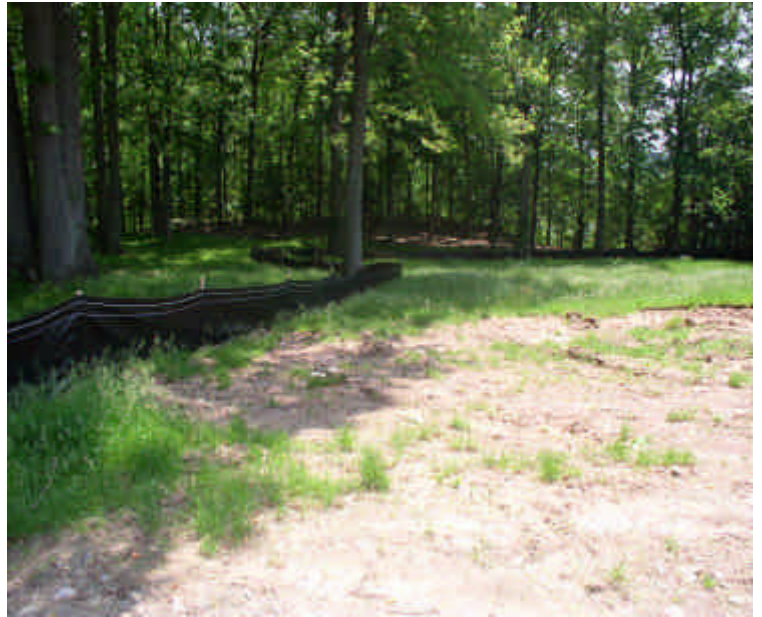
Silt fence installation is complete around the old Zolnik property. No soil is being stockpiled here yet.

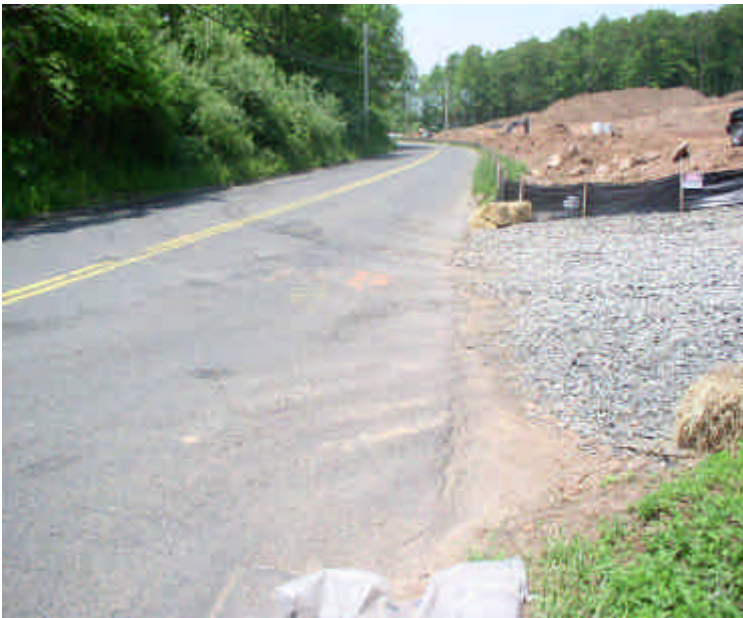
Carpenter Lane at the construction entrance, where tracking into the warm roadway pavement was noted. Small stones were swept up immediately.

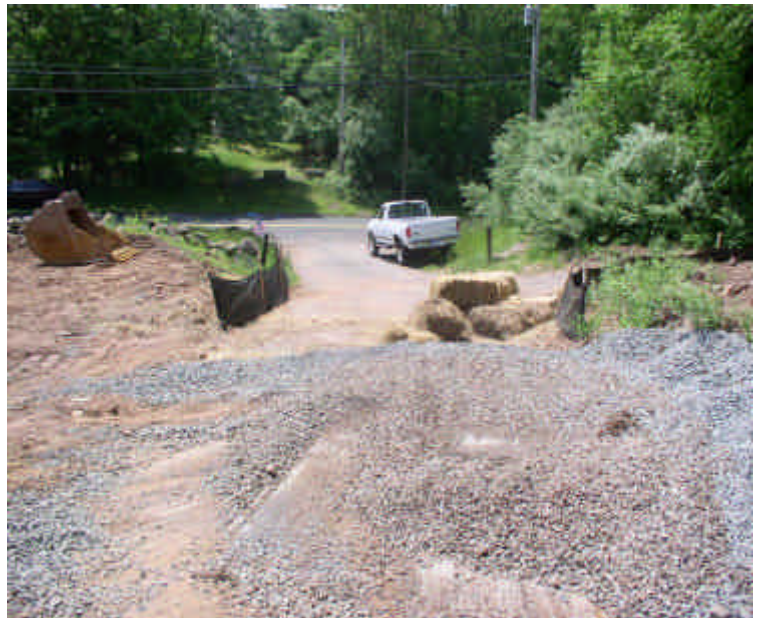
Haybales will be replaced across the western driveway where they were moved to dump stone for the installation of the new storm water system. Watch potential run-off here.

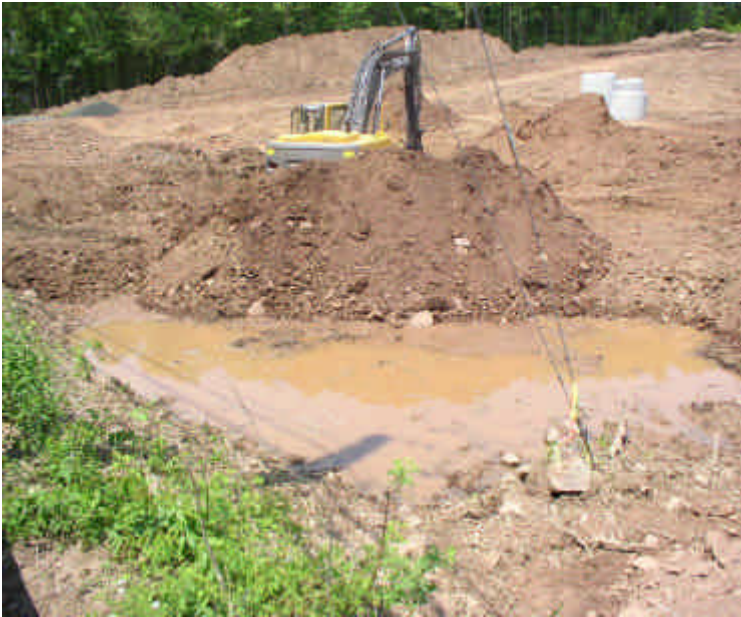
The old settling basin has been partially filled and closed off to the new storm drain. Saturated soil is being piled here from the adjacent excavation.

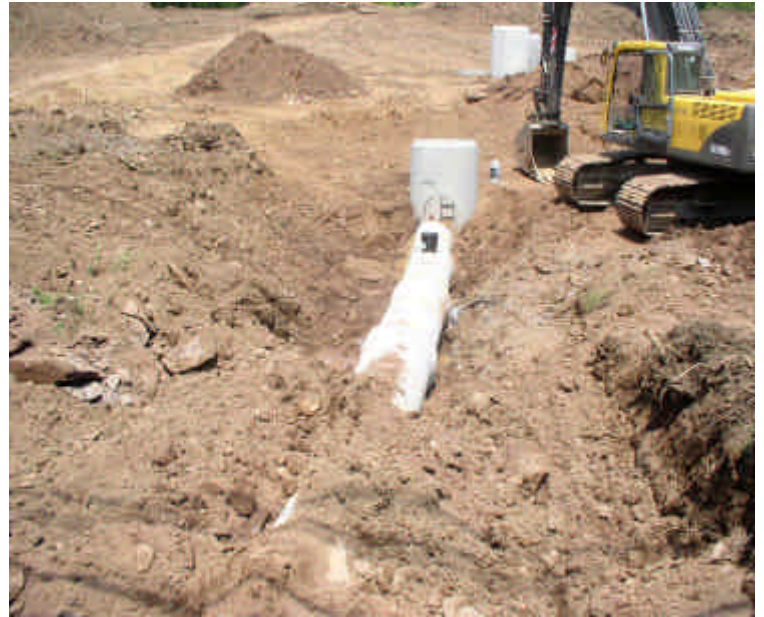
Installation of the new storm drain system. The drain pipe is being extended to a new catch basin.

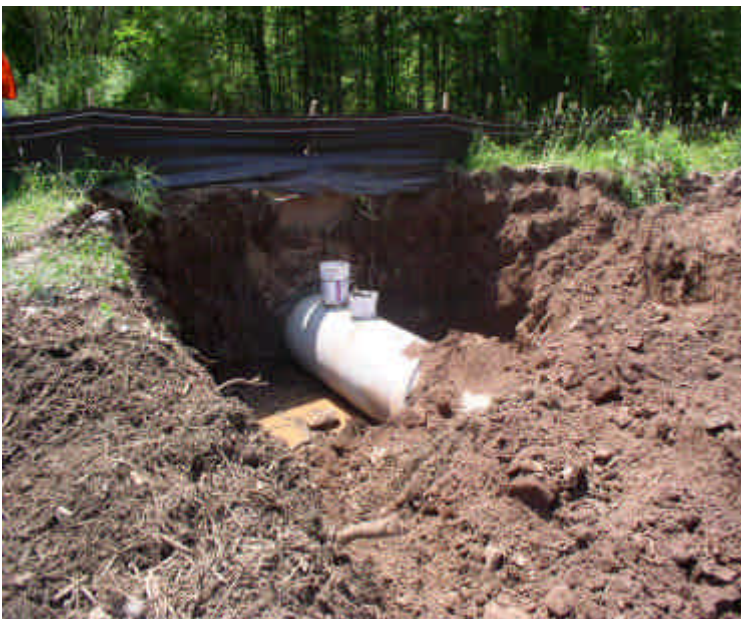
New storm drain outlet connection to the existing catch basin at Carpenter Lane.

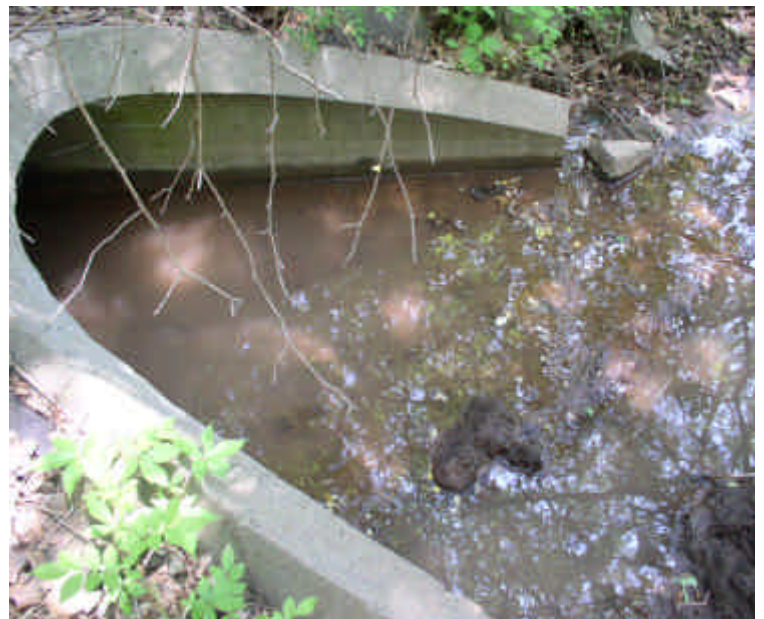
Inland Wetland and Watercourse encroachment and mitigation	Wetlands on the east side of the site contain clear water. Wetlands across Carpenter Lane are receiving slightly turbid water. 5/31/06	Continue to monitor wetlands during rain events and the construction of the new storm water controls. Some filtration controls could be placed at the	Continue to monitor

Storm water entering the wetland across Carpenter Lane is slightly turbid, resulting from the installation of the new drain system on site. This will be difficult to control until the new system is in place.

Areas of Inspection	Observation	Recommended Action	Corrected Action
		drain outlet during construction of the new system (if this is NU property). 5/31/06	
State species of concern, threatened and endangered species.	According to the D&M plan, state-listed species are not located in this work area.	NA	NA
Vegetative clearing limits (including trees to save or danger trees noted).	All vegetative clearing is complete. 5/31/06	NA	NA
Dewatering	-Active dewatering was not yet noted but saturated soil is being excavated from adjacent to the storm system installation and allowed to drain. 5/31/06	None 5/31/06	NA
Blasting	Not yet started; scheduled to start as early as next week. 5/31/06	None 5/31/06	NA
Spills and Material Storage	Soil removal was not taking place during the inspection. Soils are being stockpiled and moved around the site as needed. Soil is stored all along the western driveway. 5/31/06	Soil stockpiles should continue to be located away from the roadway and storm drain inlet. Stockpiles should be temporarily stabilized if they will be left unworked for more than 14 days. 5/31/06	NA
