Docket No. 272 – Development and Management Plan Inspection

Beseck Switching Station

Date: June 8, 2006

Location: Beseck Switching Station

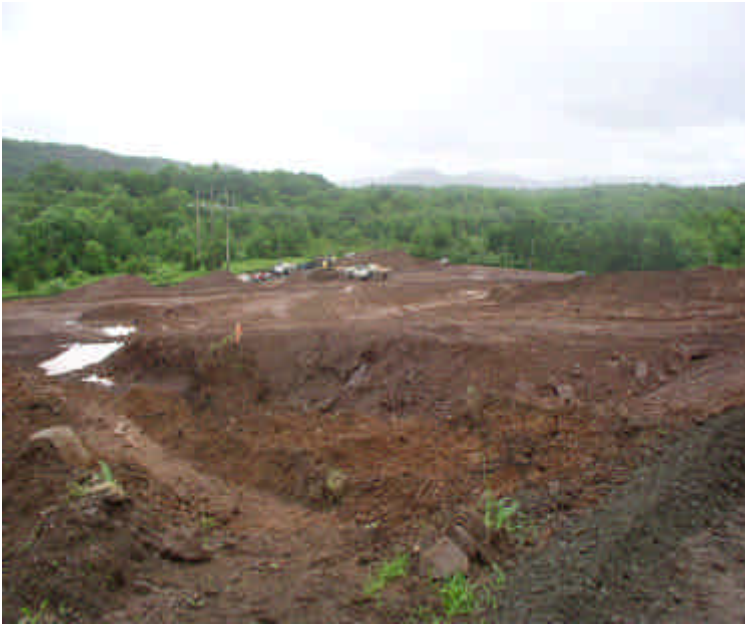
Entire site looking southeast at the major soil grading operation

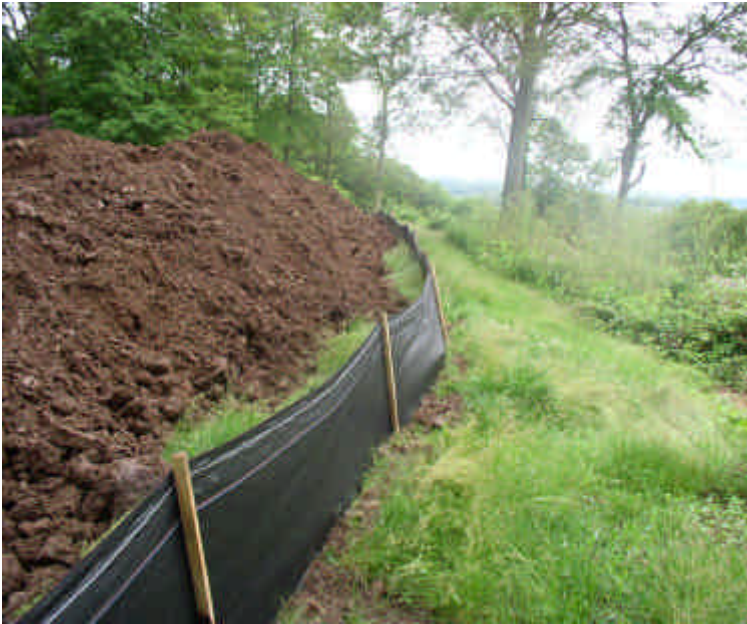
Silt fence remains in good shape around the old Zolnik property. Soil stockpiling is occurring here at this time.

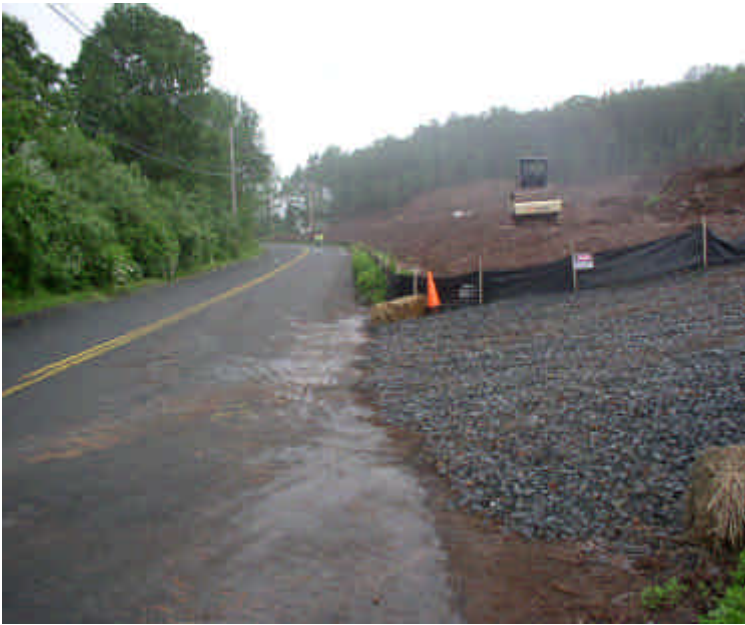
Silt barrier liners in the catch basins (CB) were being replaced during the inspection. 6/8/06 The new liners are still working well and allow water to flow more freely	Continue to monitor and maintain as needed. The new, thinner liners seem to rip more easily under the stress of excess sediment and should be replaced more frequently	CB controls are being monitored regularly.

Carpenter Lane at the construction entrance. Entrance is clean and workers were replacing the filter fabric in the catch basins.

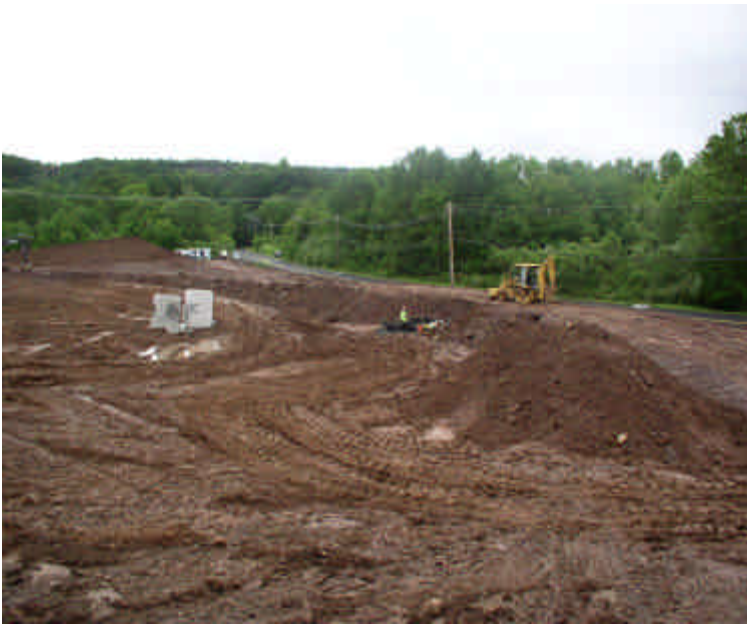
Construction is underway of the new retention ponds and storm water system along Carpenter Lane

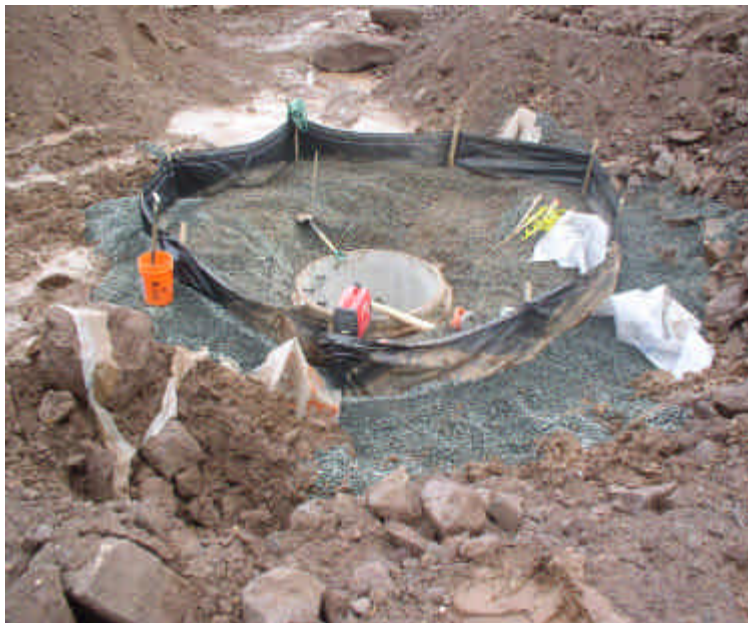
Installation of the new storm drain system. With perimeter protection. Watch exposed soil around the pipe for run-off and increase controls around the pipe.

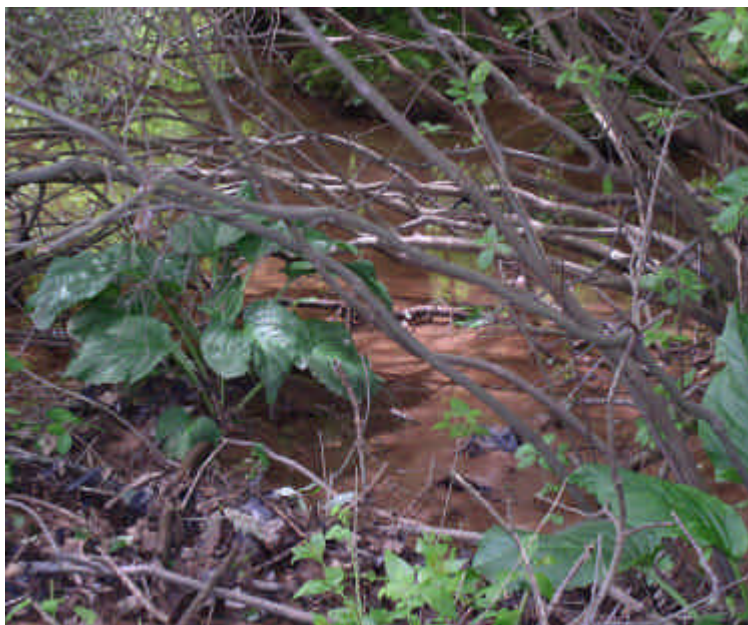
Suspended sediment within the ponded water in the wetland across Carpenter Lane.

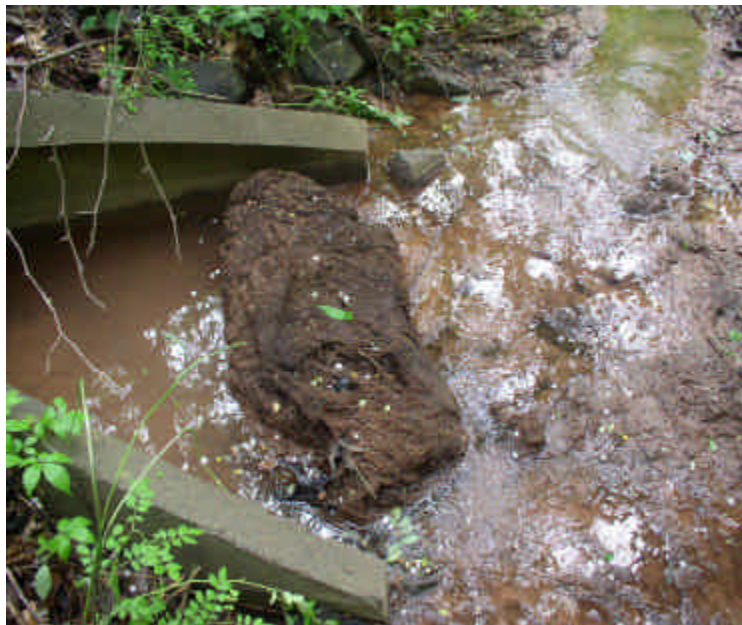
Storm water entering the wetland across Carpenter Lane is turbid, due to the interim of the installation of the new drain system on site and heavy rains. A large root ball has made its way through the system and is slowing water. Consider placing haybales here for further filtration.
