Docket No. 272 – Development and Management Plan Inspection

Beseck Switching Station Inspection

Date: June 15, 2006

Location: Beseck Switching Station

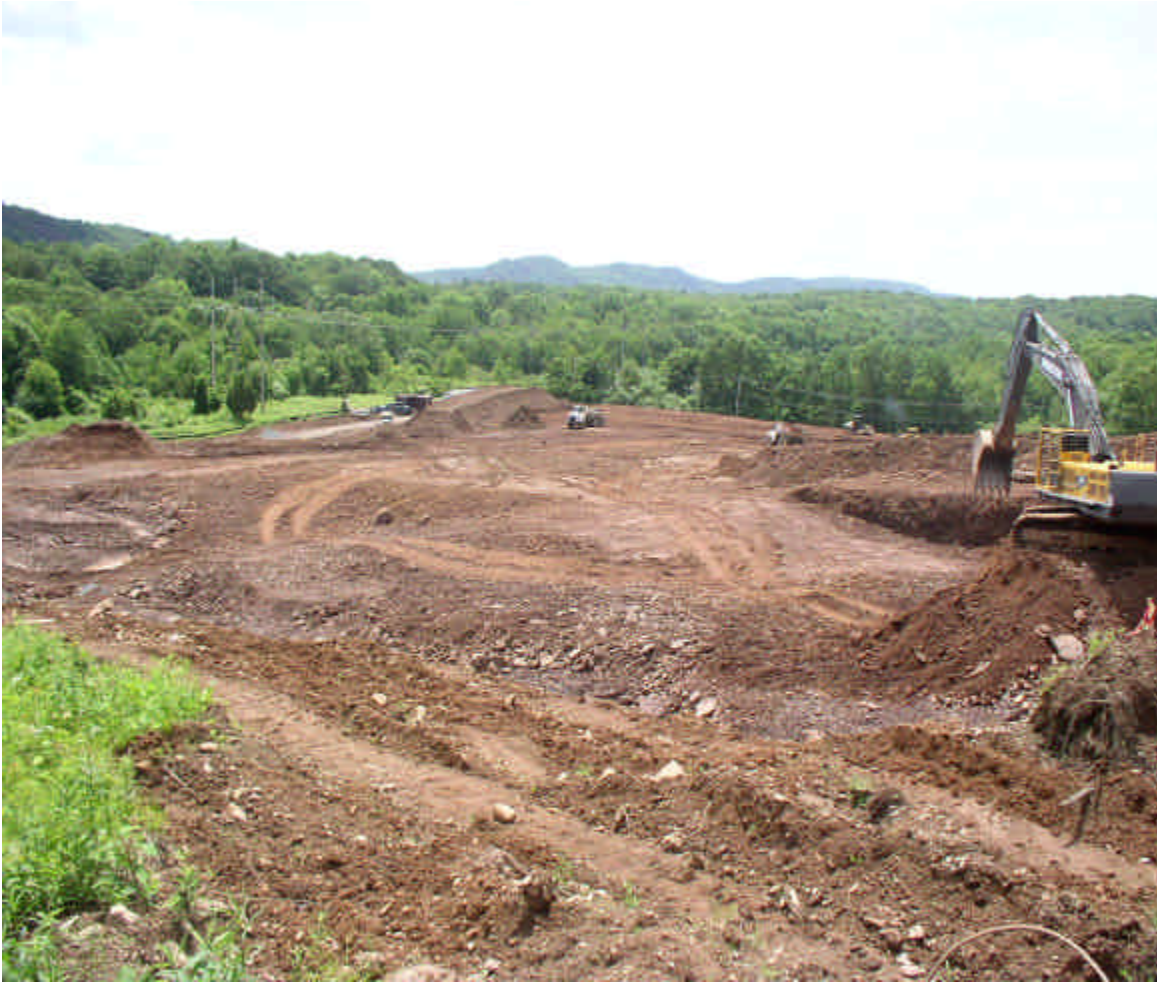
Entire site looking southeast at the major soil grading operation.

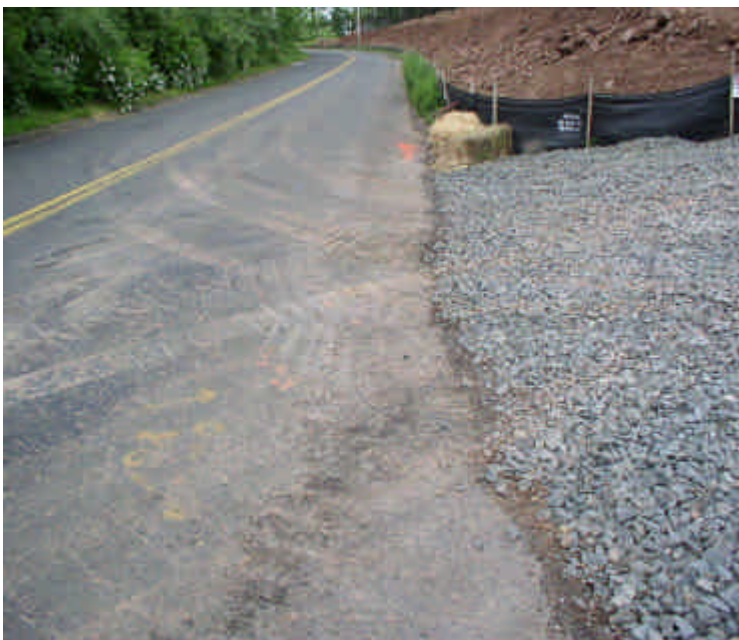
Carpenter Lane at the construction entrance.

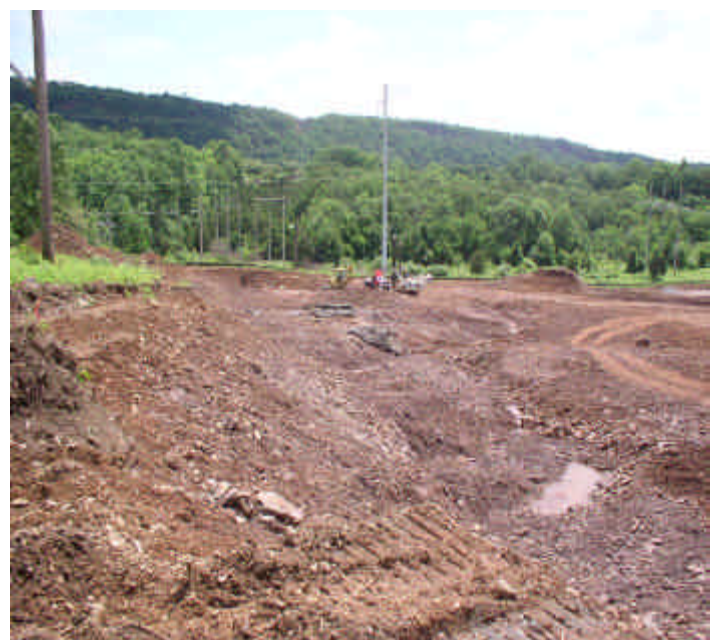
Blasting area along the north side of the site looking west.

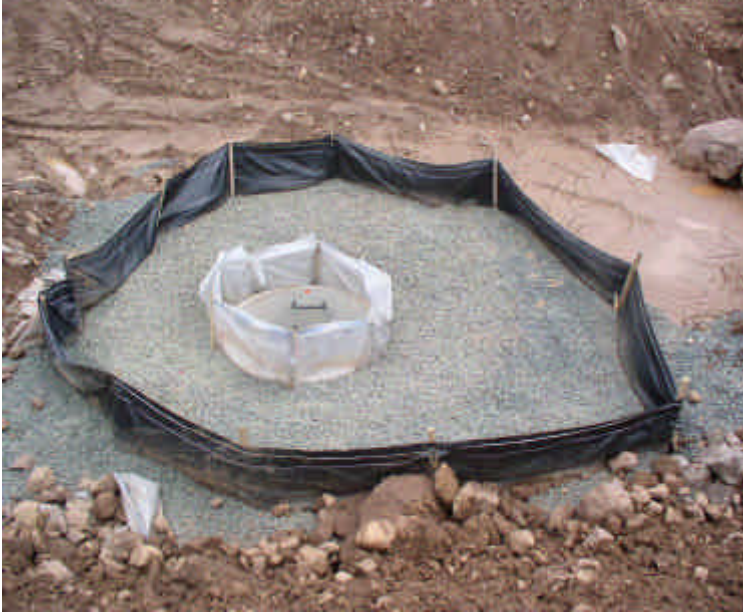
Installation of the new storm drain system with perimeter protection. Watch exposed soil around the pipe for run-off and increase controls around the pipe.

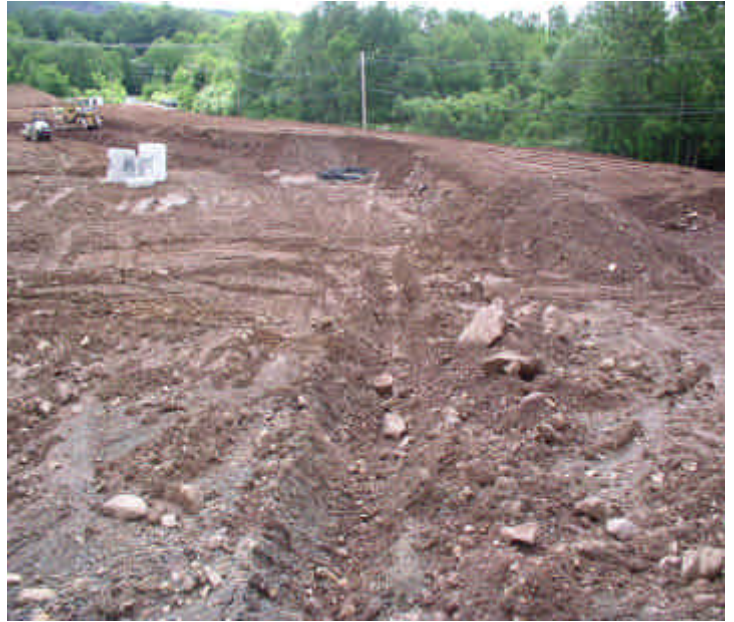
Construction is underway on the new retention ponds and storm water system along Carpenter Lane. Note the new drainage ditch installed to prevent run-off from bypassing the storm water system.

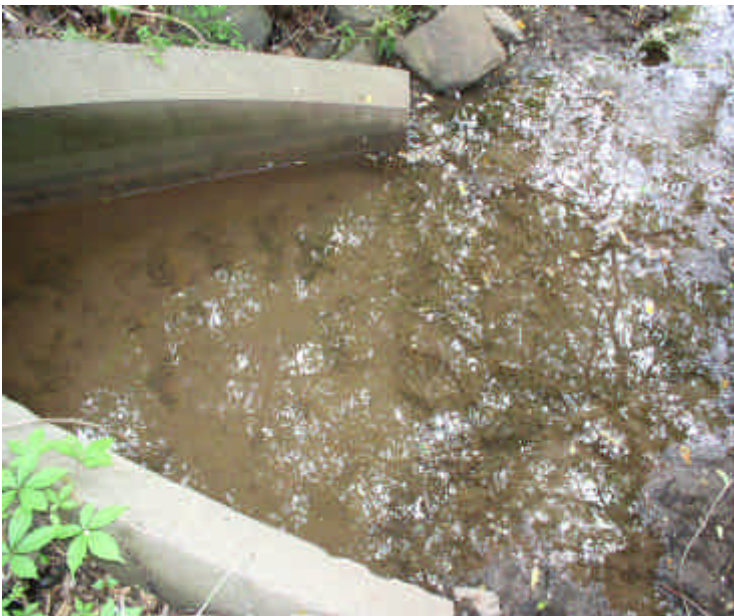
Storm water entering the wetland across Carpenter Lane is clear. Sediment within the wetland has settled out and standing water is clear.

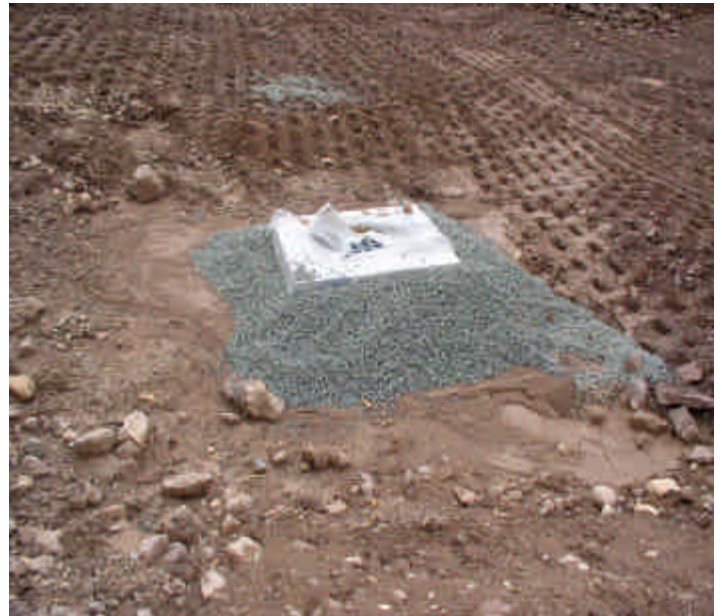
New CB installed along the southwestern side of the site is elevated, surrounded with stone, and covered with filter fabric to allow settling and filtering of storm water before it enters the CB.
