**Docket No. 272 – Development and Management Plan Inspection**

**Beseck Switching Station Inspection**

**Date:** June 22, 2006

**Location:** Beseck Switching Station

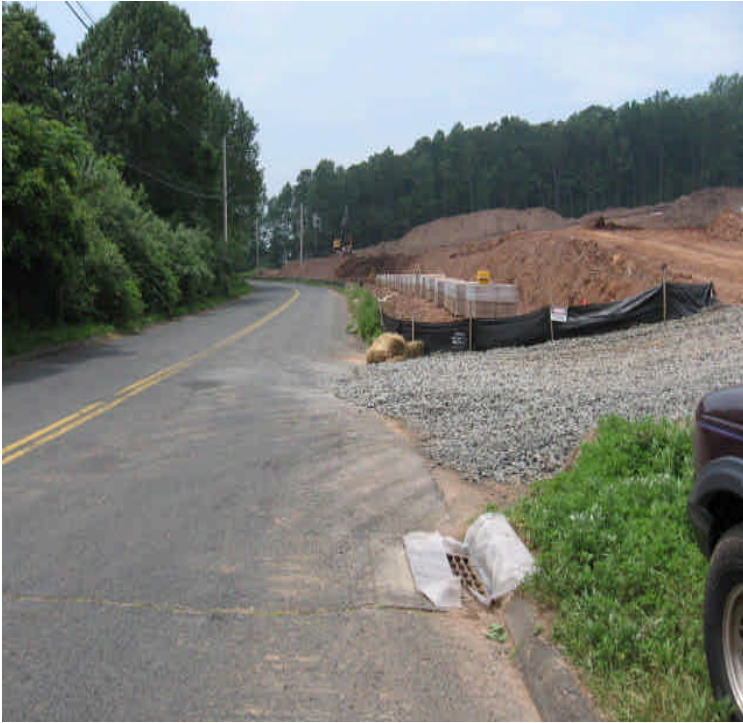
**Negligible amount of soil visible on Carpenter Lane.**

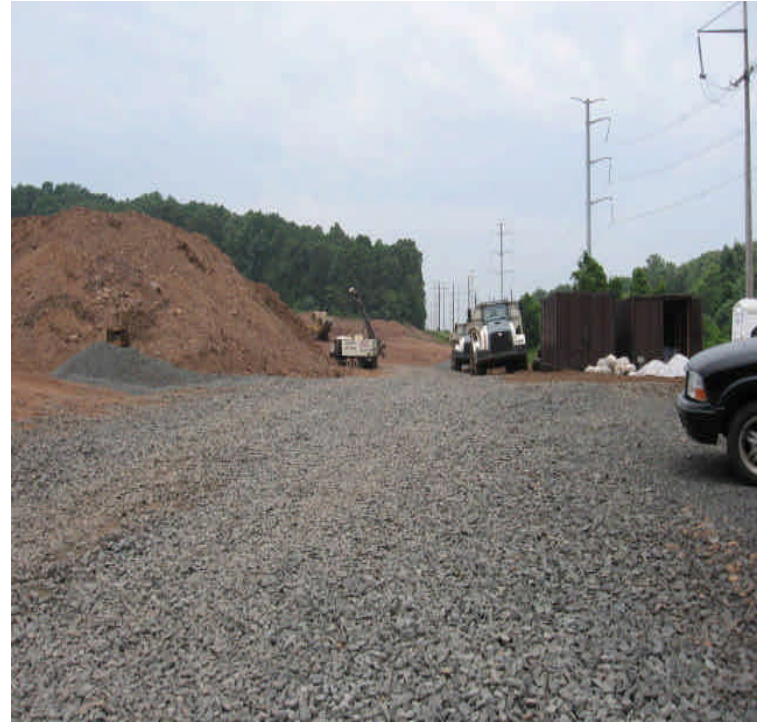
**Stone construction entrance is clean.**

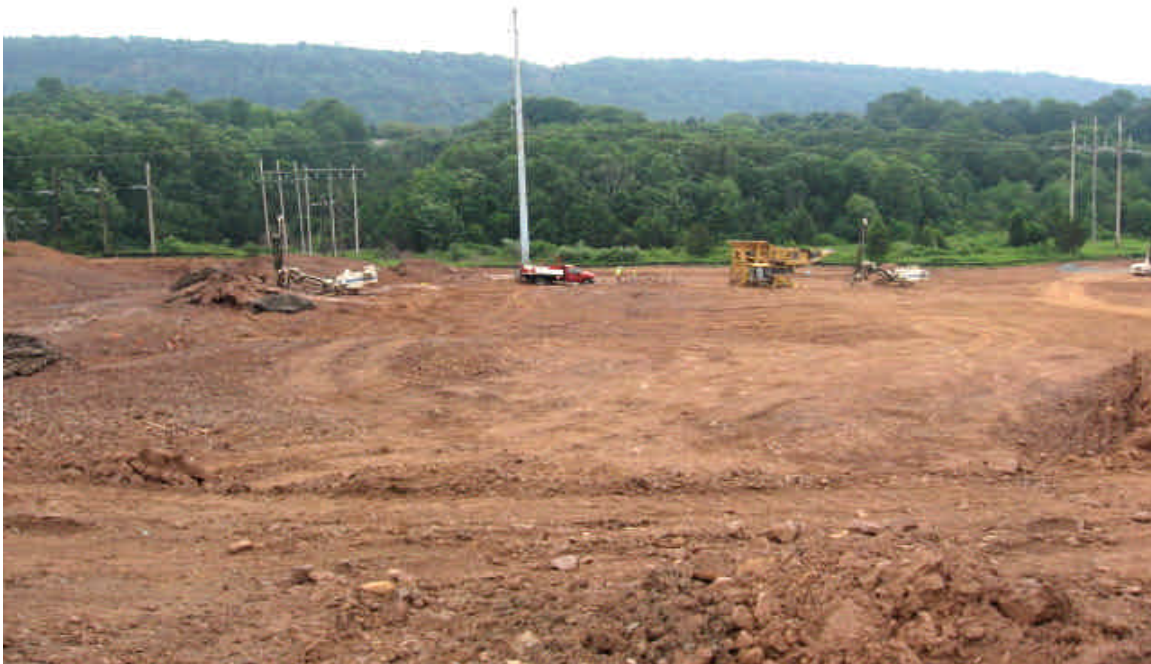
**Blasting in northern part of site, viewed west to east.**

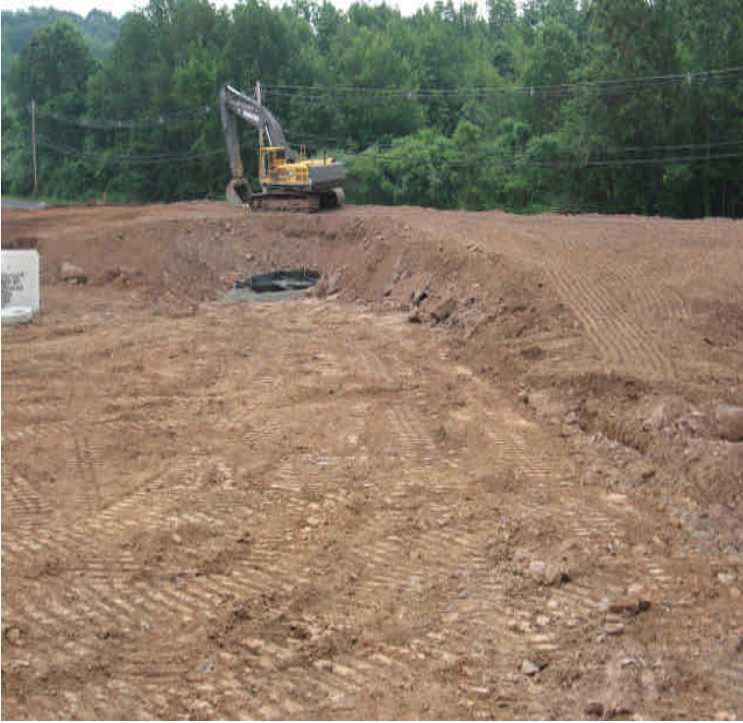
**Newly constructed storm drain at south side of site.**

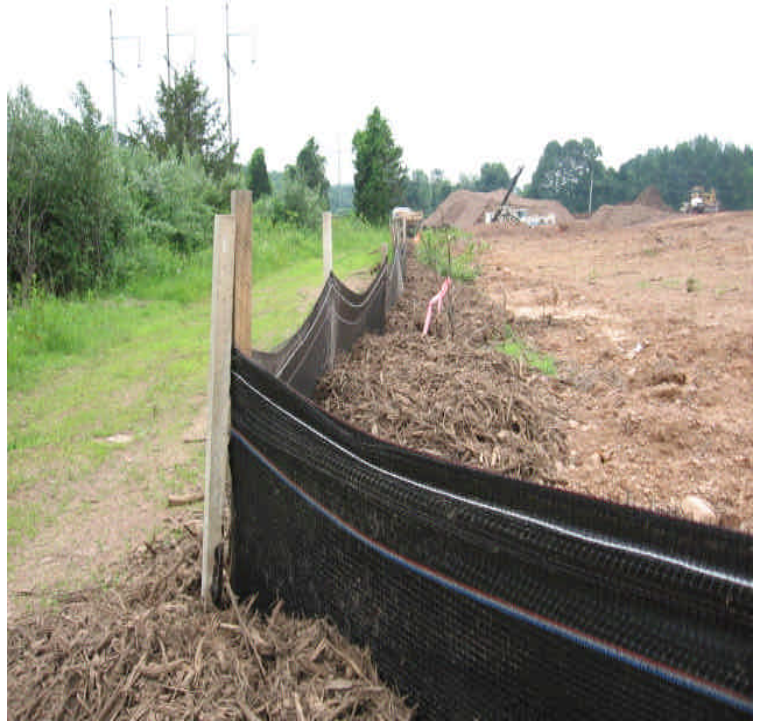
**Silt fence on east side reinforced with mesh and mulch.**

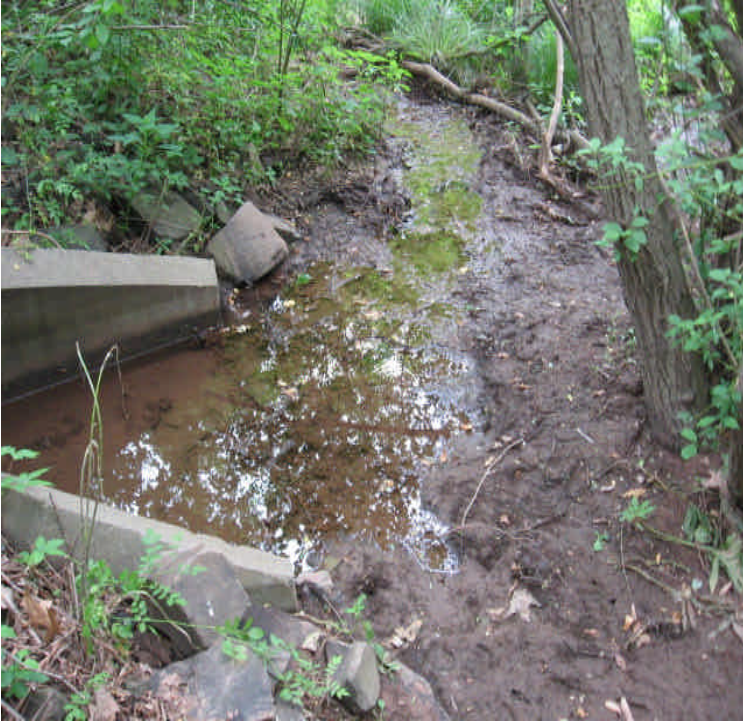
**Drain outlet in wetland with clear standing water, accumulated sediment.**

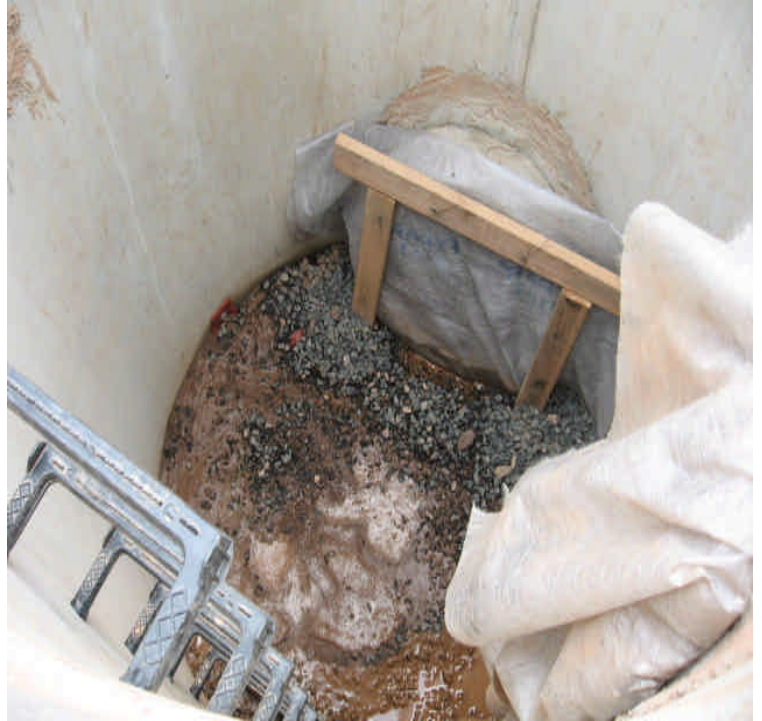
**Storm drain inlet and outlet are protected with some filter fabric.**
