Docket No. 272 - Development and Management Plan Inspection

Beseck Switching Station Inspection

Date: June 29, 2006

Location: Beseck Switching Station

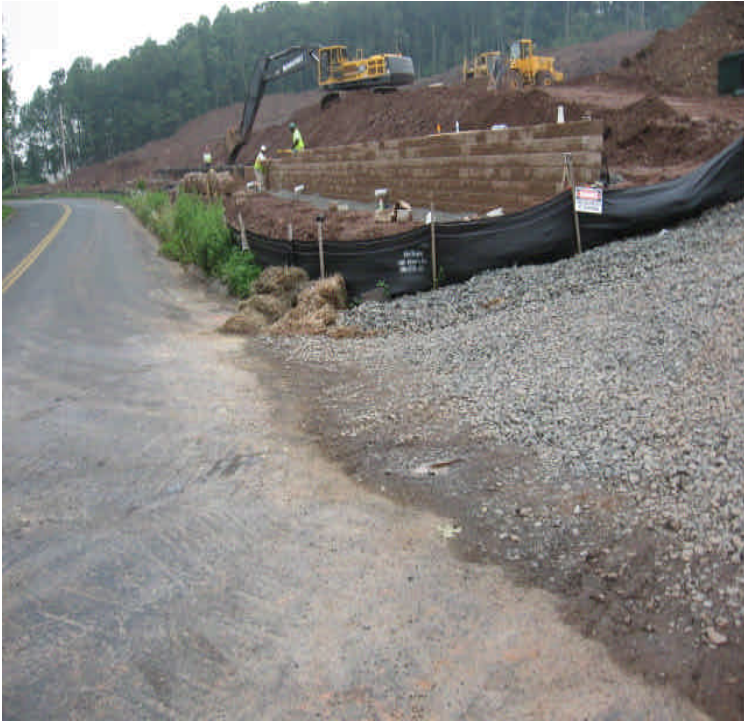
Crushed stone construction entrance pad is still clean, and only a minimal amount of soil is visible on the road.

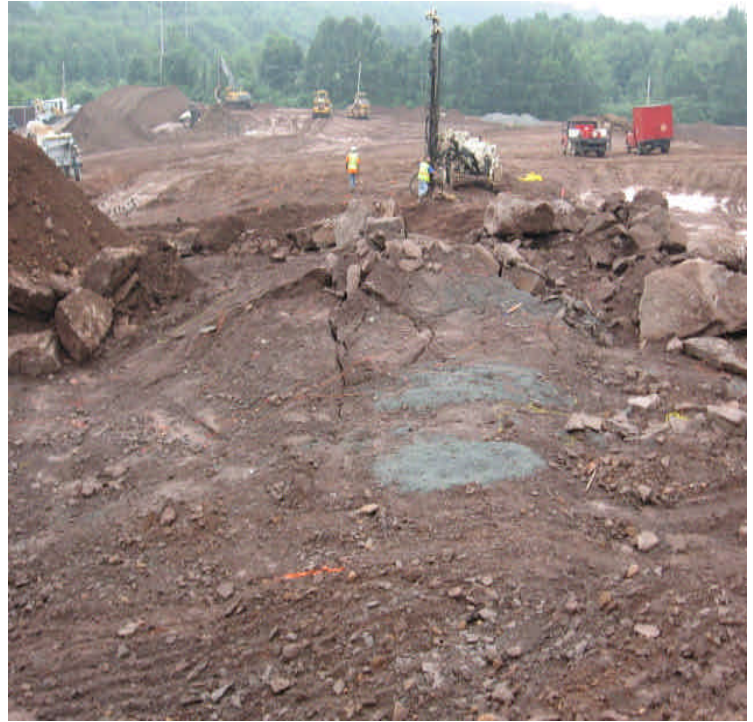
Preparations are being made for continued blasting on the northern portion of site.

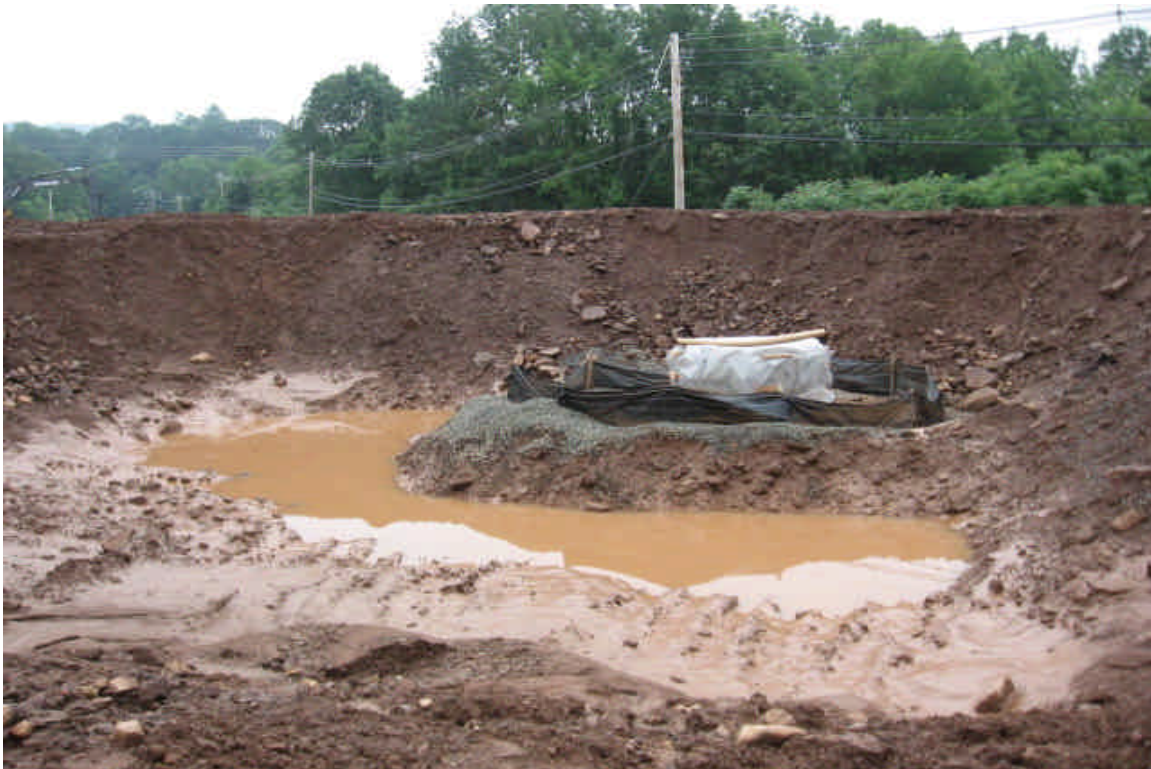
Temporary settling basin has been excavated around protected drain inlet pipe. However, sediment from site continues to enter wetland across Carpenter Lane.

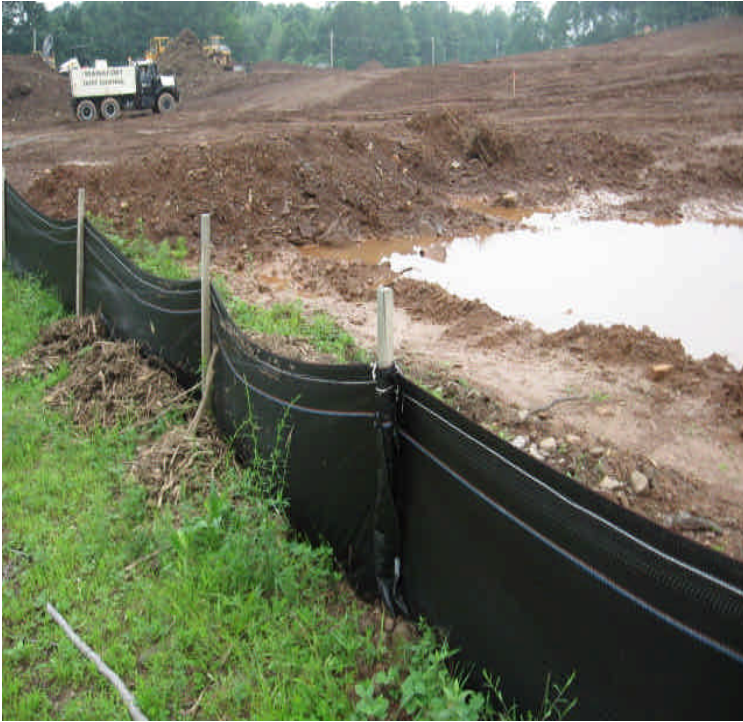
Stormwater has accumulated inside the silt fence near east side of site; no evidence of damage or stress to silt fence.

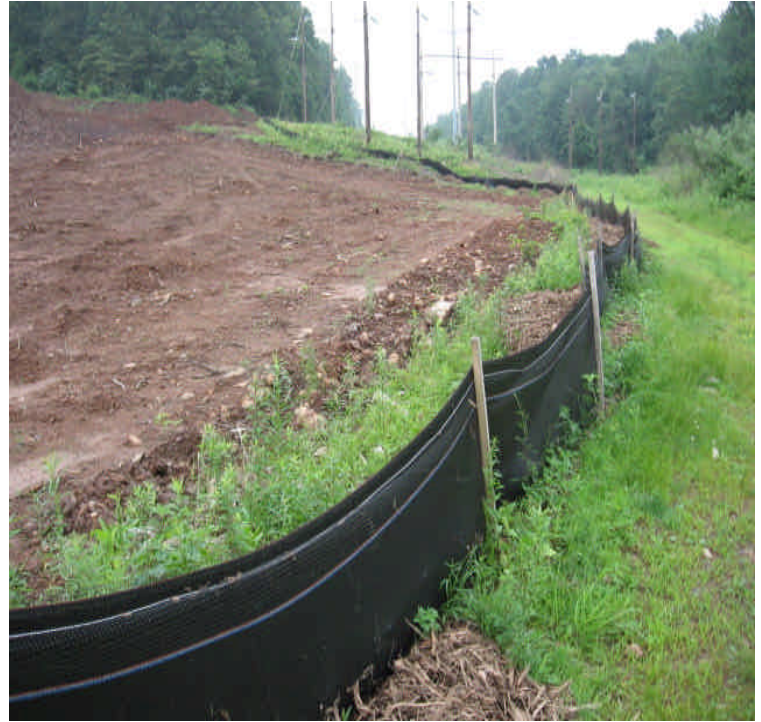
Silt fence on east side is reinforced with bark mulch. Buffers of vegetation also remain on both sides of silt fence, protecting wetland east of site.

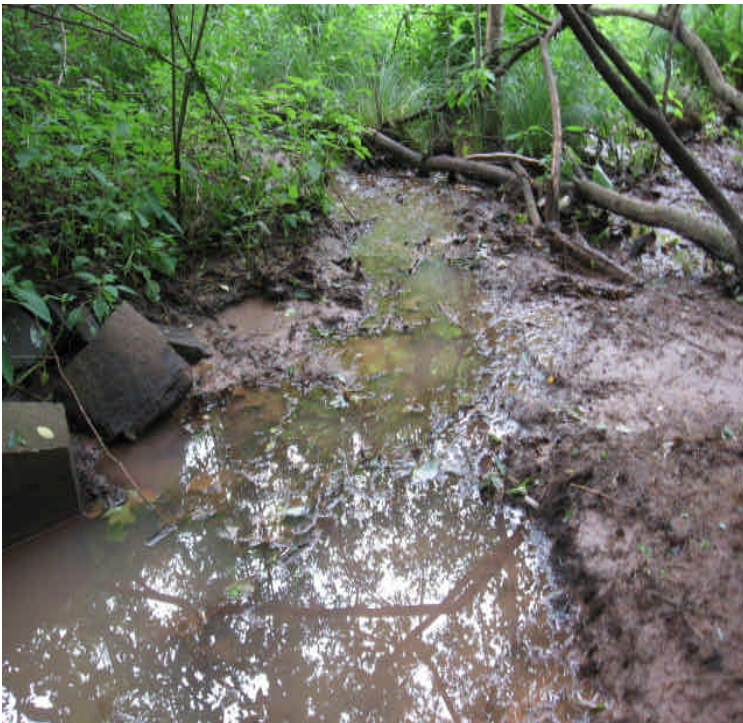
Slightly turbid water from the site was entering the wetland across Carpenter Lane from the drain outfall after the rain.

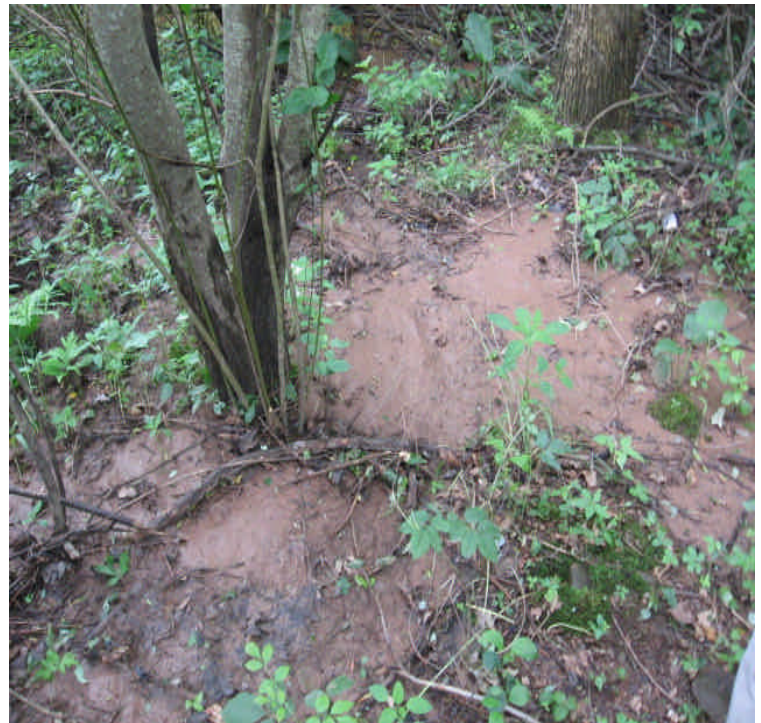
Sediment has accumulated in the wetland across Carpenter Lane from many significant rain events over past two months.
