**Docket No. 272 – Development and Management Plan Inspection**

**Beseck Switching Station Inspection**

**Date:** July 6, 2006

**Location:** Beseck Switching Station

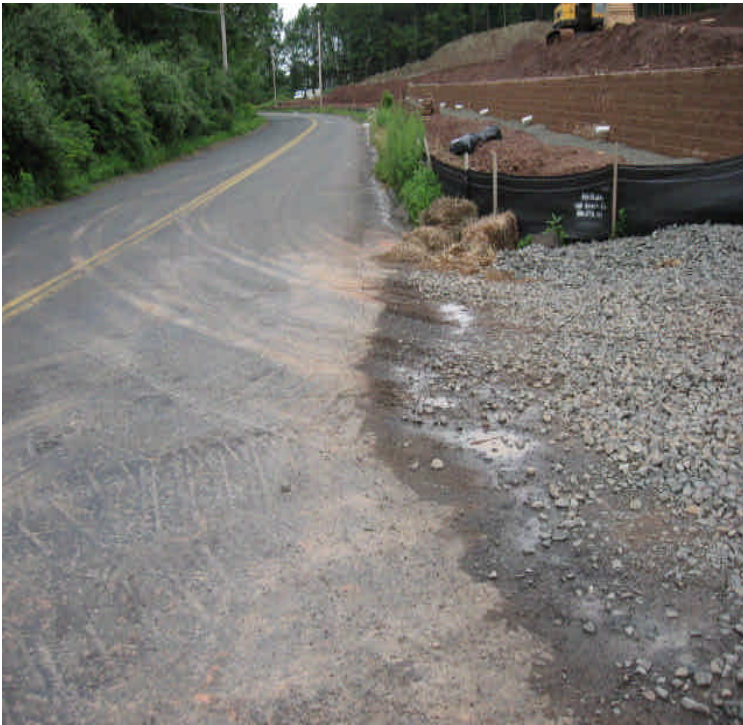
**Crushed stone construction entrance pad is still clean, with some minor sediment visible on Carpenter Lane.**

<b>Areas of Inspection</b>	<b>Observation</b>	<b>Recommended Action</b>	<b>Corrected Action</b>
<b>Access Roads and Adjacent Roadways</b>	<b>All truck traffic is using stone entrance on east side, which is still fairly clean. 7/6/06</b>	<b>Continue to check stone construction entrance and clean/refresh stone as needed. 7/6/06</b>	<b>NA</b>
	<b>Only a negligible amount of soil was visible on Carpenter Lane. 7/6/06</b>	<b>Street sweeping should be performed as needed. 7/6/06</b>	<b>NA</b>
	<b>Turbid water was flowing from the site, along Carpenter Lane, and behind the filter fabric within the catch basins (CB). This appears to be a source of the turbid water from the drain outlet. 7/6/06</b>	<b>Small stones should be used to hold down the CB liner filter fabric. Additional piles of small stone is also recommended at the road prior to where water leaves the site. 7/6/06</b>	<b>Needs attention</b>

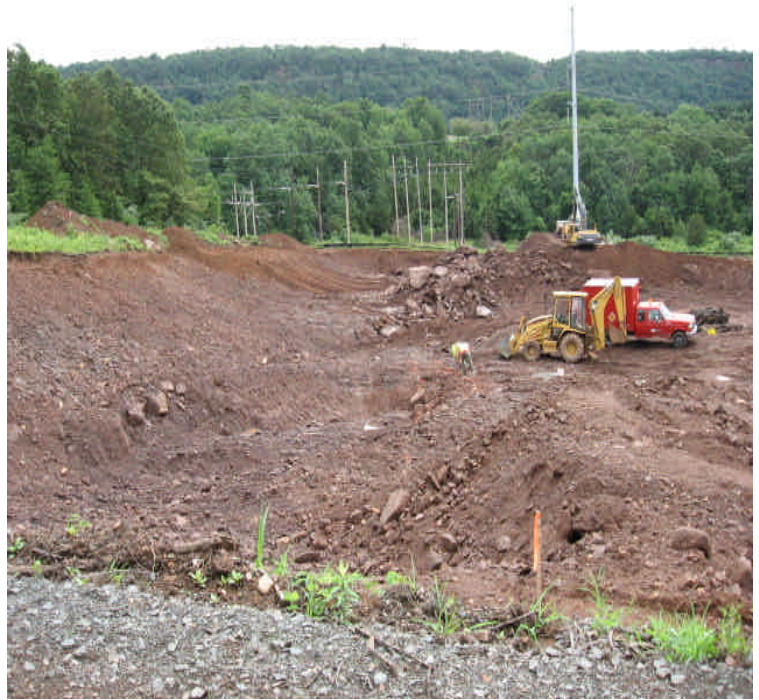
**Preparations are being made for continued blasting on the northern portion of site.**

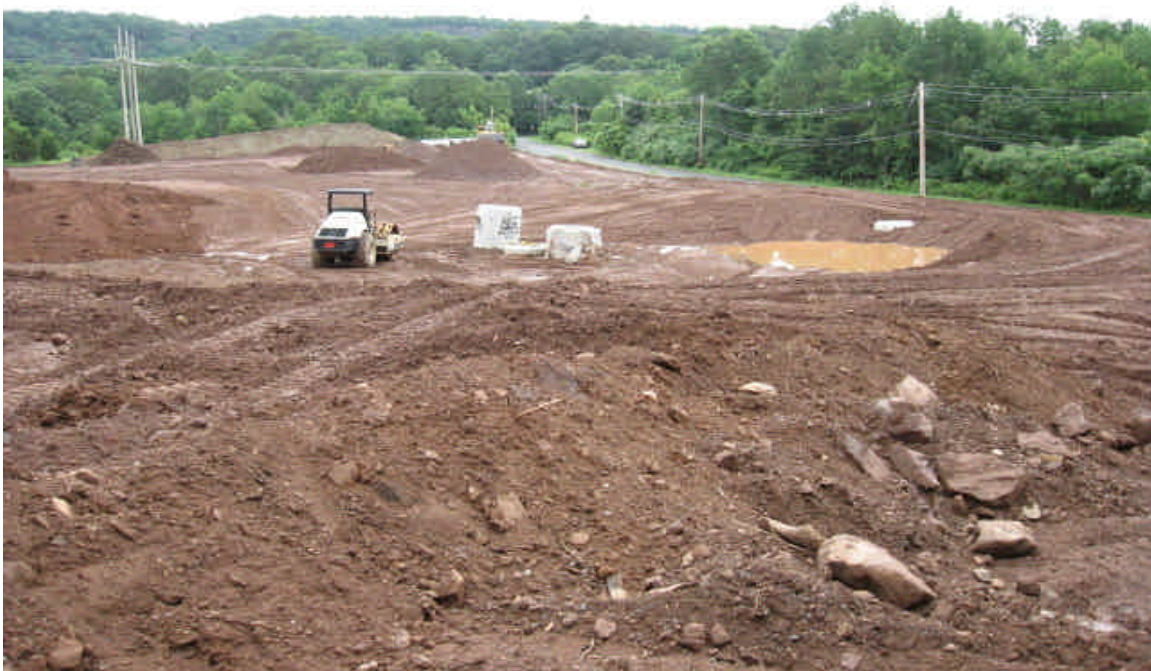
**Temporary settling basin has been excavated north of the drain inlet pipe. However, it appears that the majority of turbid water to the wetland across Carpenter Lane may be coming from site run-off to the roadway catch basins**

Areas of Inspection	Observation	Recommended Action	Corrected Action
	<p>is being installed as the site is raised. Contractor has created a basin near inlet pipe to allow water to stand and sediment to settle before entering drain. 7/6/06</p>	<p>make efforts to minimize stormwater impacts; see erosion control section for recommended actions. 7/6/06</p>	<p>section.</p>
<p><b>Erosion and Sediment Controls</b></p>	<p>All silt fence is secure and well-maintained. East side silt fence reinforced with bark mulch. 7/6/06</p> <p>Storm drain inlet is raised with a settling area north of the pipes. The new CB onsite is also raised, surrounded by stone, and covered with filter fabric. 7/6/06</p> <p>Three layers of haybales were in place across the old Zolnik driveway and looked intact. Stone berms were in place along the driveway as additional filtration. 7/6/06</p> <p>Storm water controls should change in response to grading changes; stabilize areas expected to remain unworked for more than 14 days. 7/6/06</p>	<p>Continue to inspect and maintain silt fence throughout site as needed. 7/6/06</p> <p>Consider seeding walls of basin to reduce sediment load reaching wetland. 7/6/06 Also, see access road section regarding potential source of turbidity. 7/6/06</p> <p>None. 7/6/06</p> <p>Additional stabilization of open areas with seed, mulch, or straw should be considered in order to help reduce sediment loads in run-off (as applicable). 7/6/06</p>	<p>NA</p> <p>Settling basin was built north of drain inlet.</p> <p>Stone berms were installed and the stockpile was seeded</p> <p>Needs evaluation</p>

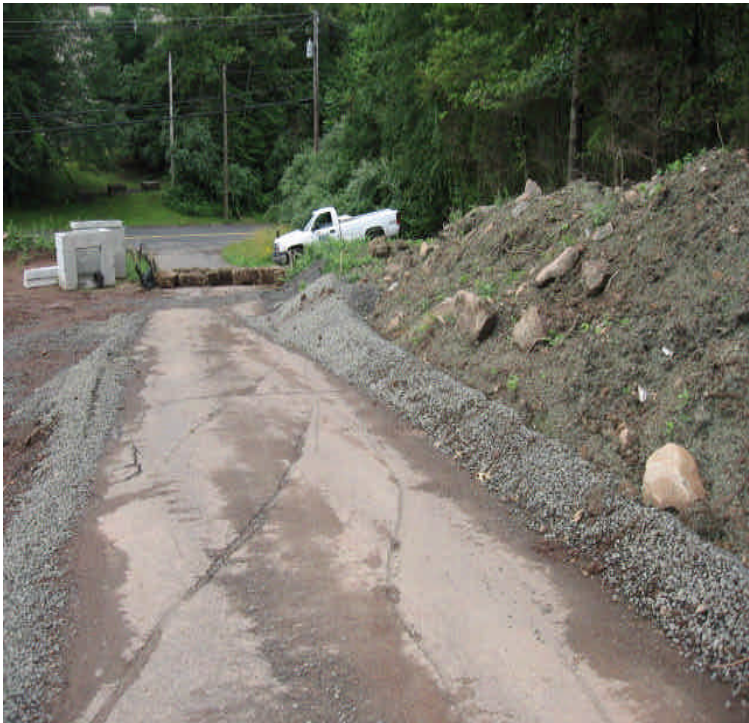
**Haybales across old Zolnik driveway; soil stockpile to right has been hydroseeded and stone berm installed to filter runoff.**

<b>Spills, Soils and Material Storage</b>	<b>No additional soil has been removed from site in past week. Crushed rock has not yet been removed from site. 7/6/06</b>  <b>Soil stockpiles along western driveway (former Zolnik) and in the southeast area have been hydroseeded this week. 7/6/06</b> <b>Soil within the Zolnik property will be compacted and eventually stabilized. It remains contained. 7/6/06</b>  <b>Large expanses of disturbed soil on site will continue to make sediment attenuation difficult at stormwater inlet areas. Any areas that will be unworked for several weeks should be stabilized. 7/6/06</b>	<b>None</b>  <b>Stockpiles should continue to be located away from the roadway and storm drain. Place seed for temporary stabilization of any stockpiles that will remain unmoved for more than 14 days. 7/6/06</b>  <b>Consider placing seed as a temporary stabilization measure to reduce sediment loads where work is not actively occurring or not expected to occur for 14 days. Also, add stone to the site entrance to the road for filtration. 7/6/06</b>	<b>NA</b>  <b>Existing stockpiles have been seeded. 7/6/06</b>  <b>Needs evaluation for feasibility</b>

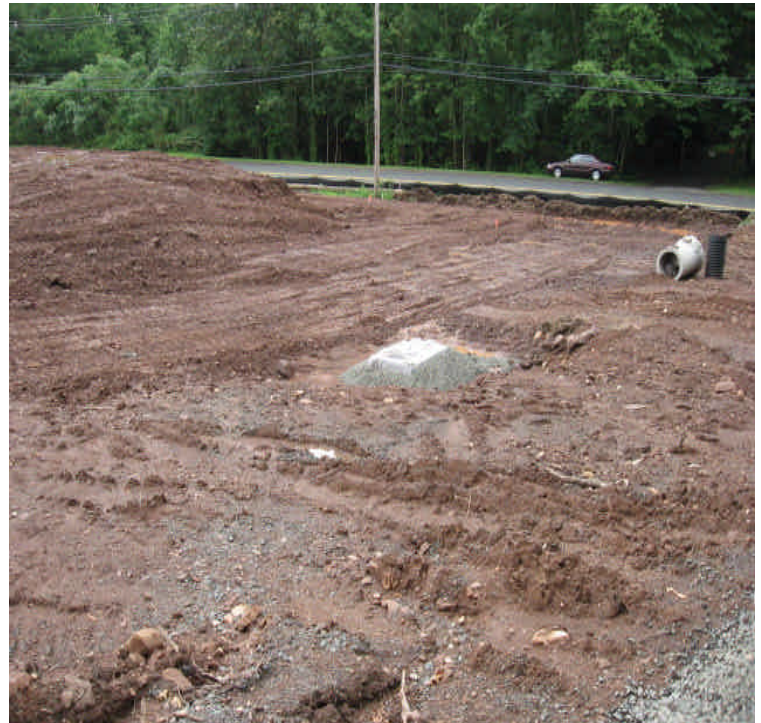
**Raised catch basin onsite, surrounded by stone and covered with filter fabric.**

<b>Silt barrier liners in catch basins are being replaced after every sig. rain event. 7/6/06</b>	<b>Continue to monitor and maintain liners as needed. 7/6/06</b>	<b>CB controls should be monitored regularly.</b>
<b>Foundation and site construction</b>	<b>Grading onsite continues; blasting and excavation in northern portion, filling in southern portion. 7/6/06</b>	<b>Erosion controls may need to be adjusted as grading changes. 7/6/06</b>	<b>NA</b>
	<b>Block retaining walls are under construction along south side of site. 7/6/06</b>	<b>Ensure erosion controls are not damaged. 7/6/06</b>	<b>NA</b>
	<b>New storm drain system</b>	<b>Contractor continues to</b>	<b>See erosion control</b>

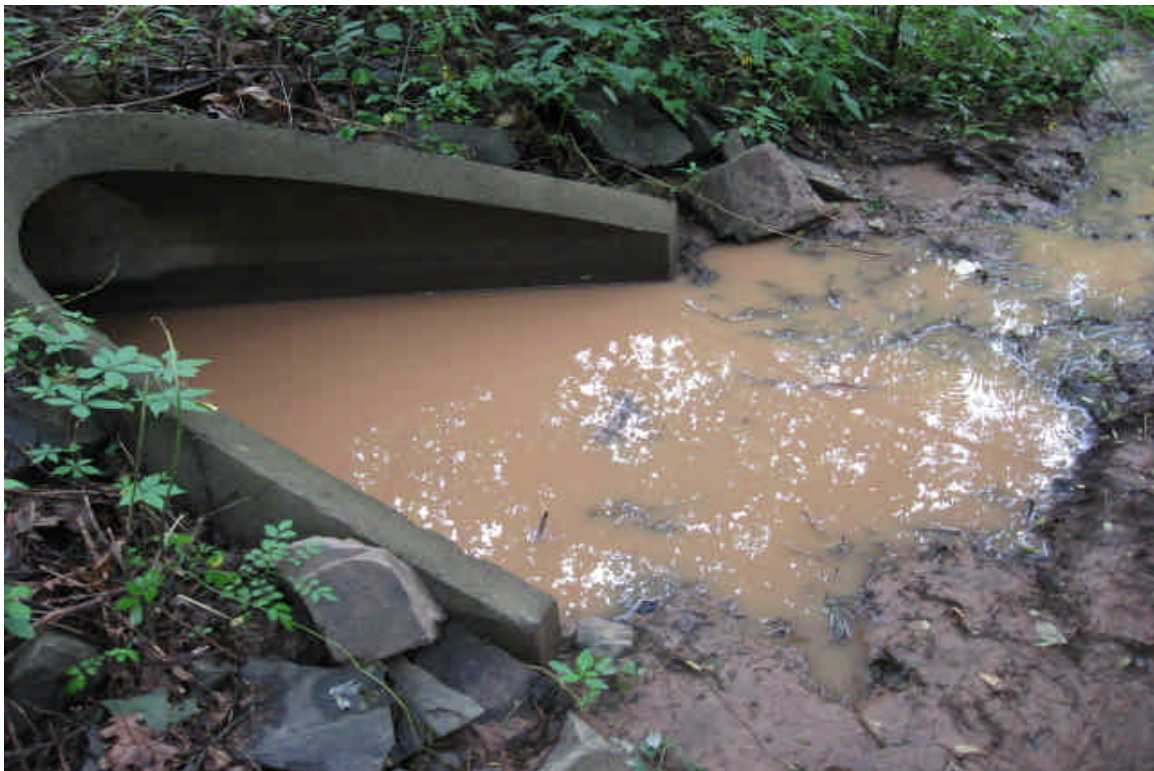
<p><b>Inland Wetland and Watercourse encroachment and mitigation</b></p>	<p>Wetlands on east side of site were clean and well protected. 7/6/06</p> <p>Wetlands south of site across Carpenter Lane contain accumulated sediment near drain outlet, with turbid water flowing from the outfall pipe. This is likely due to site run-off to roadway CBs. 7/6/06</p>	<p>Continue to monitor. 7/6/06</p> <p>Continue to monitor outlet area. Accumulated sediment from the site is evident and should be removed carefully from the wetland by hand (shovels) at the next opportunity. 7/6/06 Still recommend haybales at the outlet. 5/31-7/6/06</p>	<p>NA</p> <p>Needs attention at the next low flow opportunity.</p>

**Turbid water from the site was entering the wetland across Carpenter Lane from the drain outlet after the rain event. Sediment accumulation from previous events is present here. When the area dries out, this will be removed carefully by hand.**
