Docket No. 272 – Development and Management Plan Inspection

Beseck Switching Station Inspection

Date: July 13, 2006

Location: Beseck Switching Station

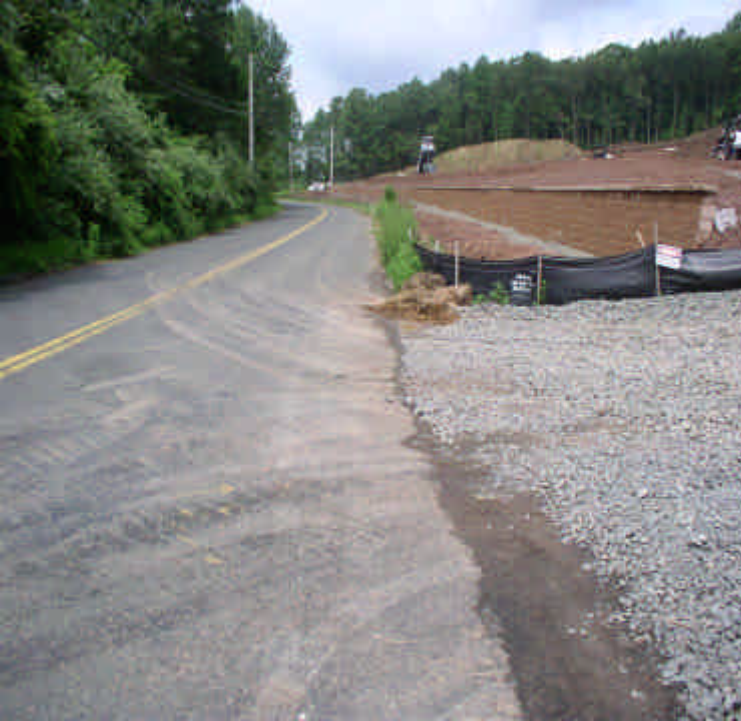
Crushed stone construction entrance pad is still clean, with some minor sediment tracking visible on Carpenter Lane.

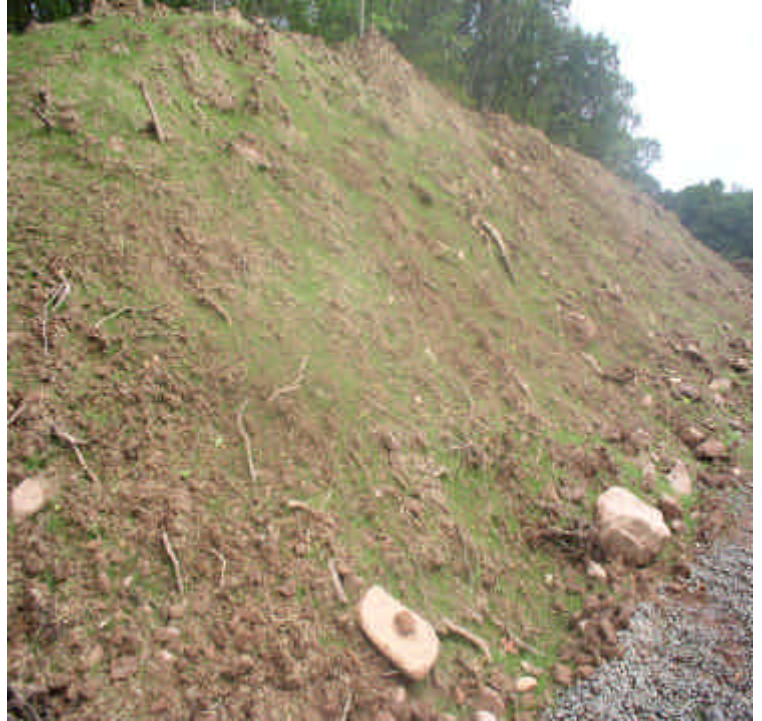
Grass growing on the newly seeded soil stockpiles.

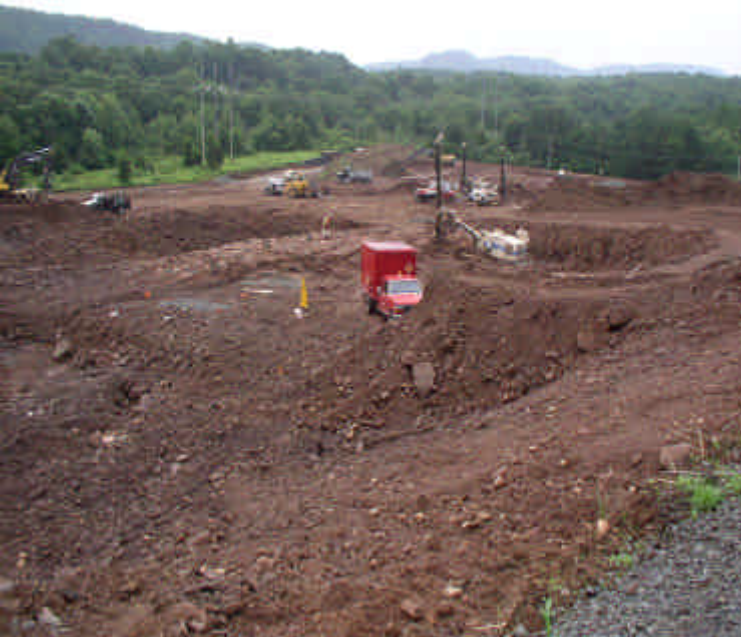
Entire site from northwest corner looking southeast at major grading and blasting operations.

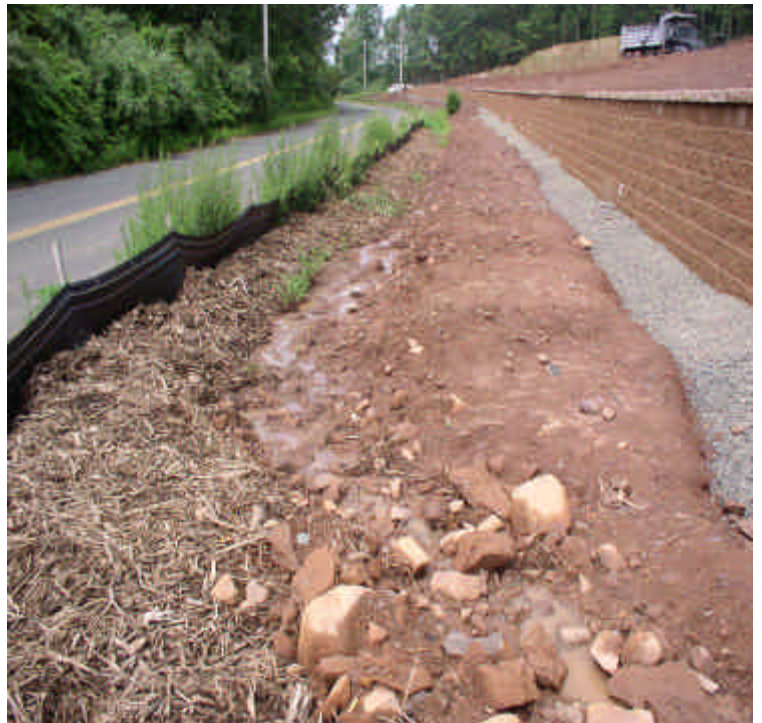
Bark mulch and silt fence along Carpenter Lane and new stone wall. Stormwater is being diverted to a settling area onsite.

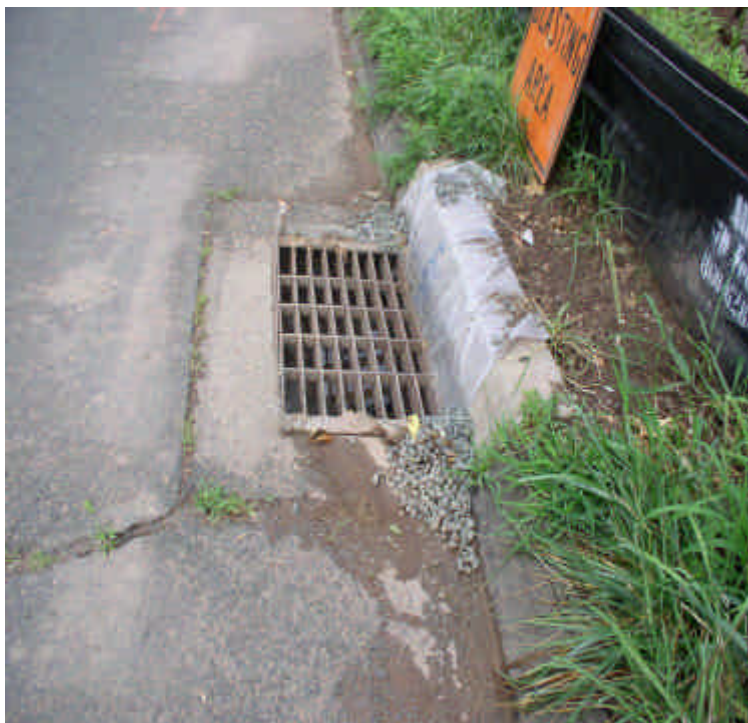
Stone in place, holding the edges of catch basin filter fabric.

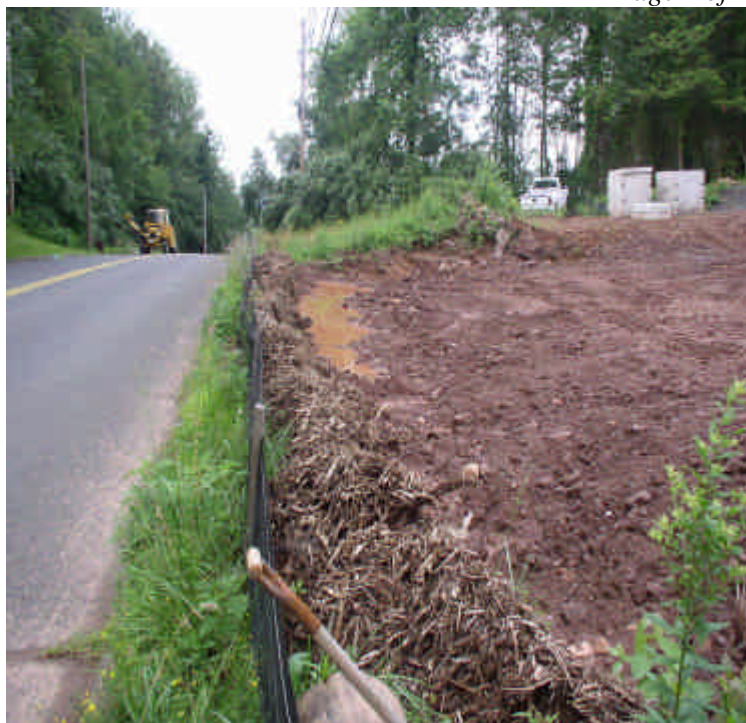
New water settling area dug in the southwest corner of the site.

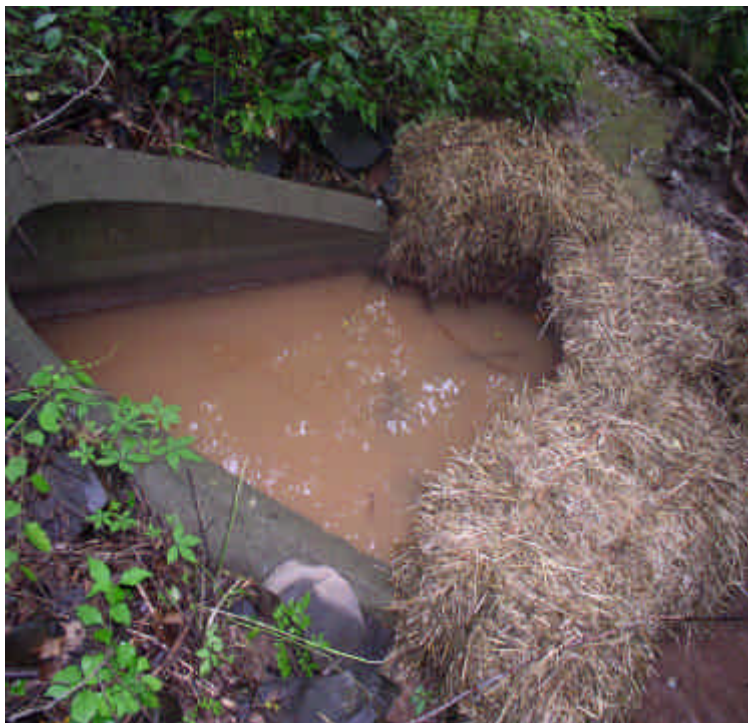
Haybales were placed for additional filtration at the storm drain outlet. Water from the outlet was still turbid.

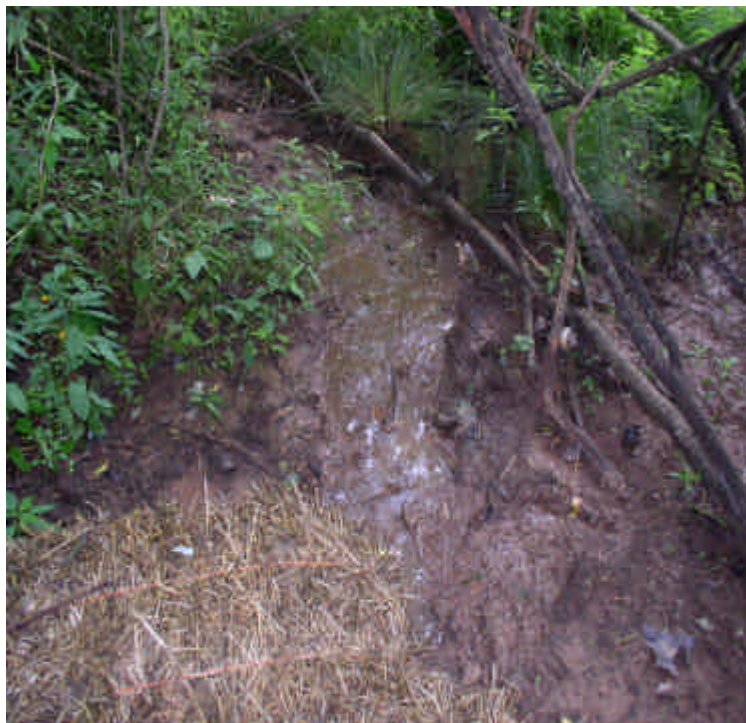
Water filtering through the haybales had improved clarity. Sediment accumulation from the previous rain events will be removed when conditions have dried out.
