Docket No. 272 – Development and Management Plan Inspection

Beseck Switching Station Inspection

Date: July 20, 2006

Location: Beseck Switching Station

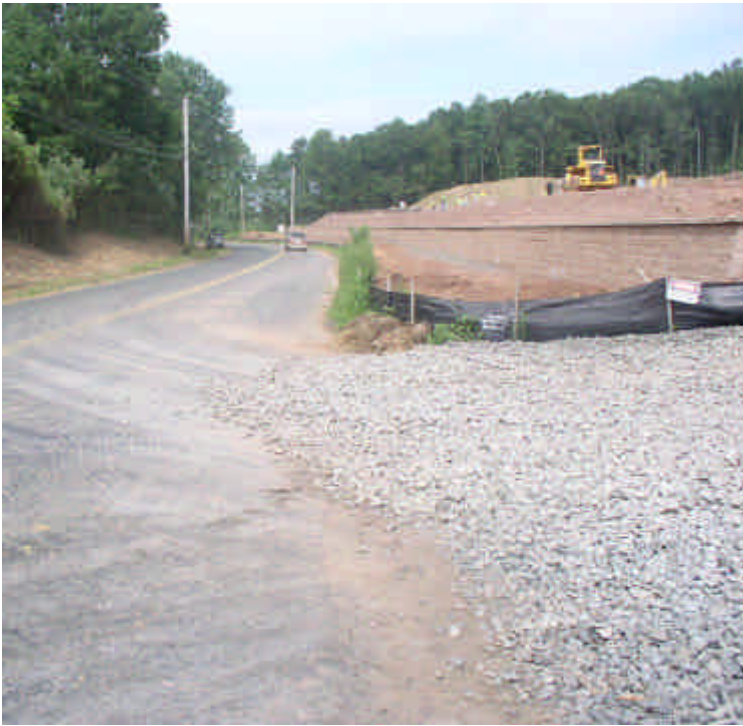
Crushed stone construction entrance pad is clean; loose stone should be pulled back off Carpenter Lane and the road cleaned/swept, including the gutters by hand if necessary.

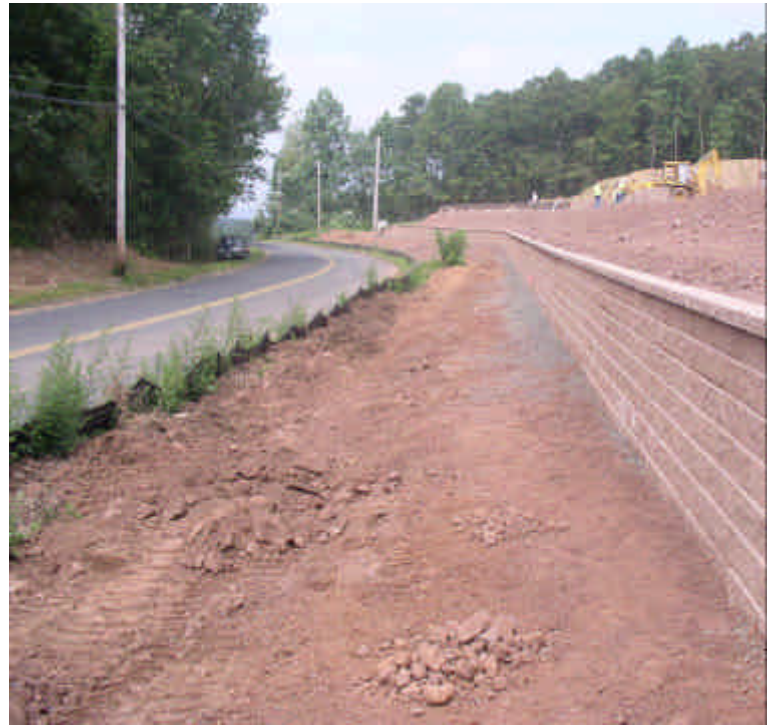
Grading and seeding remain to be done between Carpenter Lane and 1st retaining wall.

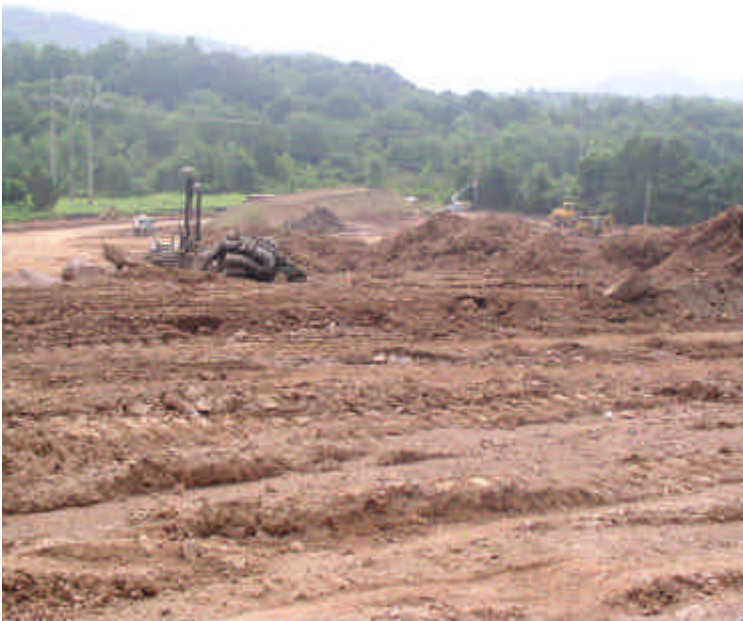
Entire site from northwest corner looking southeast at major grading and blasting operations.

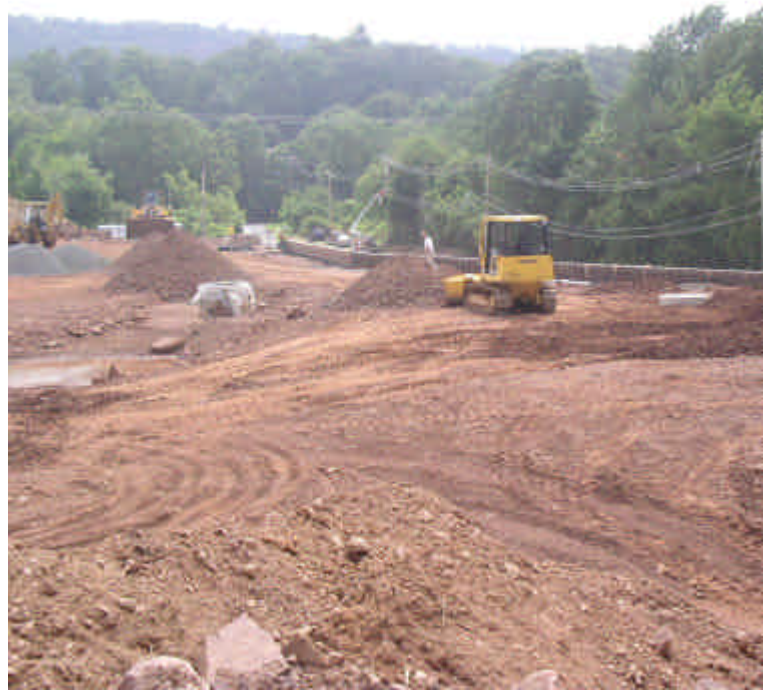
New stormwater inlet and manhole above 2nd retaining wall.

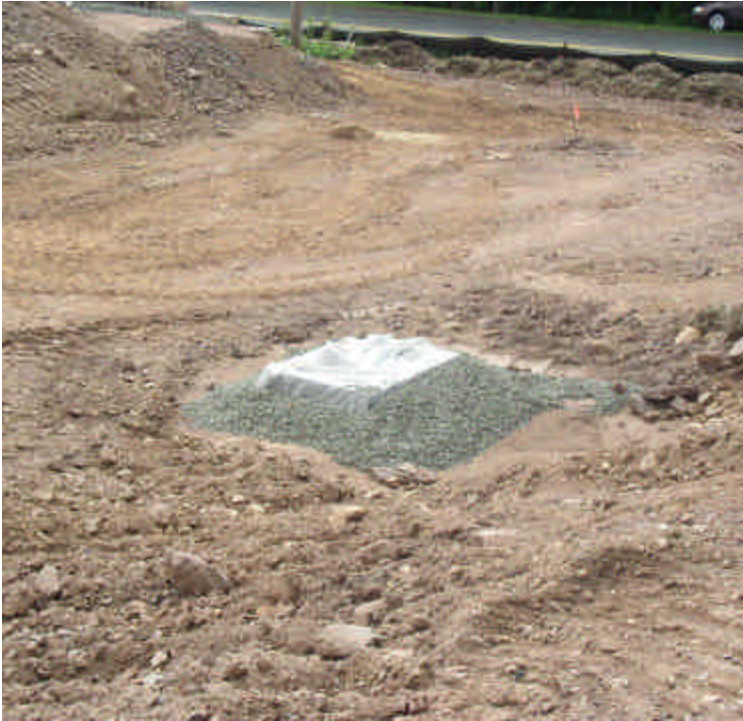
Catch basin inlet onsite is surrounded by stone and covered with fabric.

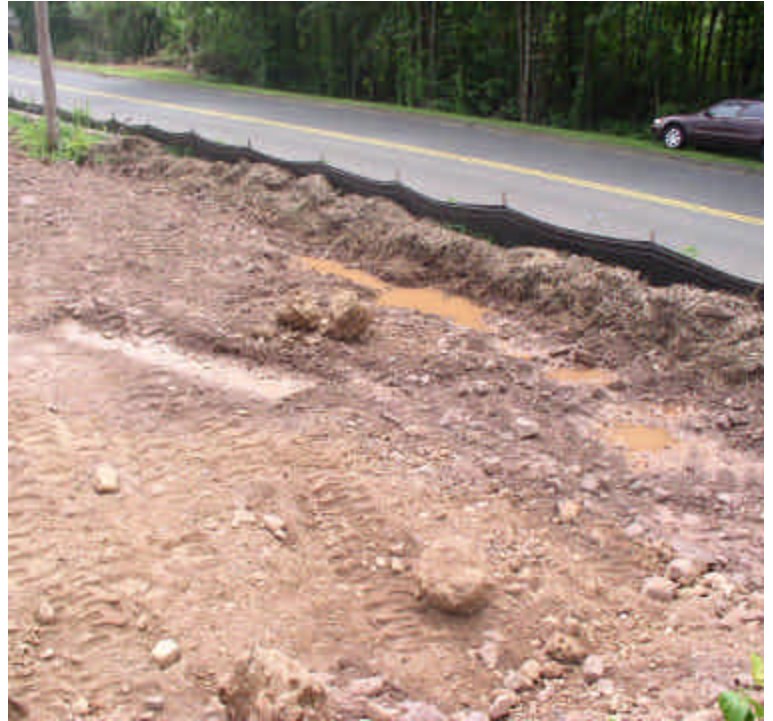
The new settling area dug in the southwest corner of the site is almost dry.

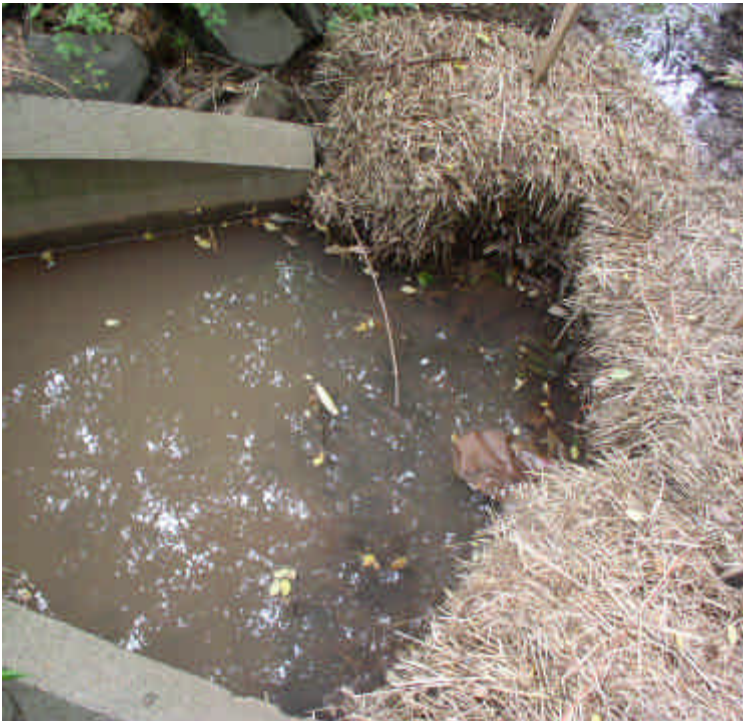
Haybales remain in place for additional filtration at the storm drain outlet. Water from the outlet was slightly turbid.

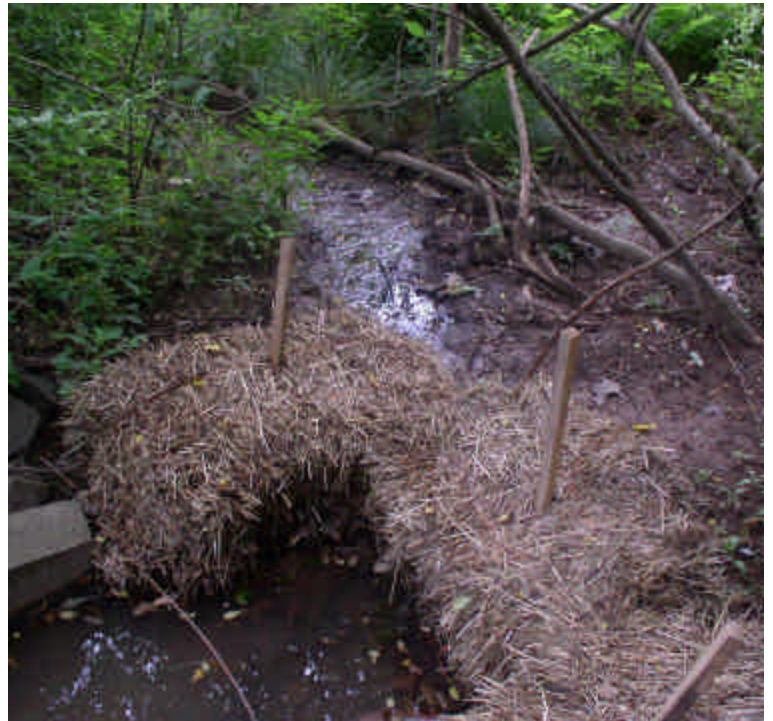
Water filtered by haybales is clearer than flow at the culvert. Sediment accumulation from the previous rain events will be removed when standing water in wetland has dried.
