Docket No. 272 – Development and Management Plan Inspection

Beseck Switching Station Inspection

Date: July 27, 2006

Location: Beseck Switching Station

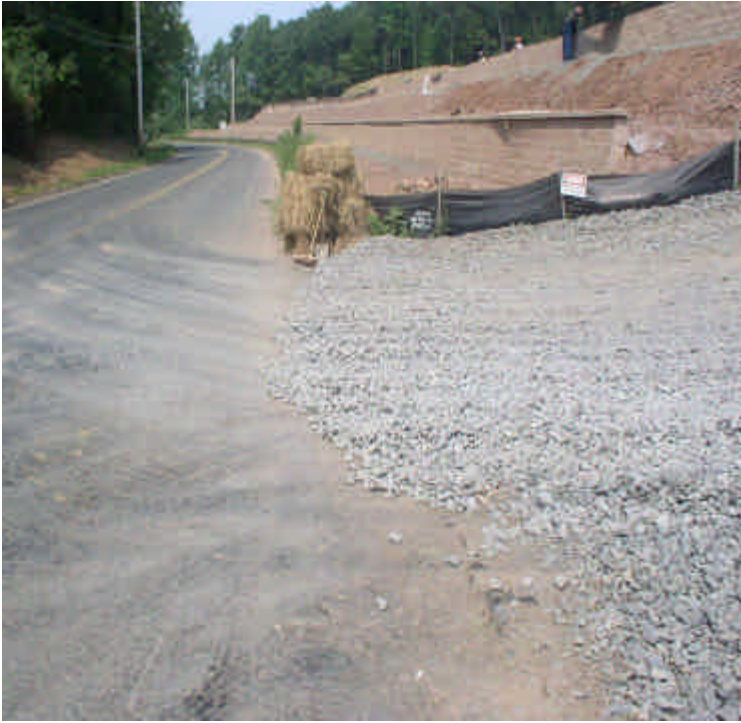
Crushed stone construction entrance pad is clean; loose stone continues to be pulled back off Carpenter Lane and the road should continue to be cleaned/swept, including the gutters by hand if necessary.

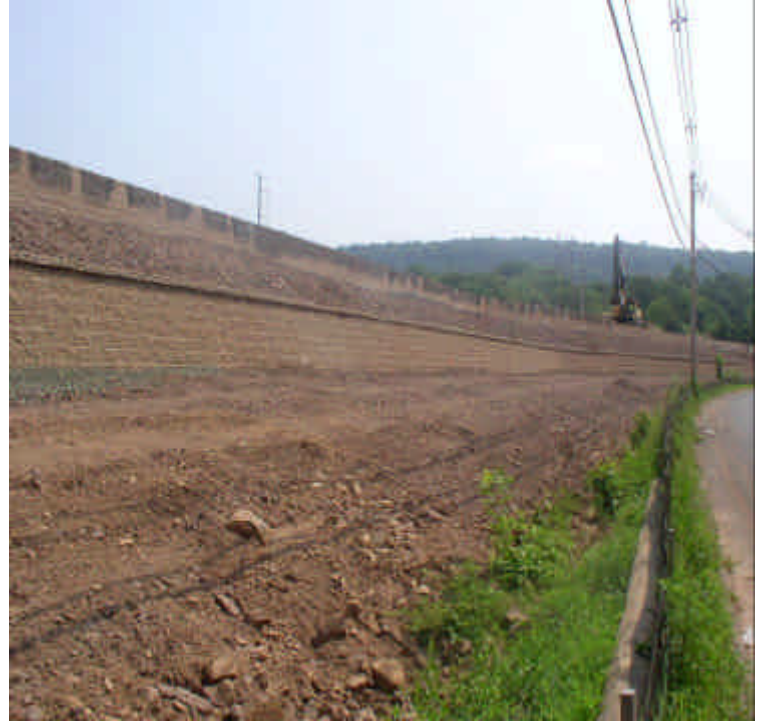
Grading and seeding remain to be done between Carpenter Lane and 1st retaining wall.

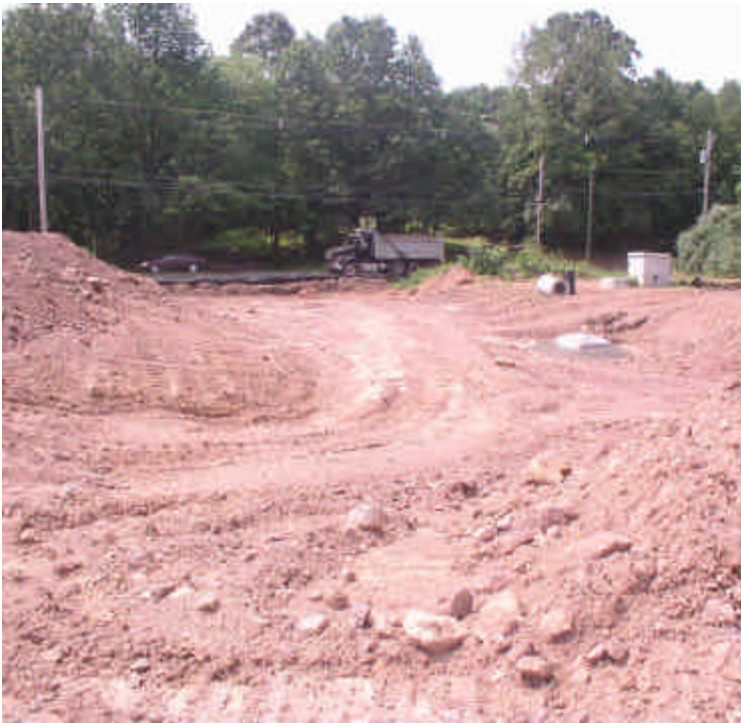
New site entrance to be constructed in this location with existing catch basin.

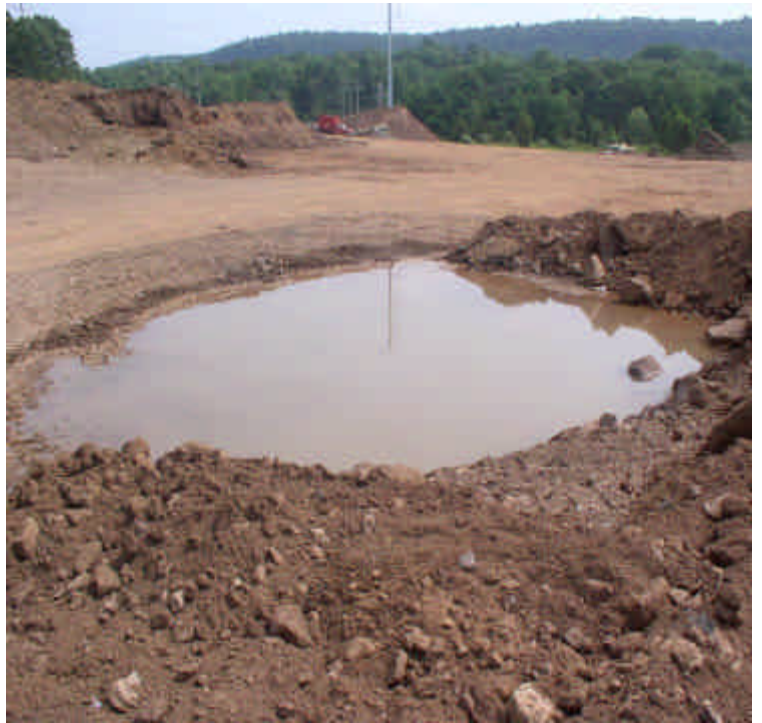
Detention pond/settling area holding pooled run-off.

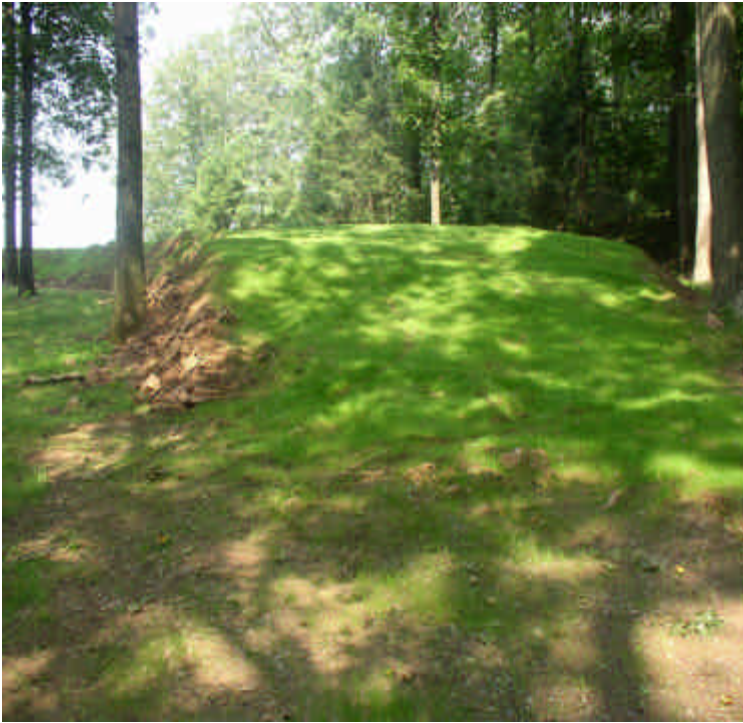
Stockpile and graded areas at old Zolnik property with grass growth.

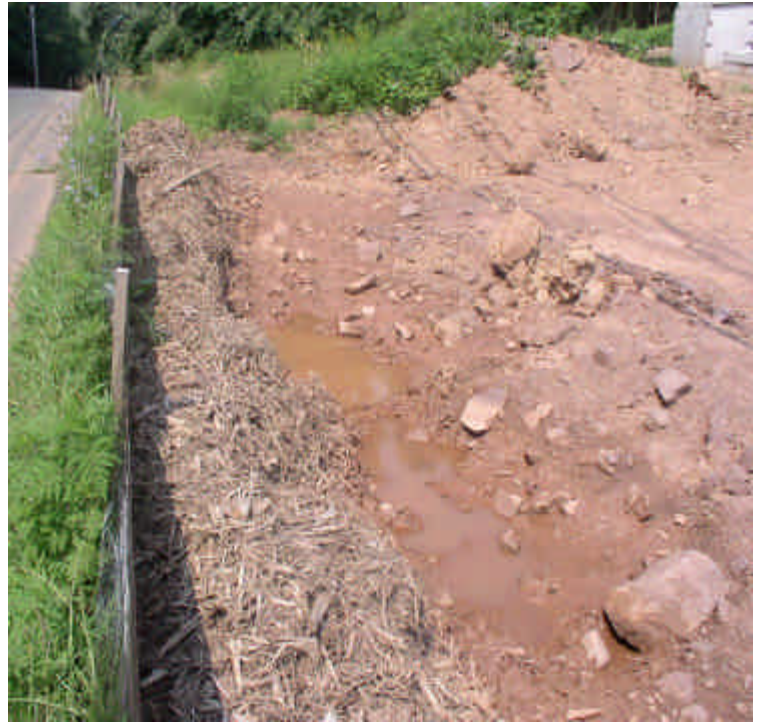
The temporary settling area in the southwest corner of the site remains in place but is holds little water at this time.

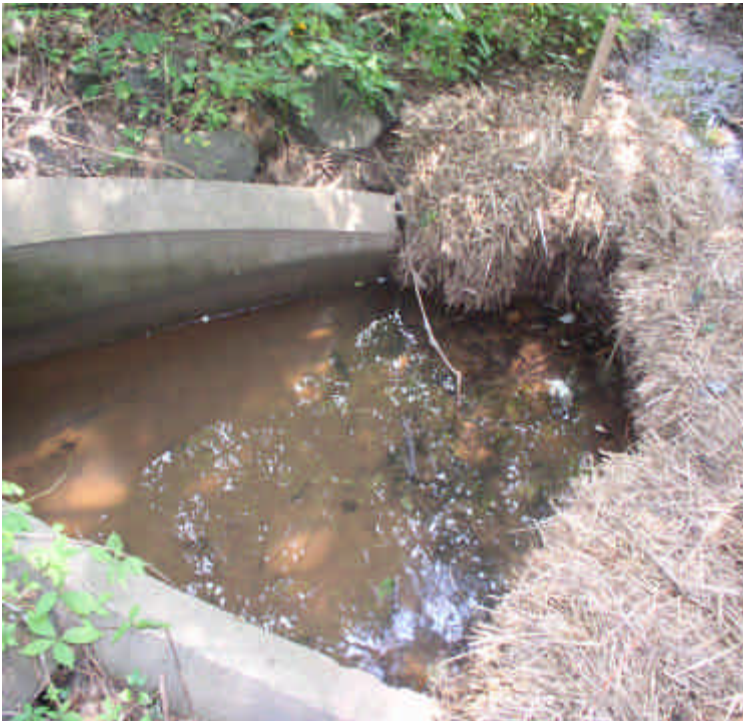
Haybales remain staked in place for additional filtration at the storm drain outlet. Water from the outlet was clear.

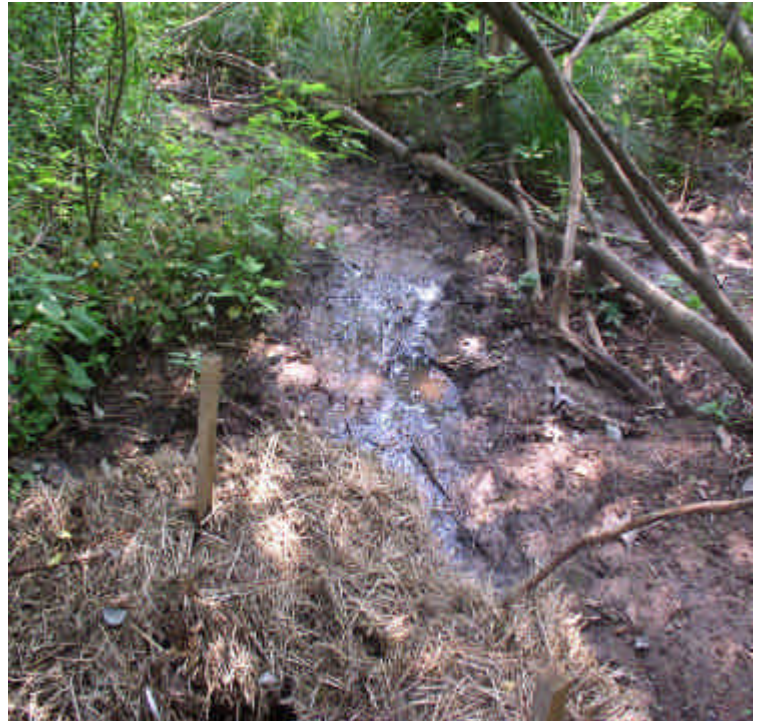
| Areas of Inspection | Observation | Recommended Action | Corrected Action |
|---|--|---|--|
| | Wetlands south of site across Carpenter Lane contain accumulated sediment near drain outlet, with clean water flowing from the outlet. 7/27/06 | Continue to monitor outlet area. Accumulated sediment from the site should be removed carefully from the wetland by hand (shovels) at the next opportunity when conditions have dried. | Sediment will be removed as soon as standing water has dried. |
| | Sediment accumulation is also attributed to grout damage in the new drainage pipe, which has since been repaired. 7/13-7/27/06 A line of haybales remains at the outfall pipe to filter water as it enters the wetland. 7/27/06 | NA Monitor haybales and remove sediment as needed so new haybale line continues to work properly. 7/27/06 | NA NA |

Flow from the culvert is being filtered by haybales prior to entering the wetland. Sediment accumulation from the previous rain events will be removed when standing water in wetland has dried.
