Docket No. 272 – Development and Management Plan Inspection

Beseck Switching Station Inspection

Date: August 17, 2006

Location: Beseck Switching Station

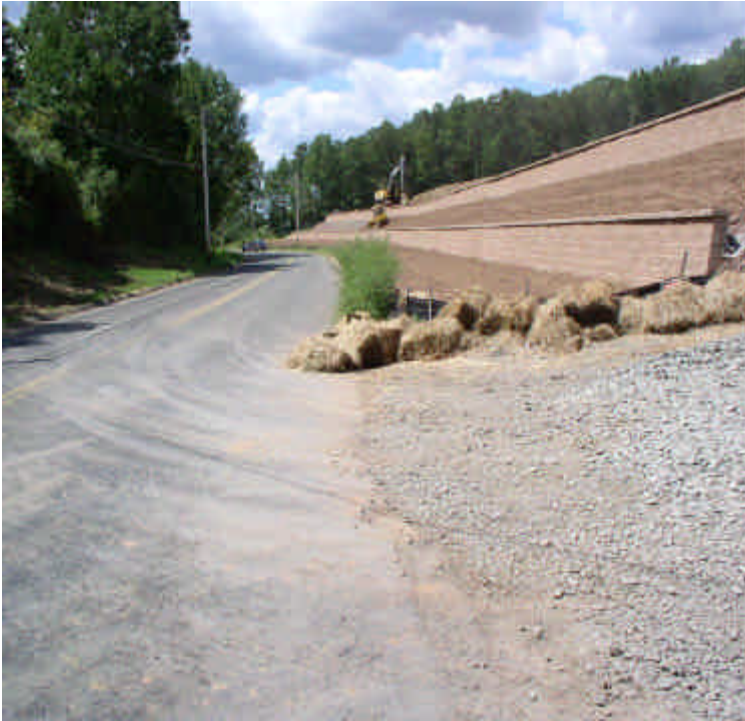
Crushed stone construction entrance pad is mostly clean; some minor tracking was noted on Carpenter Lane. The road should continue to be cleaned and swept, including the gutters, by hand if necessary.

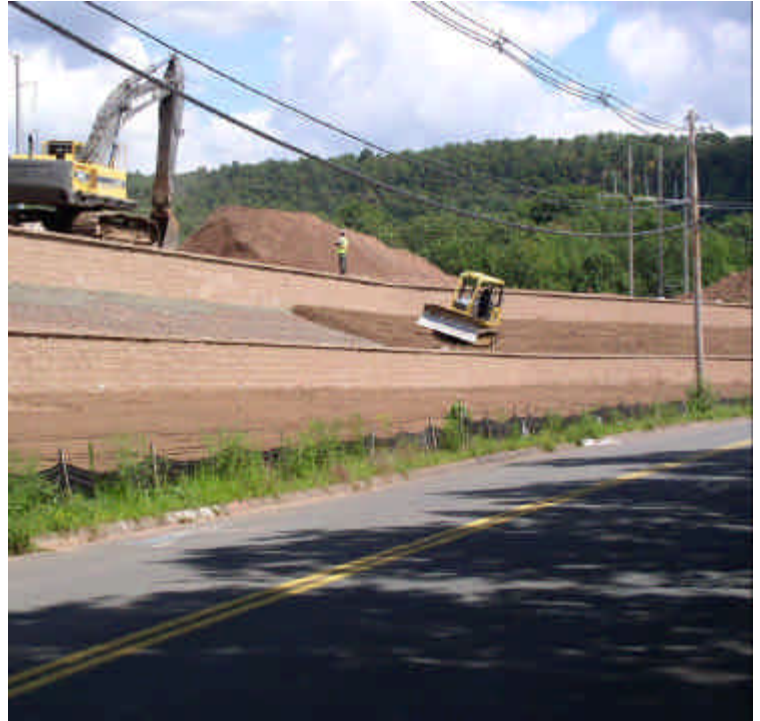
Final grading of loam is underway along the retaining walls and adjacent to Carpenter Lane.

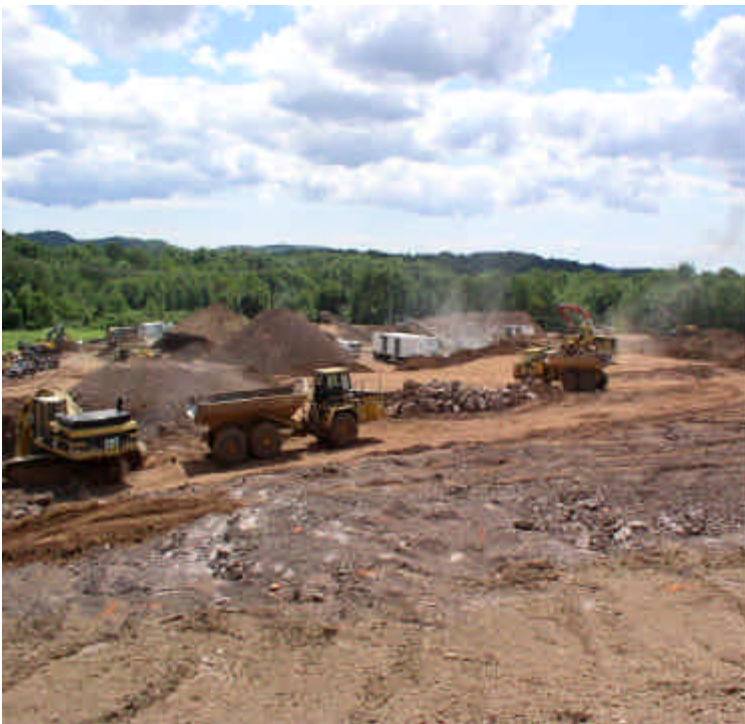
Major grading operations looking from northwest to southeast. Some airborne dust is noted. Continue to wet the soils when necessary.

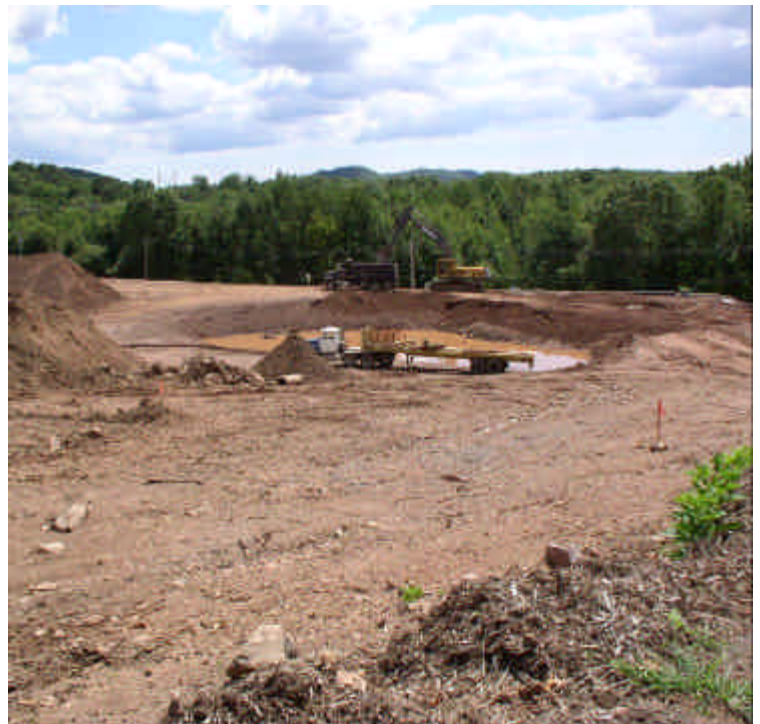
Detention pond/settling area retaining stormwater run-off.

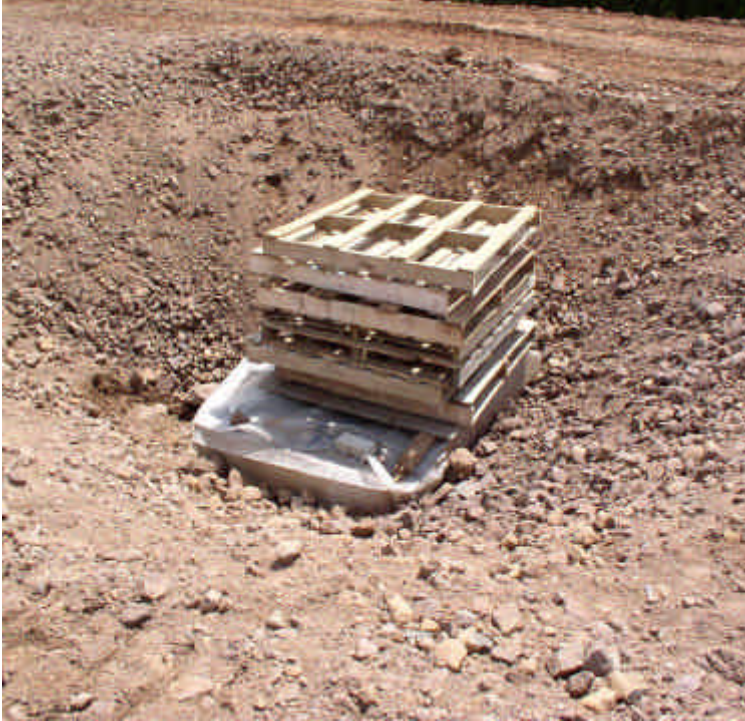
New southern catch basin, slightly raised with inlet protection.

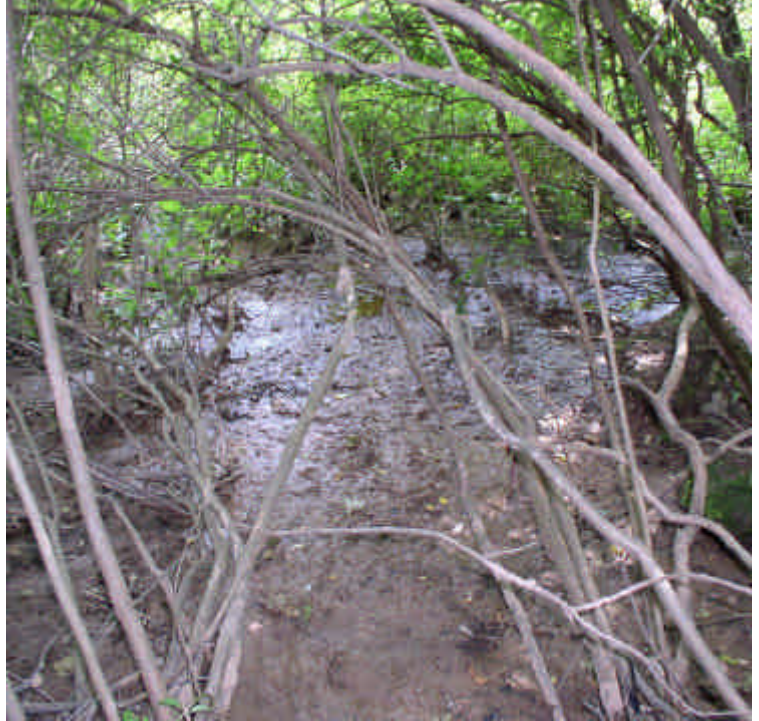
Sediment removal from wetland across Carpenter Lane is complete and the area looks good.

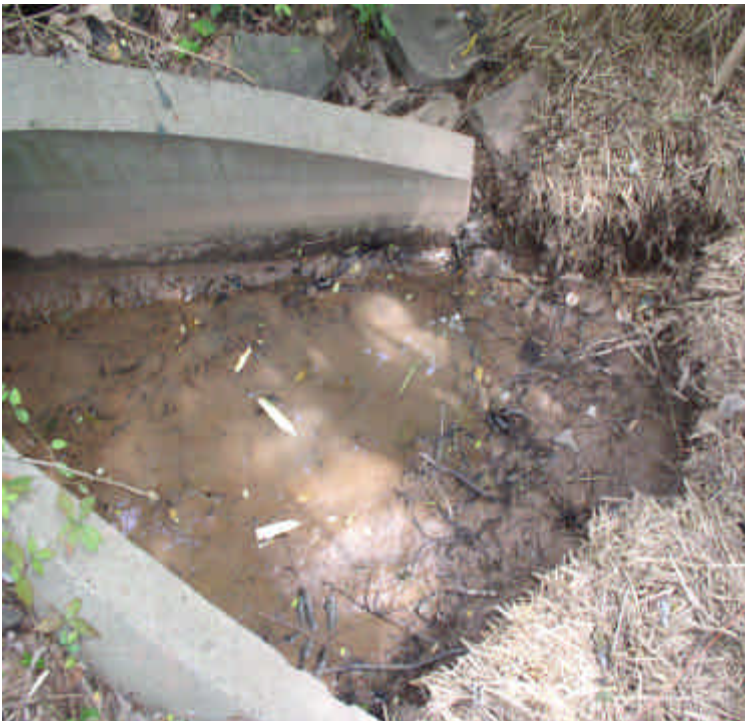
Remove accumulated sediment from the end of the outfall pipe on a regular basis.

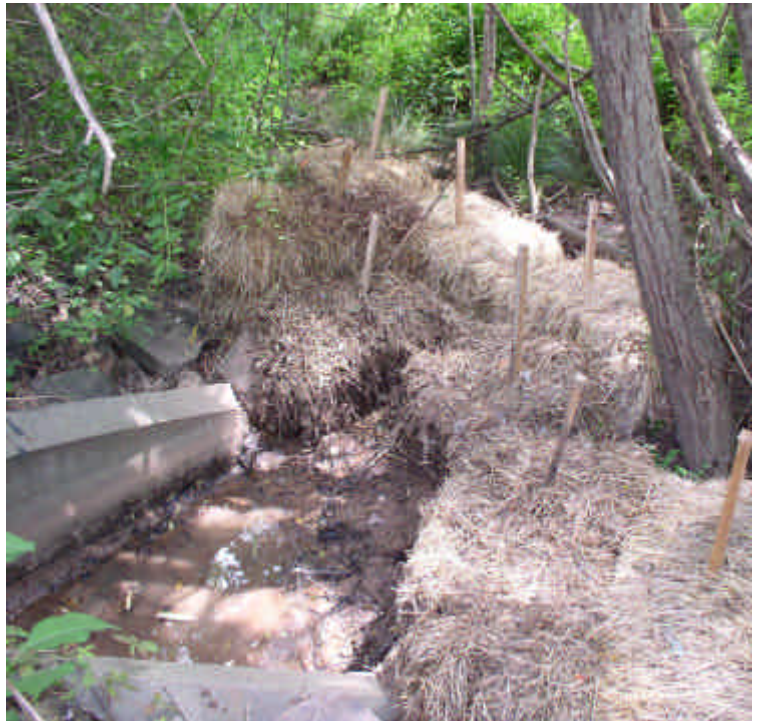
New haybales installed for additional filtration at the storm drain outlet.
