Docket No. 272 – Development and Management Plan Inspection

Beseck Switching Station Inspection

Date: August 24, 2006

Location: Beseck Switching Station

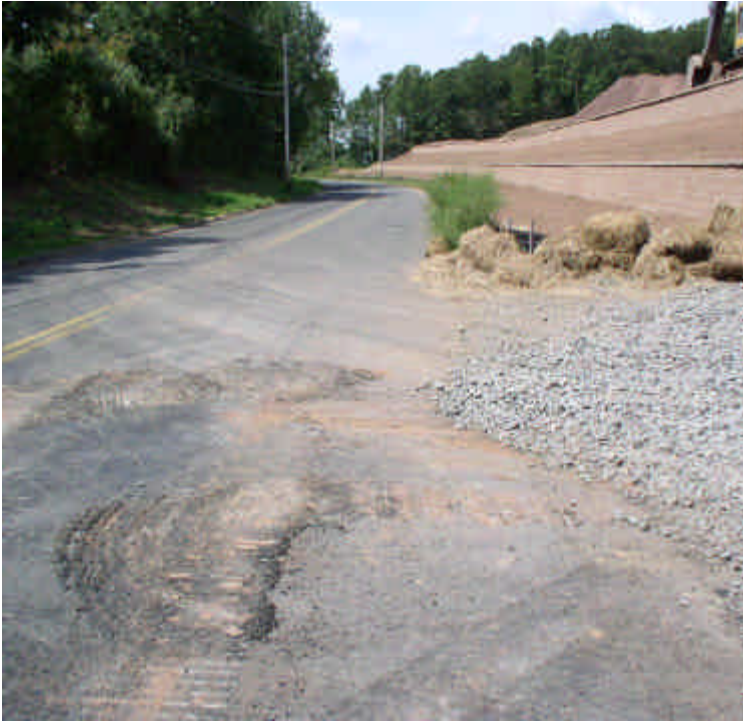
Crushed stone construction entrance pad is mostly clean; some minor tracking and road damage was noted on Carpenter Lane. The road should continue to be cleaned and swept, including the gutters, by hand if necessary.

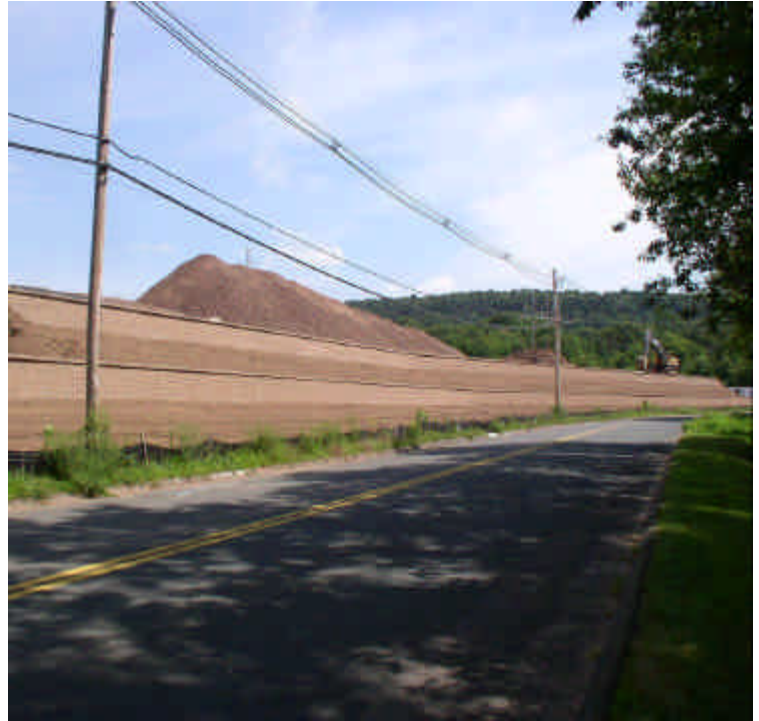
Final grading of loam is complete along the retaining walls and adjacent to Carpenter Lane.

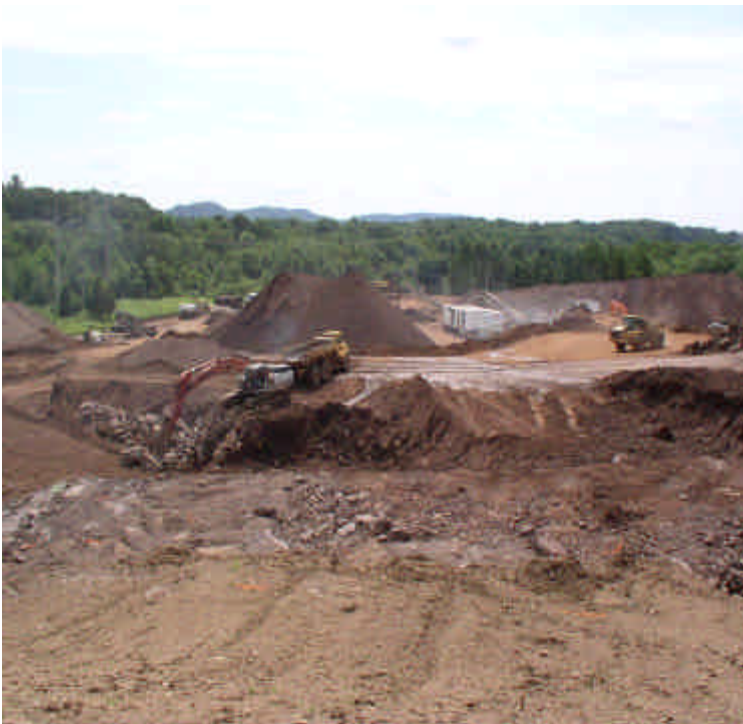
Major grading operations looking from northwest to southeast. Some airborne dust is noted. Continue to wet the soils when necessary.

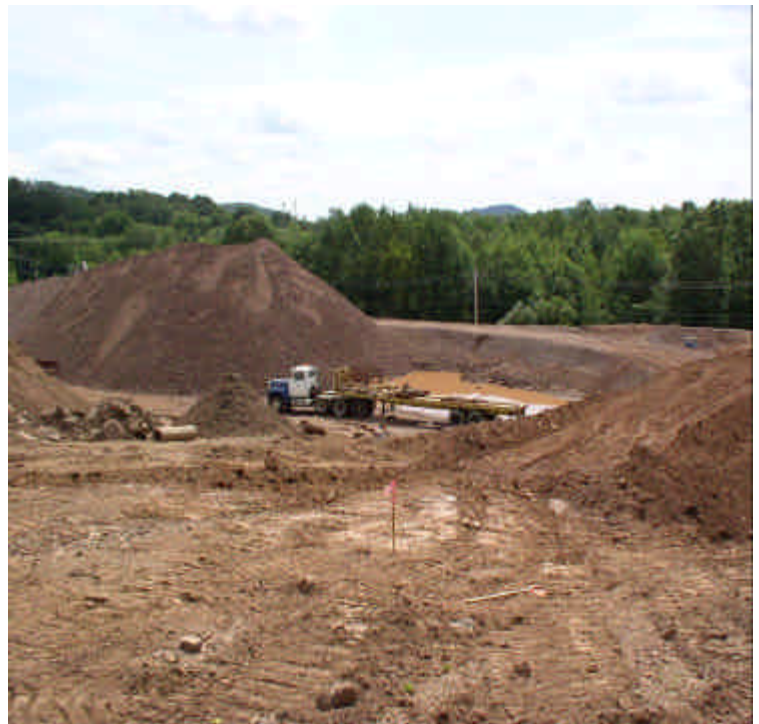
Detention pond/settling area retaining stormwater run-off. Large stockpiles are also present.

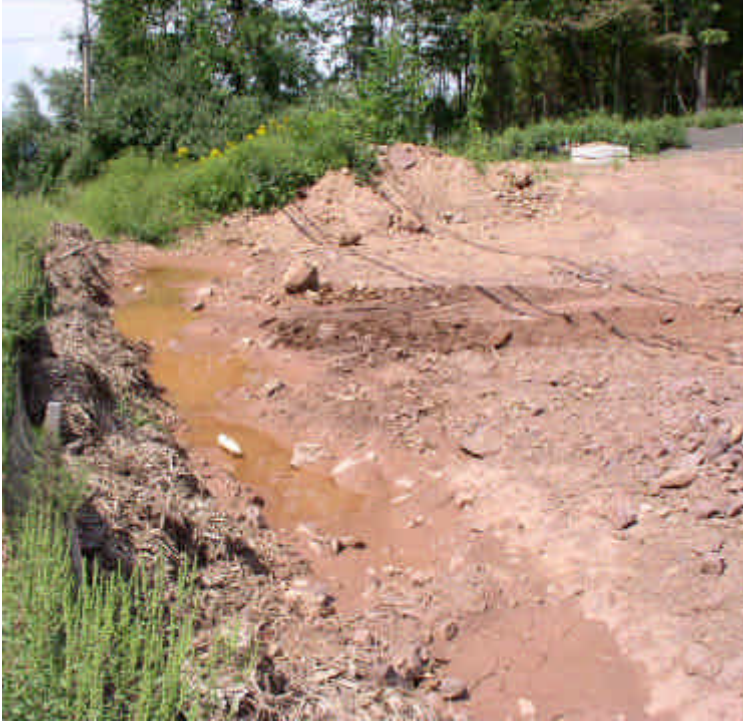
Small ponded area adjacent to Carpenter Lane.

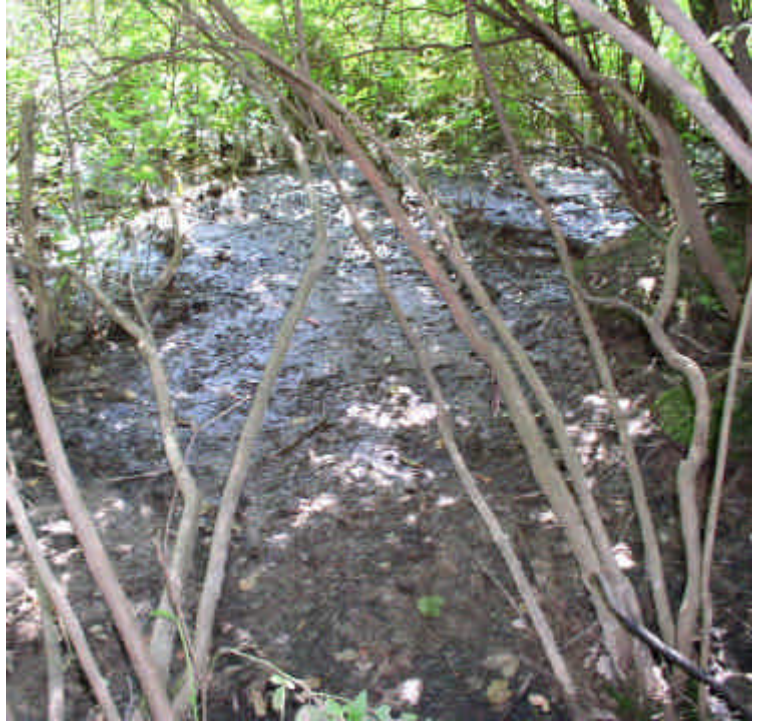
Sediment removal from wetland across Carpenter Lane is complete and the area looks good.

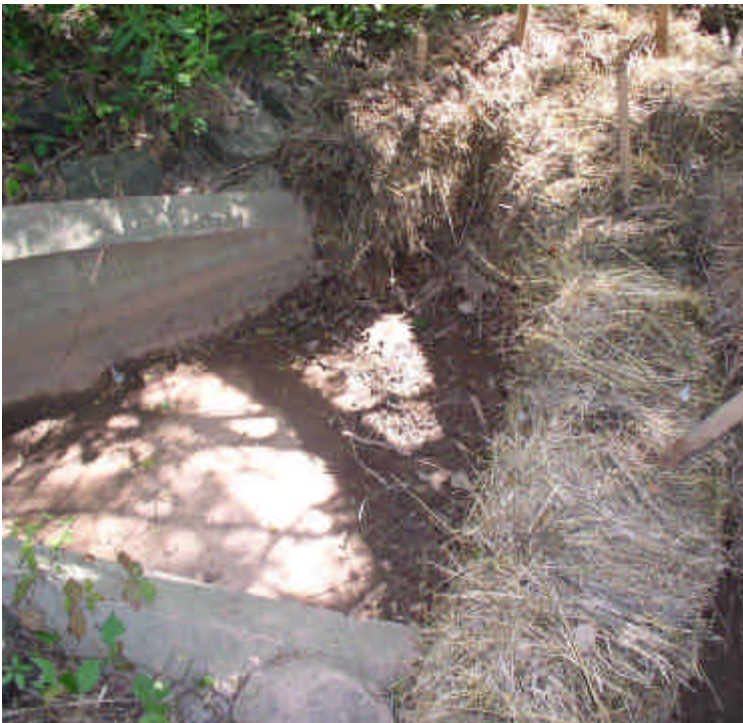
Sediment and old haybales have been removed from the end of the outfall pipe. Sediment removal should continue on a regular basis.

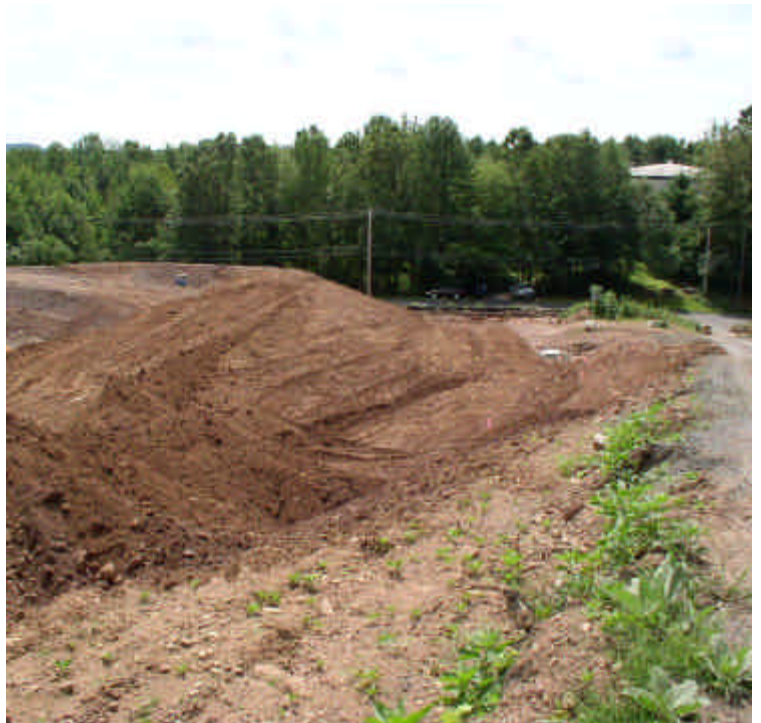
The new access driveway has been graded.
