**Docket No. 272 – Development and Management Plan Inspection**

**Beseck Switching Station Inspection**

**Date:** September 13, 2006

**Location:** Beseck Switching Station

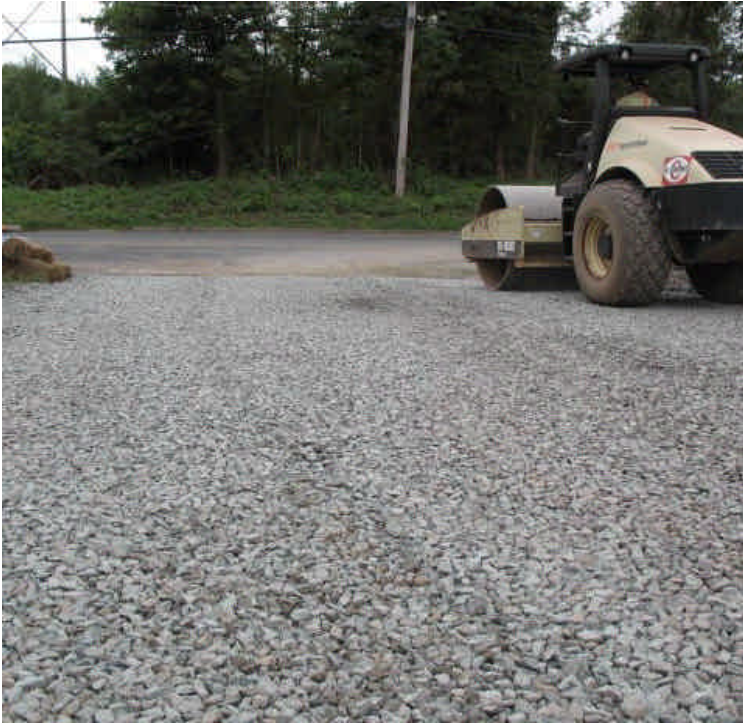
**Crushed stone construction entrance pad refreshed with new stone, being compacted. Carpenter Lane should continue to be cleaned and swept, including the gutters, by hand if necessary.**

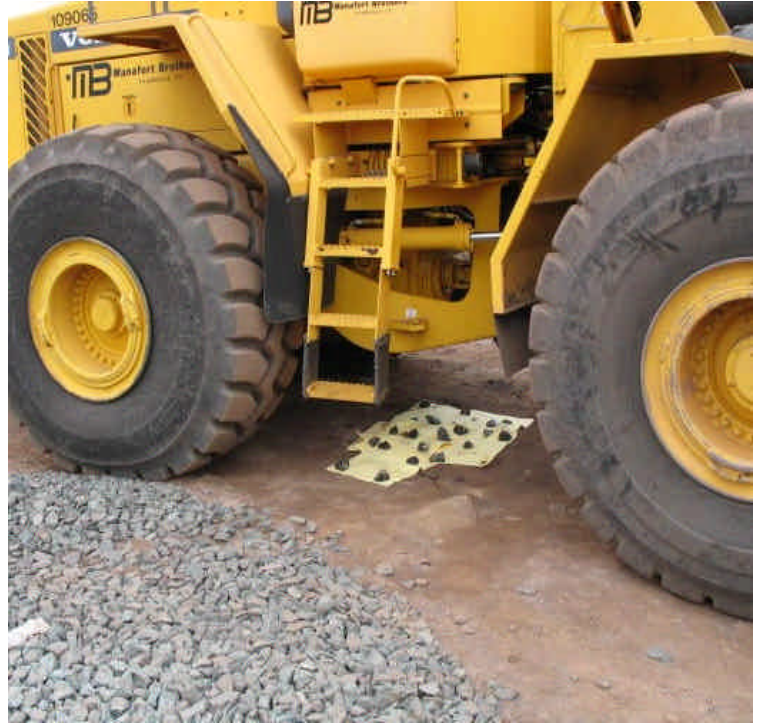
**Spill controls being used under a leaking vehicle.**

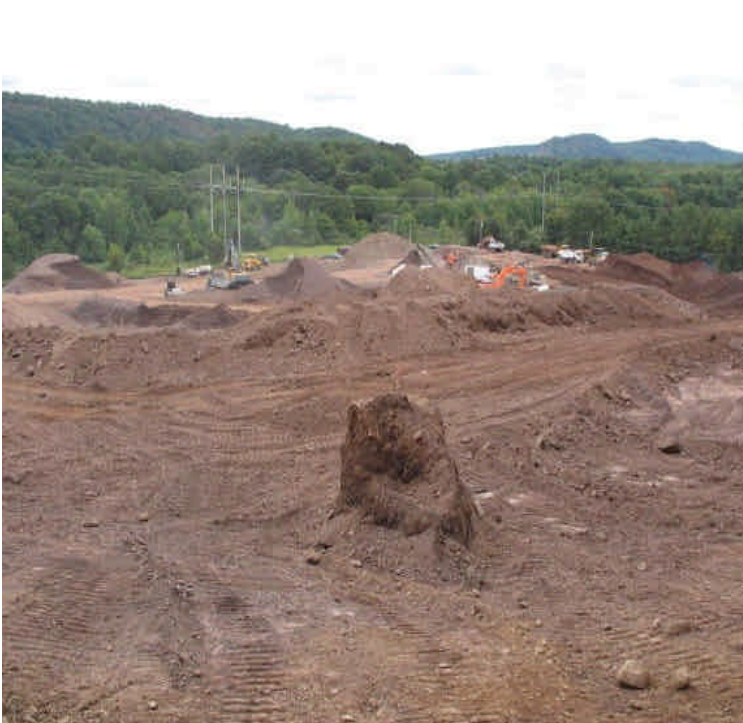
**Major grading operations looking from northwest to southeast.**

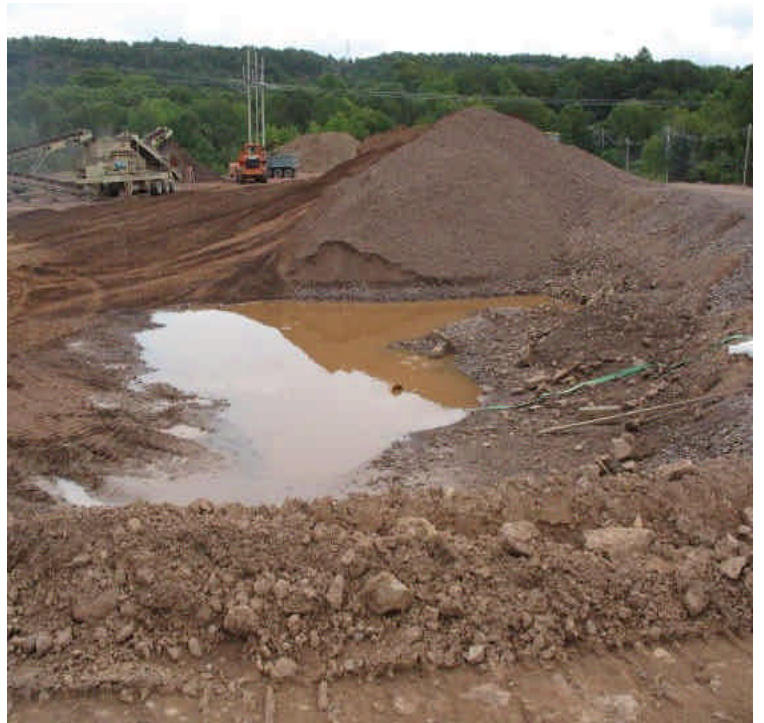
**Detention pond/settling area retaining stormwater run-off. Large stockpiles are also present.**

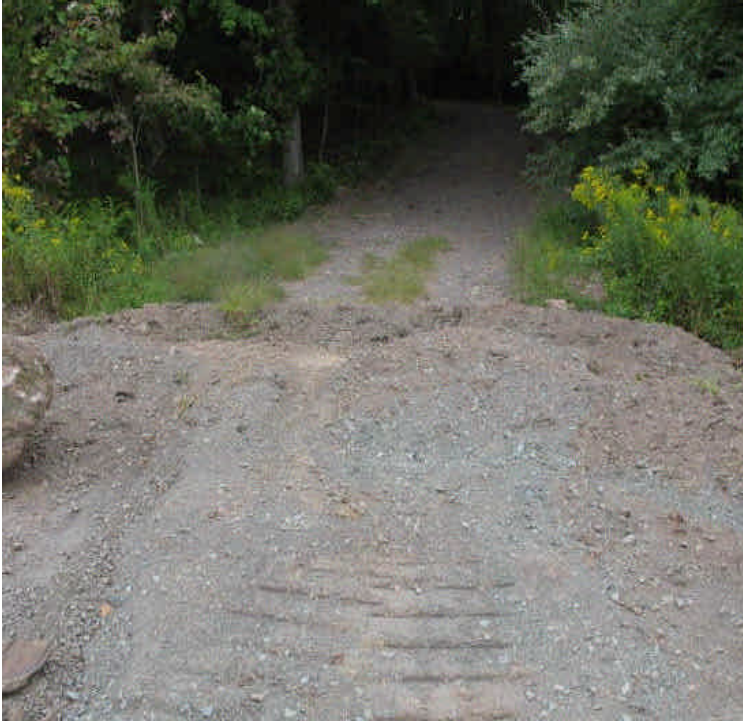
**New water bar across old Zolnik driveway at the tree line northwest corner of the site.**

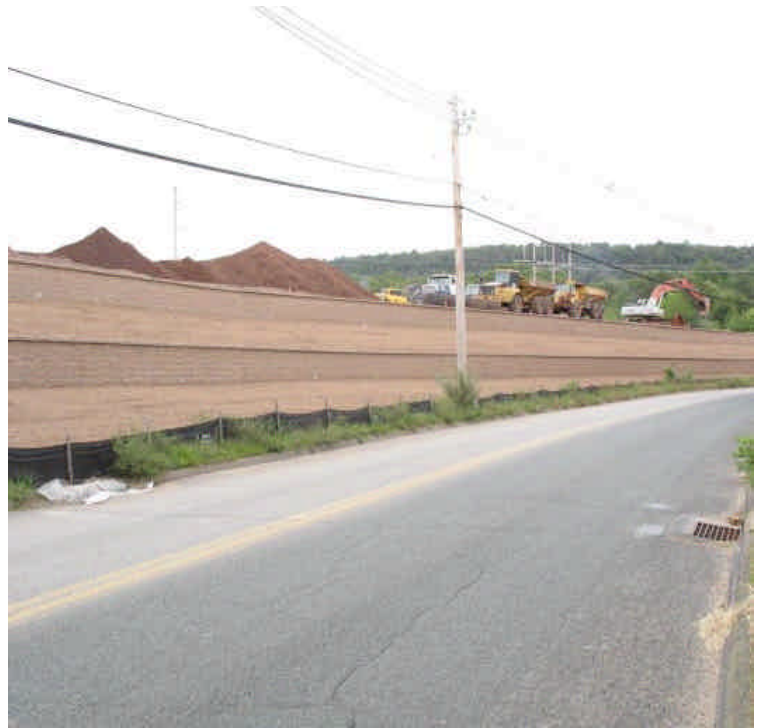
**Loamed & fertilized area adjacent to the finished retaining walls should be seeded soon.**

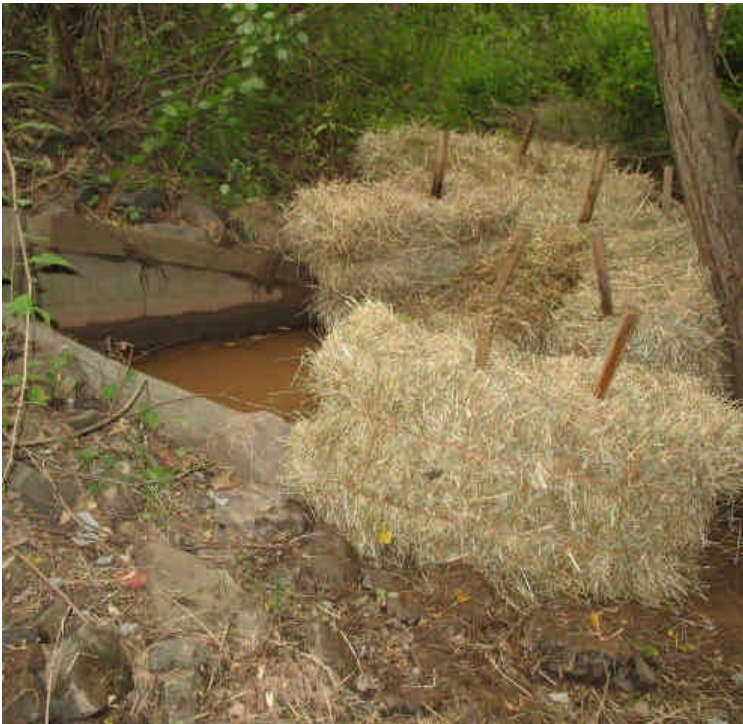
**Sediment-laden water being flushed from the storm drain system and filtered before entering wetlands. Water pumping has been reduced. New haybales were added and sediment was removed from the outlet.**

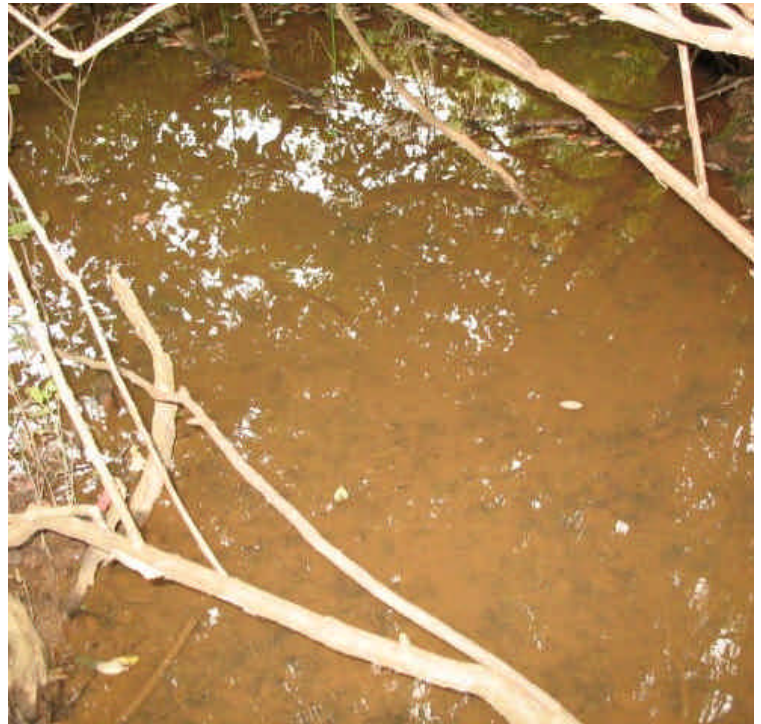
**Clear standing water is now present in the wetland, small amount of sediment has settled out.**
