**Docket No. 272 – Development and Management Plan Inspection**

**Beseck Switching Station Inspection**

**Date:** September 21, 2006

**Location:** Beseck Switching Station

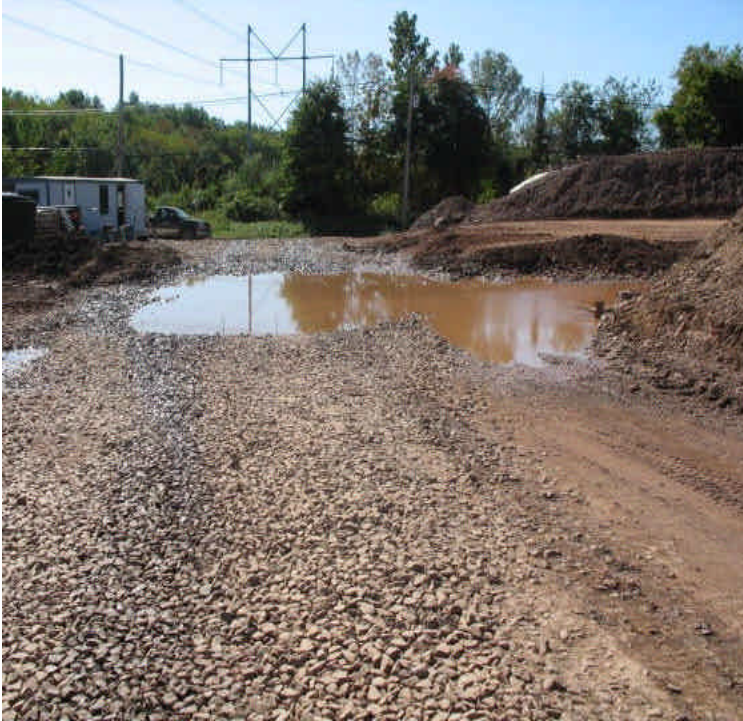
**Crushed stone construction entrance pad with wheel wash area, Carpenter Lane should continue to be cleaned and swept, including the gutters, by hand if necessary.**

<b>Areas of Inspection</b>	<b>Observation</b>	<b>Recommended Action</b>	<b>Corrected Action</b>
<b>Access roads and adjacent roadways</b>	<b>All truck traffic is using stone entrance on east side. Sediment tracking was observed - mostly dust from trucks leaving the site. Street sweeper was cleaning the roadway during the inspection. Sweeper should use more water; as observable amounts of dust were produced. 9/21/06</b>	<b>Continue to clean/refresh stone construction entrance. Continue to keep Carpenter Lane clear of stone. Use more water while sweeping the streets to reduce dust production. Clean gutter by hand. 9/21/06</b>	<b>Stone continues to be pulled back from roadway and refreshed with new stone. Street sweeping was occurring.</b>
	<b>Small settling area created from recent rains near the stone entrance is used to wash truck tires. 9/21/06</b>	<b>Monitor and clean stone as needed. 9/21/06</b>	<b>Water used to clean truck tires.</b>

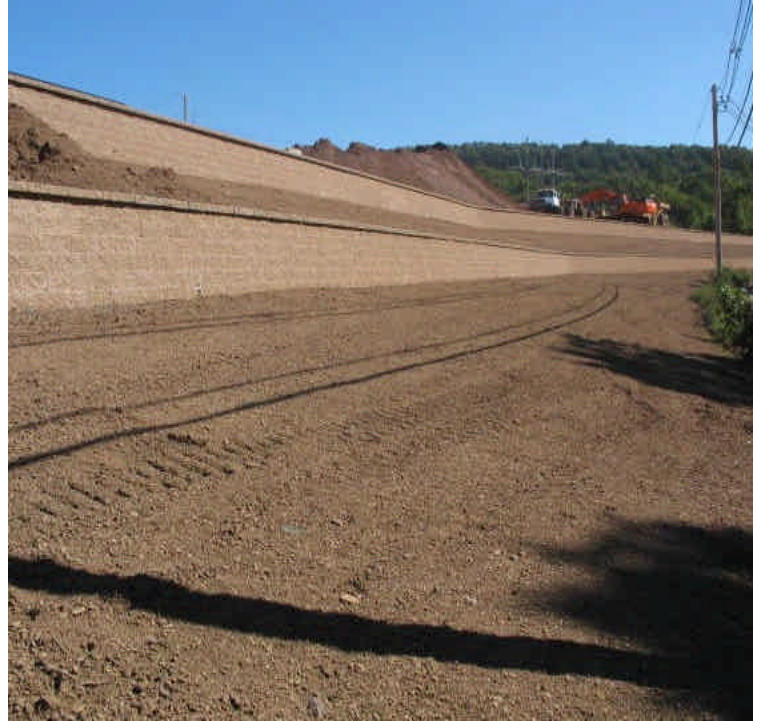
**Front slopes along Carpenter Lane have been fertilized and limed, and should be hydroseeded as soon as possible. Recommended seeding time for the fall usually ends Oct 15<sup>th</sup>.**

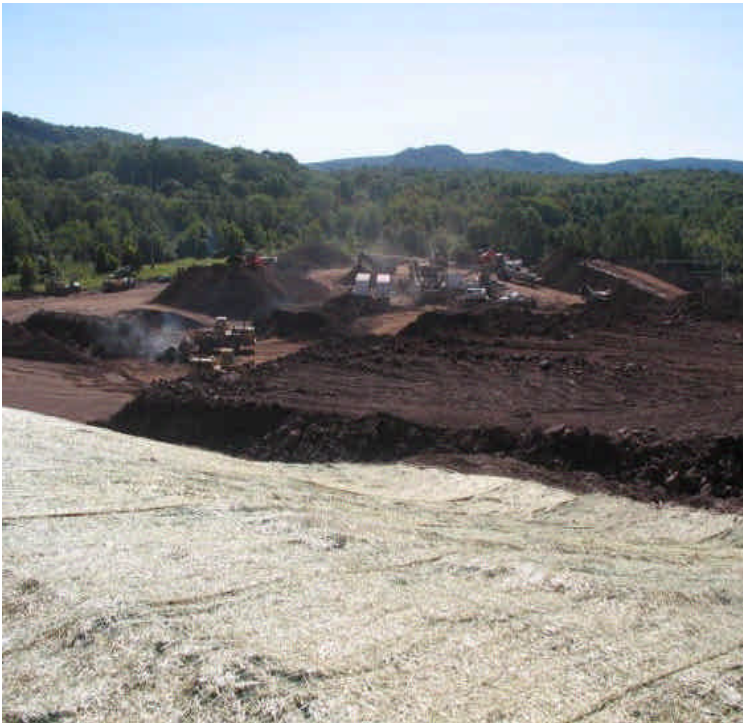
**Major grading operations looking from northwest to southeast.**

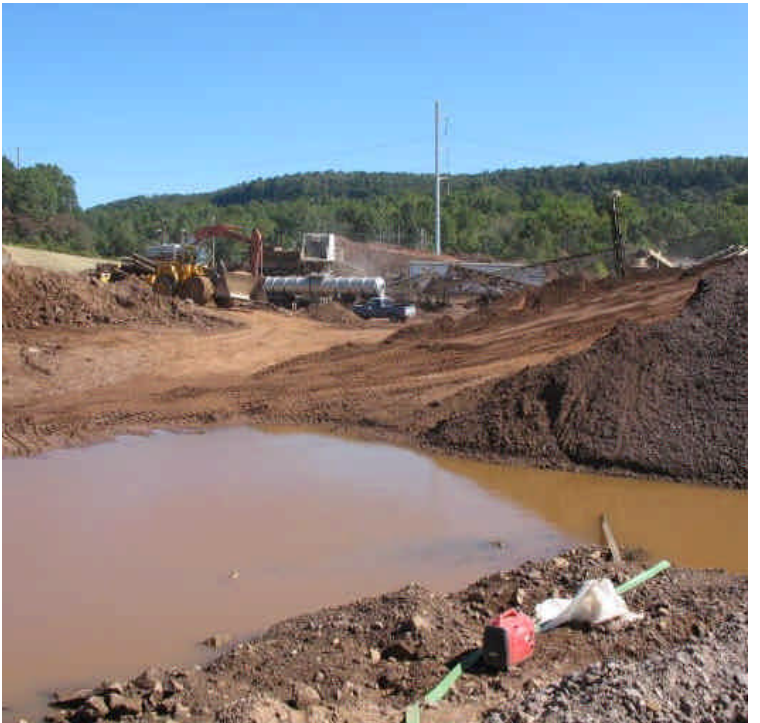
**Detention pond/settling area retaining stormwater run-off.**

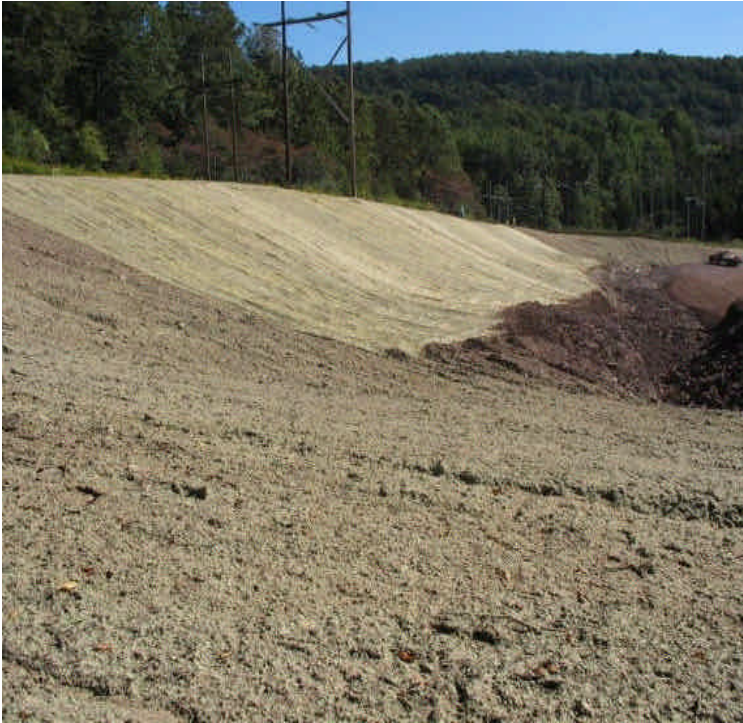
**Hydroseeded northern slope with hay mat installation.**

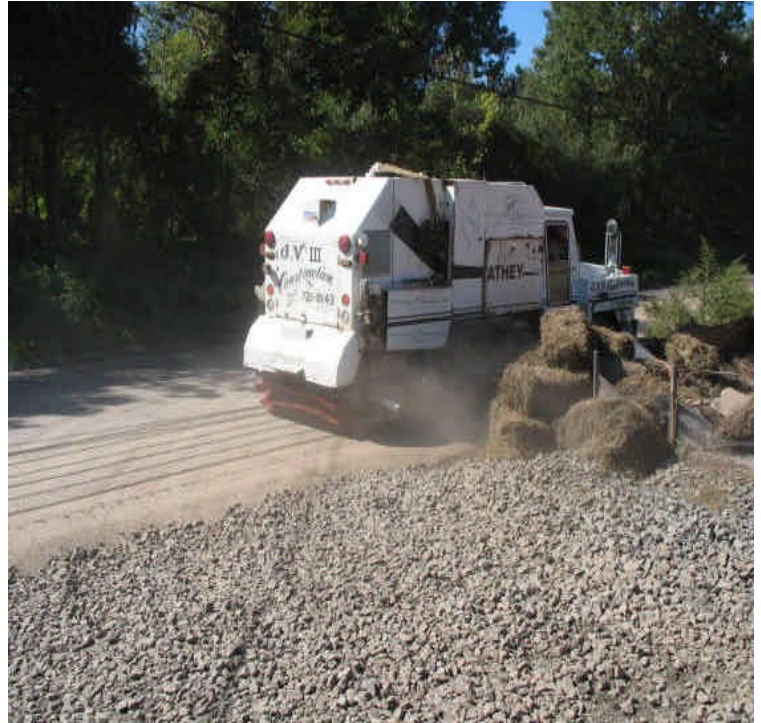
**Street Sweeping along Carpenter Lane. More water is needed to reduce dust production.**

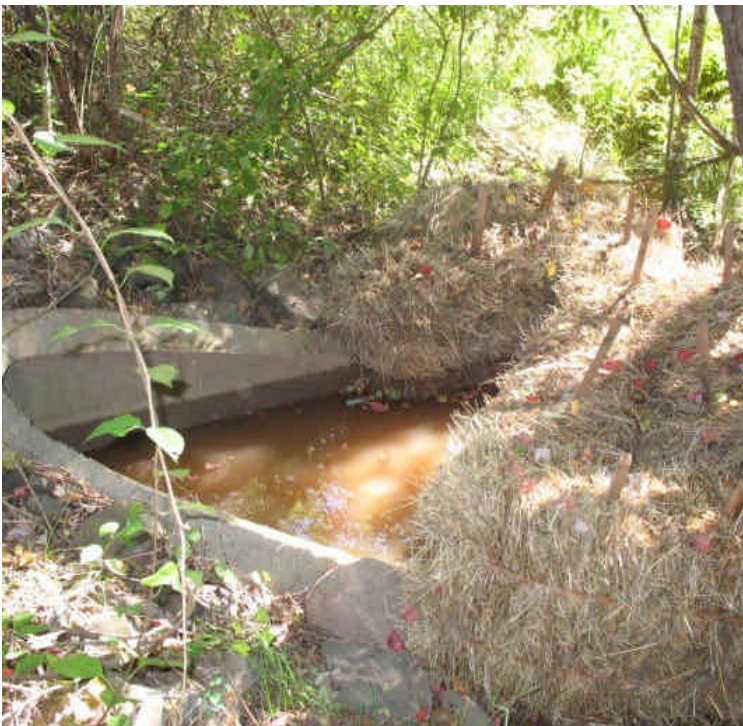
**Sediment-laden water being flushed from the storm drain system and filtered before entering wetlands. Water pumping continues at night without monitoring. Sediment filled water continues to enter the wetland.**

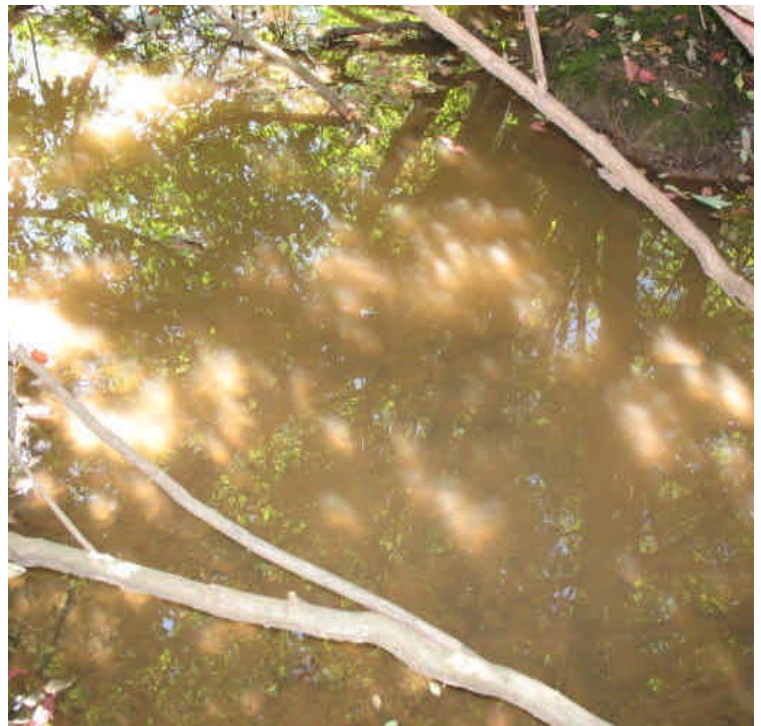
<p><b>Inland Wetland and Watercourse encroachment and mitigation</b></p>	<p>Wetlands on east side of site were clean and well protected. 9/21/06</p> <p>The wetlands across Carpenter Lane have additional sediment accumulation, and outlet pipe was discharging turbid water due to pumping from the settling basin, which continues to overtake haybales at outlet pipe and increase sedimentation in the wetland. 9/21/06</p>	<p>Continue to monitor. 9/21/06</p> <p>Continue to monitor. The wetland sediment accumulation is not extensive at this time, and removal would likely do more harm than good. However, must establish a pumping schedule with monitoring of the outlet for overflow. Do not use pump unattended. Consider using a vac truc/frac tank on site if feasible to eliminate this re-occurring problem. 9/21/06</p>	<p>NA</p> <p>Needs attention and evaluation.</p>
<p><b>State species of concern, threatened and endangered species.</b></p>	<p>According to the D&amp;M plan, state-listed species are not located in this work area.</p>	<p>None 9/21/06</p>	<p>NA</p>

**Sediment-filled standing water in the wetland, sediment continues to accumulate. Pumps should not be left unattended and a better solution is needed.**
