Docket No. 272 – Development and Management Plan Inspection

Beseck Switching Station Inspection

Date: September 28, 2006

Location: Beseck Switching Station

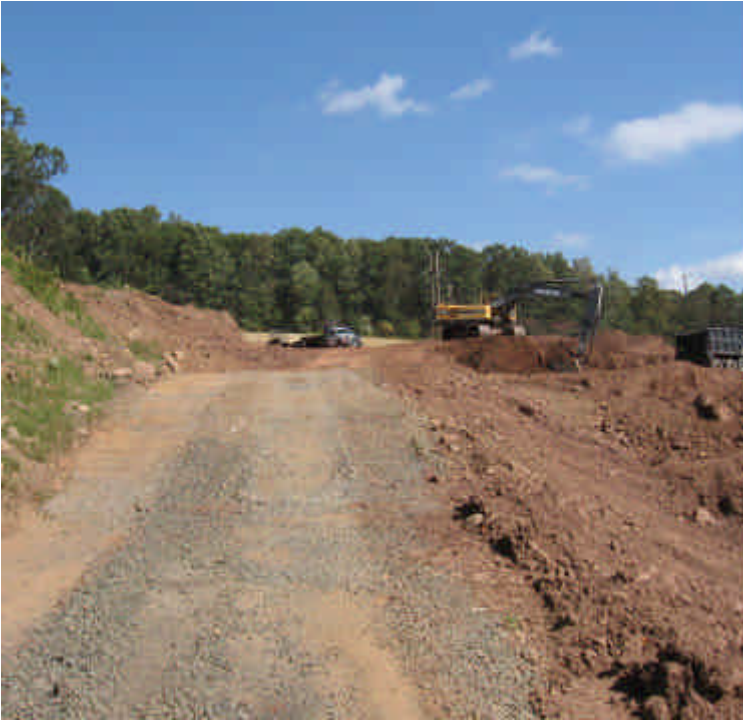
Driveway on western side of site is being used as truck entrance, not for exit; erosion controls remain functional.

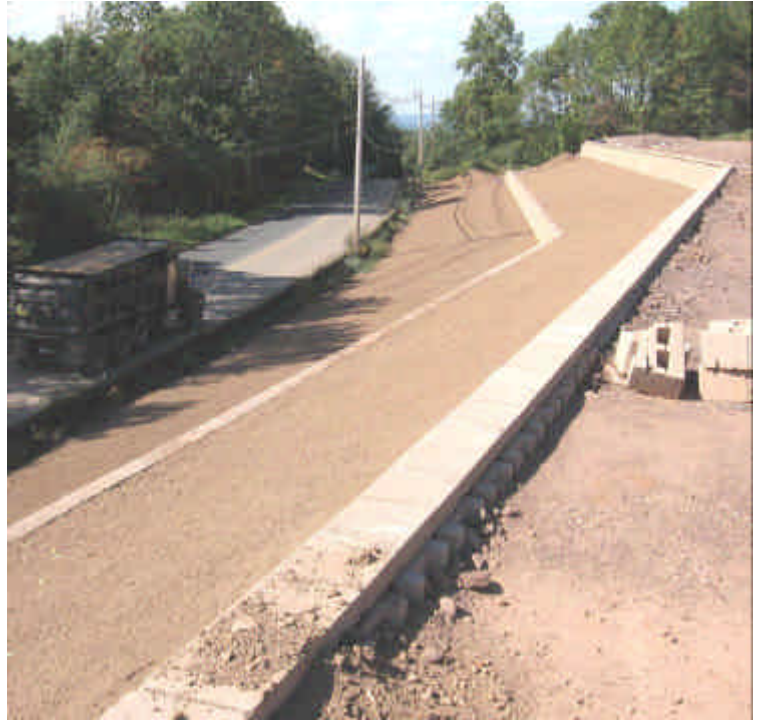
Carpenter Lane has some sediment accumulation but is being swept regularly. Southern slopes have now been seeded.

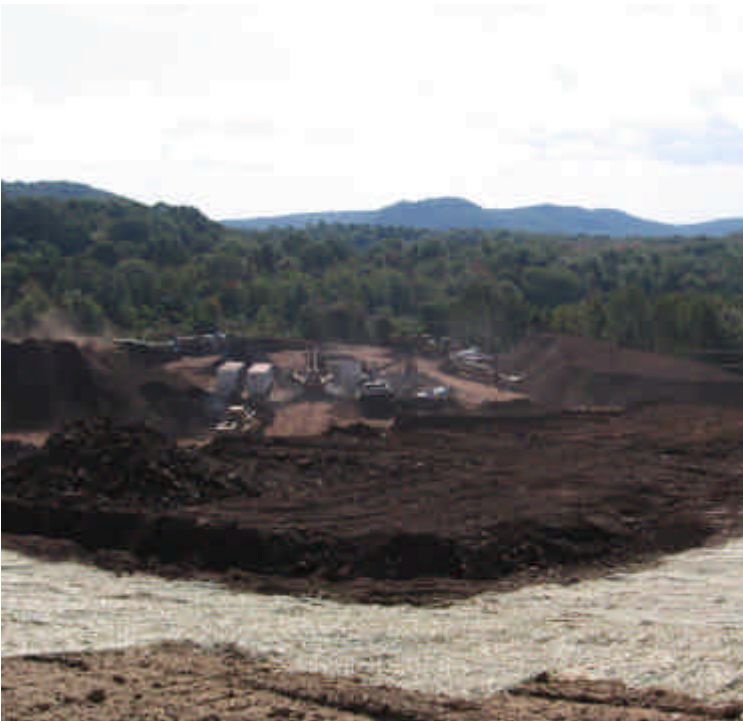
Major grading operations looking from northwest to southeast.

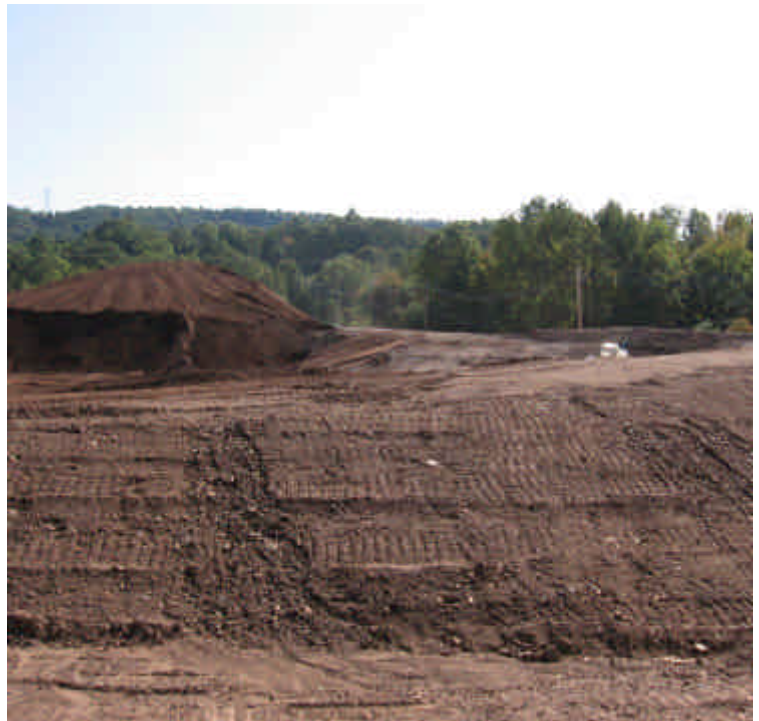
Detention pond under construction.

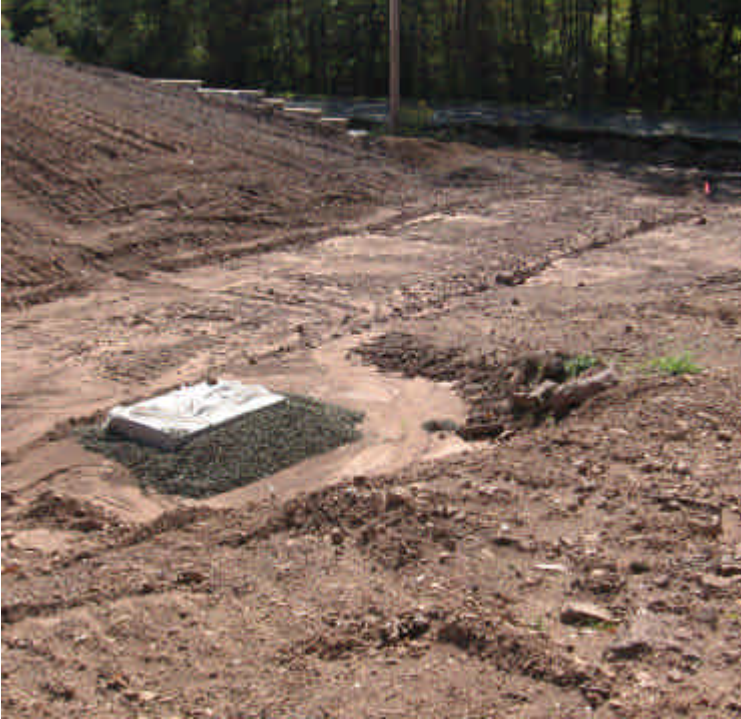
Stormwater inlet structure at southwest corner remains protected.

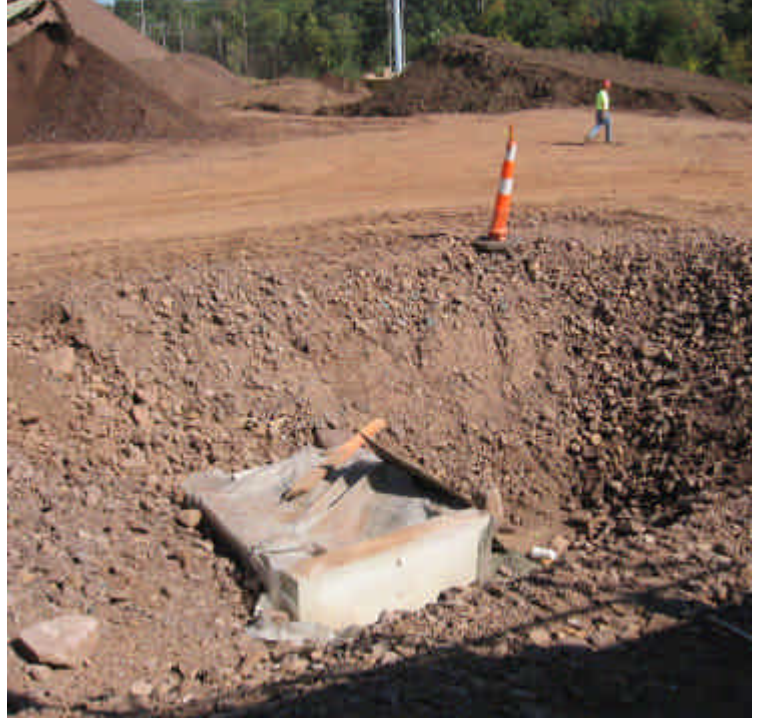
Stormwater inlet in southeast corner under construction but some controls are in place.

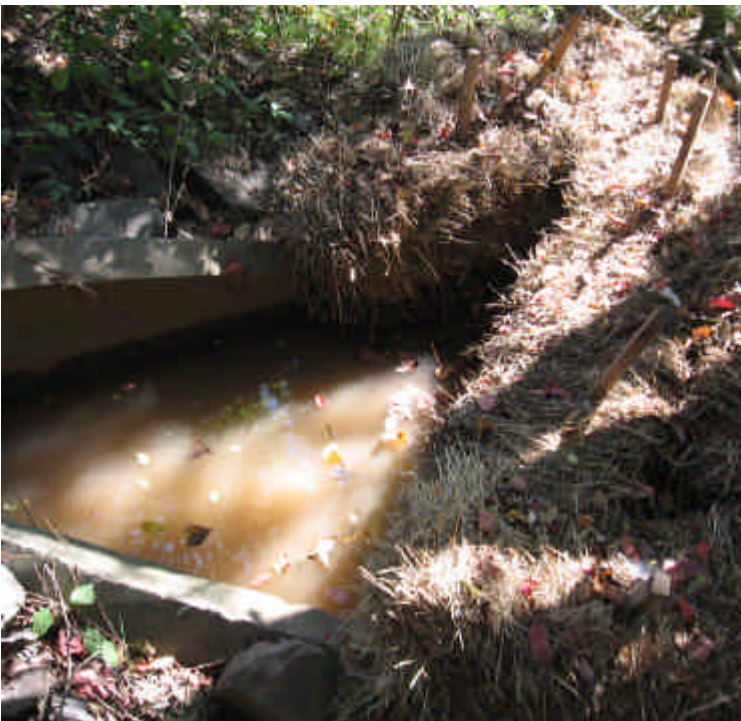
Turbid water in outlet remaining from the temporary storm drain system.

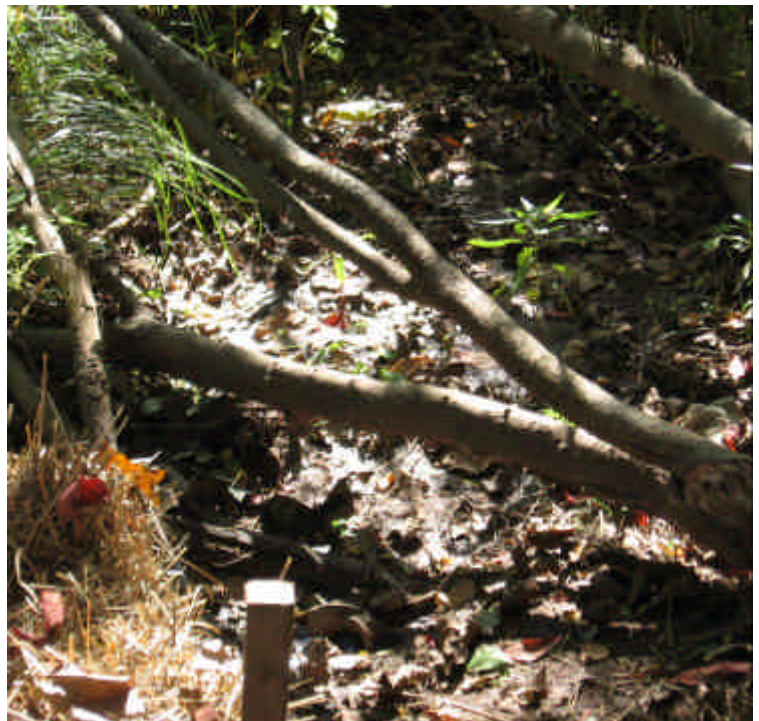
Wetland contains minor accumulation of sediment but leaf litter and substrate is still visible.
