Docket No. 272 – Development and Management Plan Inspection

Beseck Switching Station Inspection

Date: October 5, 2006

Location: Beseck Switching Station

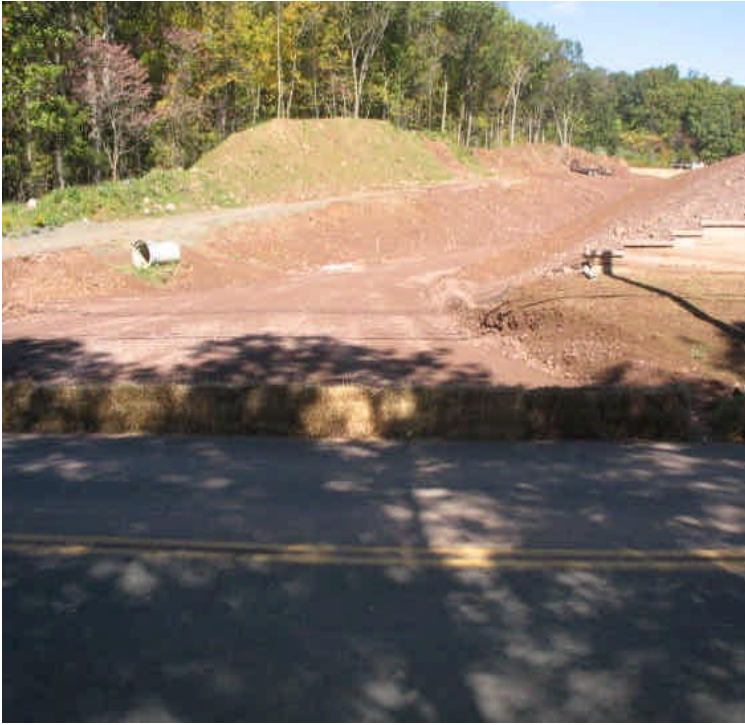
New, permanent site entrance installed on west side, with haybale barrier in place along Carpenter Lane.

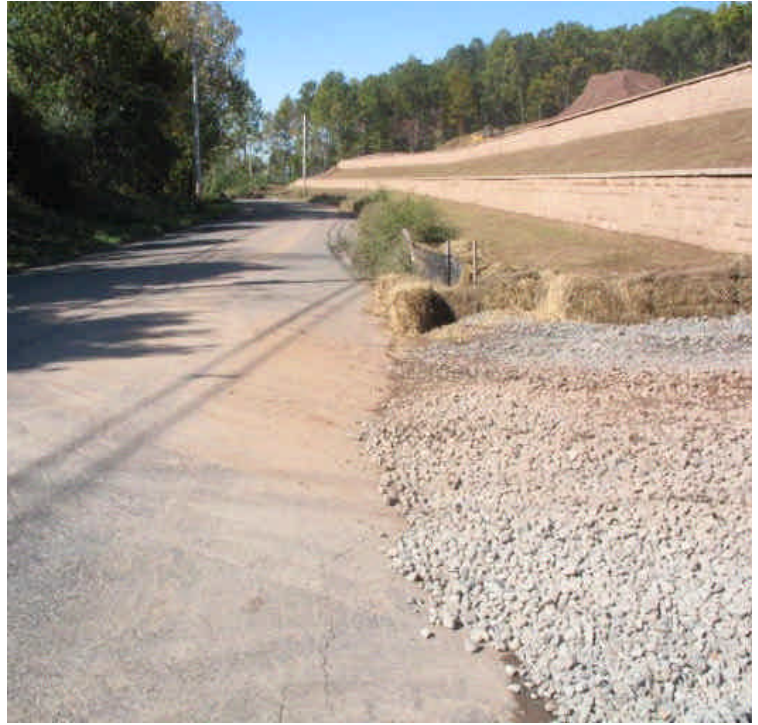
Carpenter Lane has some sediment tracking but is being swept regularly. New grass growth was noted on southern slopes.

Areas of Inspection	Observation	Recommended Action	Corrected Action
Access roads and adjacent roadways	All truck traffic leaving the site is using stone entrance on east side. Sediment/dust tracking was visible on Carpenter Lane. 10/5/06	Continue to clean/refresh stone construction entrance. Continue to keep roadway clear of stone. Clean gutter by hand to remove buildup. 10/5/06	Stone continues to be pulled back from roadway and refreshed with new stone. But still needs attention
	Equipment has done some damage to the road surface. 8/24-10/5/06	Clean and repair road surface as needed. 8/24-10/5/06	Needs attention when feasible
	Trucks have been entering the site from the western driveway; no sediment or road damage was noted here. 10/5/06	Monitor road and erosion controls in driveway for sediment accumulation and damage; clean and repair as needed. 10/5/06	NA
	Haybales remain at the edge of the entrance pad and were placed across the new western site entrance. 10/5/06	Continue to monitor the stormwater leaving the site; replace controls as needed. 10/5/06	Haybale barrier was placed across the new site entrance.

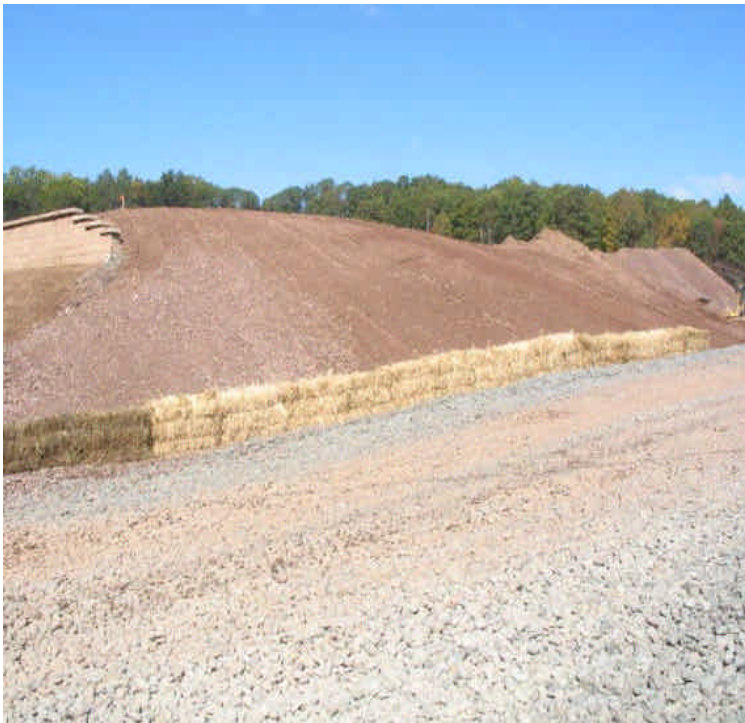
New haybales at base of detention basin slope near site entrance.

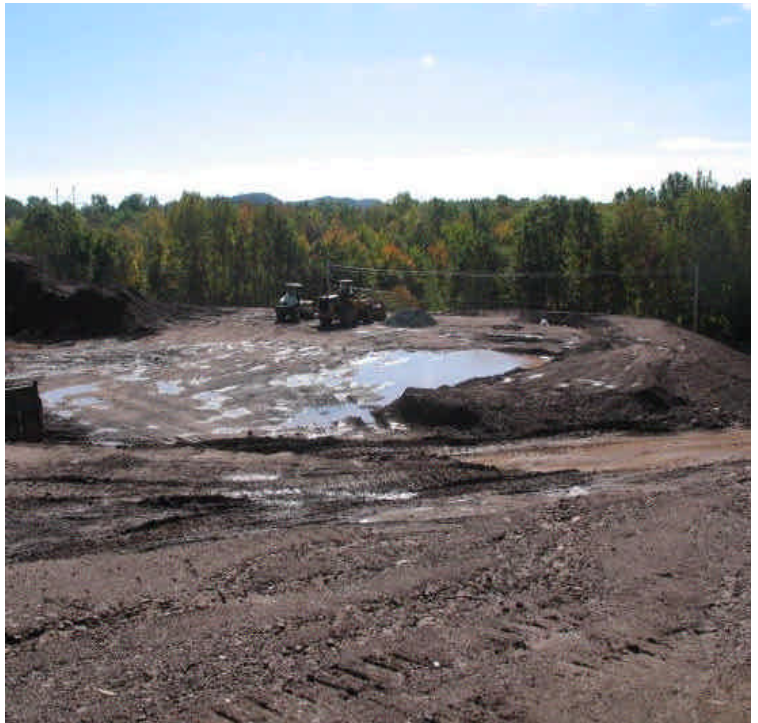
Detention pond under construction.

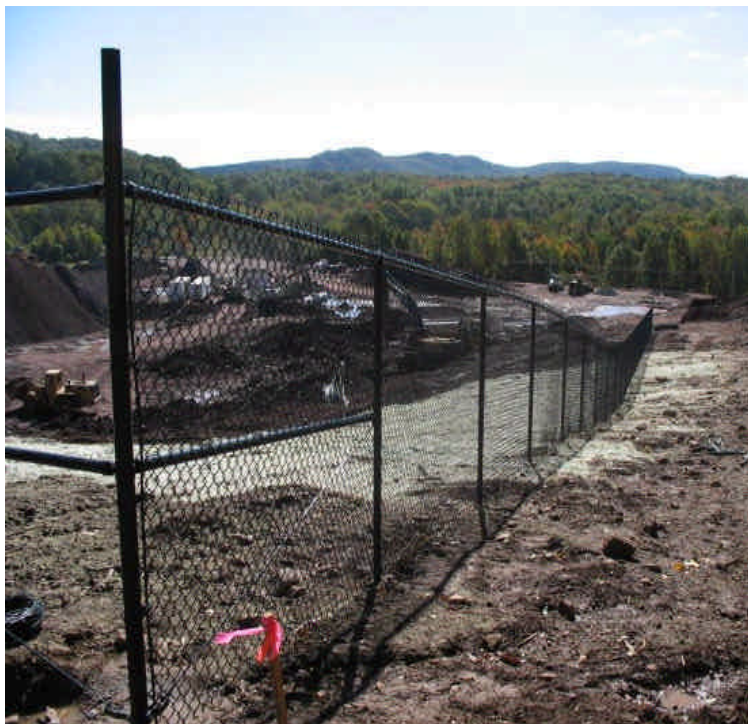
New perimeter fence installation along the western boundary of the site.

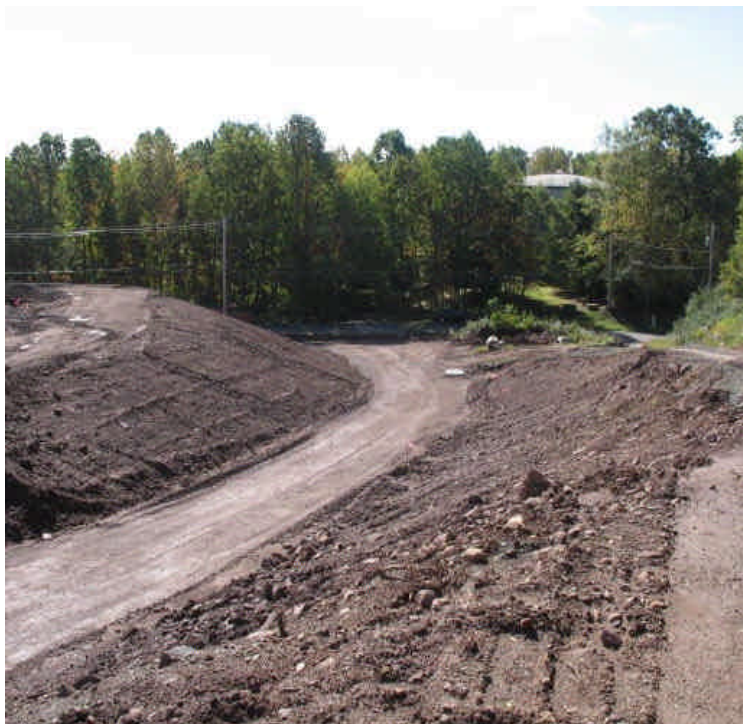
New site entrance near old Zolnik driveway.

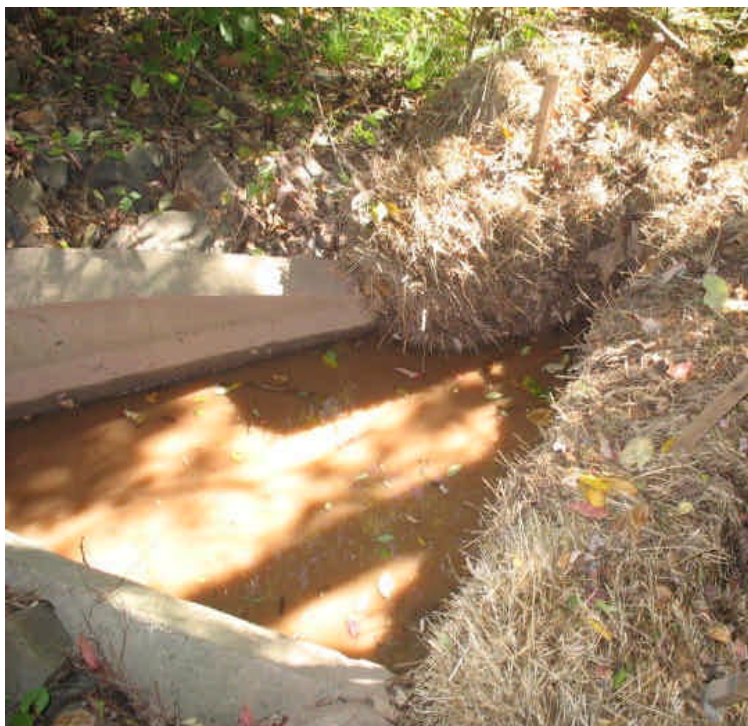
<p>Inland Wetland and Watercourse encroachment and mitigation</p>	<p>Wetlands on east side of site were clean and well protected. 10/5/06</p> <p>The wetlands across Carpenter Lane have received additional sediment accumulation and highly turbid water since the last inspection. The outlet pipe contained standing turbid water. These turbidity events are common and additional controls are needed to protect the wetland 10/5/06</p>	<p>Continue to monitor. 10/5/06</p> <p>Sediment accumulated in the wetland does not warrant removal yet. (It will have to be evaluated after sediment settles out) If pumping of standing water on site is required, monitor pipe outlet to ensure sediment does not bypass haybales. Additional controls are needed at some point along the system to prevent sediment from entering the wetland 10/5/06</p>	<p>NA</p> <p>Needs attention</p>
<p>State species of concern, threatened and endangered species.</p>	<p>According to the D&M plan, state-listed species are not located in this work area.</p>	<p>None 10/5/06</p>	<p>NA</p>

Turbid water continues to be present in the storm drain outlet.

Areas of Inspection	Observation	Recommended Action	Corrected Action
	<p>prevent turbidity and sedimentation to the wetland need improvement as these events continue to occur. Other sediment and erosion control measures should be considered. Haybales at outlet pipe are the last line of defense and cannot effectively filter the existing sediment load. 10/5/06</p> <p>New CBs remain protected and covered with filter fabric. Fabric should be replaced as needed if obstructed by sediment. 10/5/06</p> <p>New grass growth was noted at southern site slope along Carpenter Lane. 10/5/06</p>	<p>removing sediment from storm water should be evaluated and an effective solution should be established and set in place (i.e. stabilization of exposed soils, additional drain inlet protection, flocculants, additional attention to the roadway etc.). 10/5/06</p> <p>Inspect and maintain CB protections as needed. 10/5/06</p> <p>Continue to seed any remaining areas soon – fall seeding should generally be completed by October 15th. 10/5/06</p>	<p>NA</p> <p>NA</p>

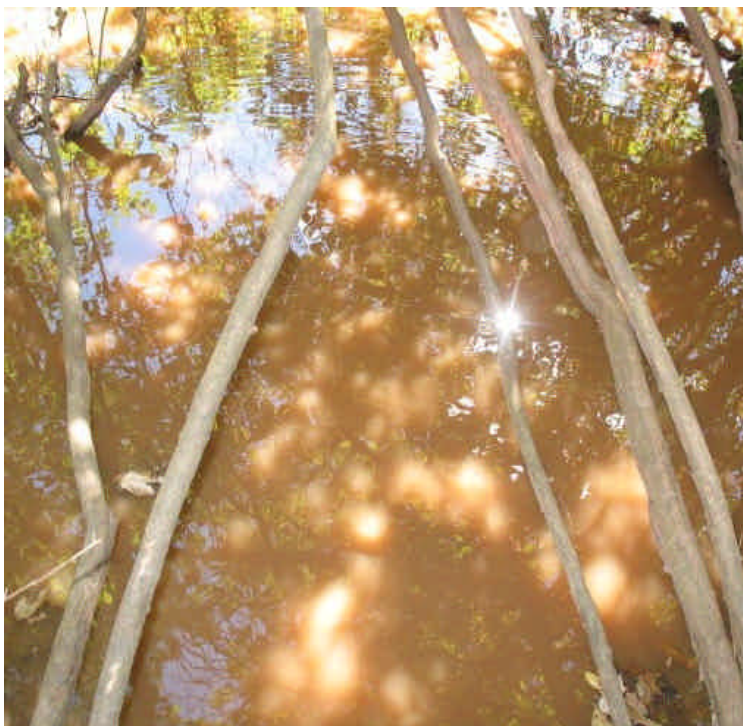
Wetland continues to receive turbid water from the outlet.
