Docket No. 272 – Development and Management Plan Inspection

Beseck Switching Station Inspection

Date: October 12, 2006

Location: Beseck Switching Station

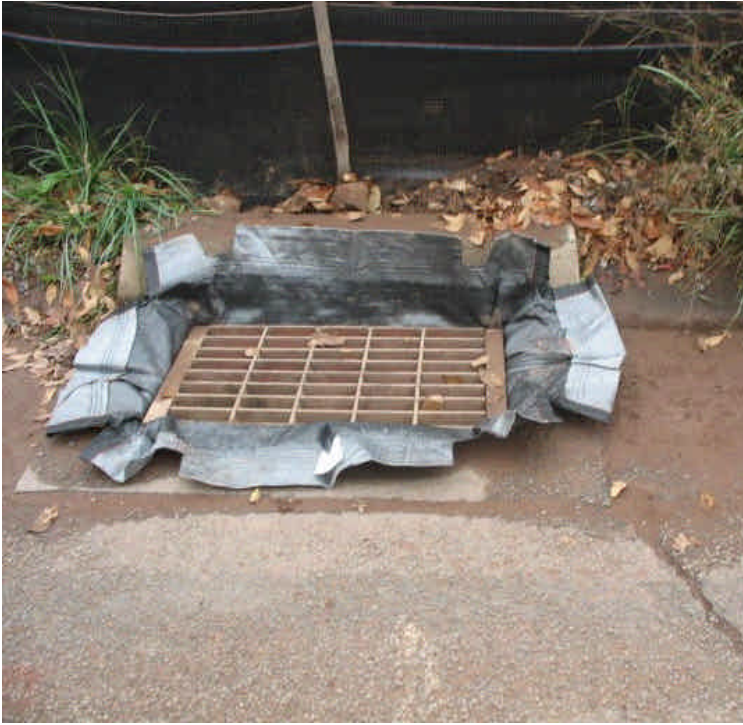
New silt liners installed in catch basins along Carpenter Lane.

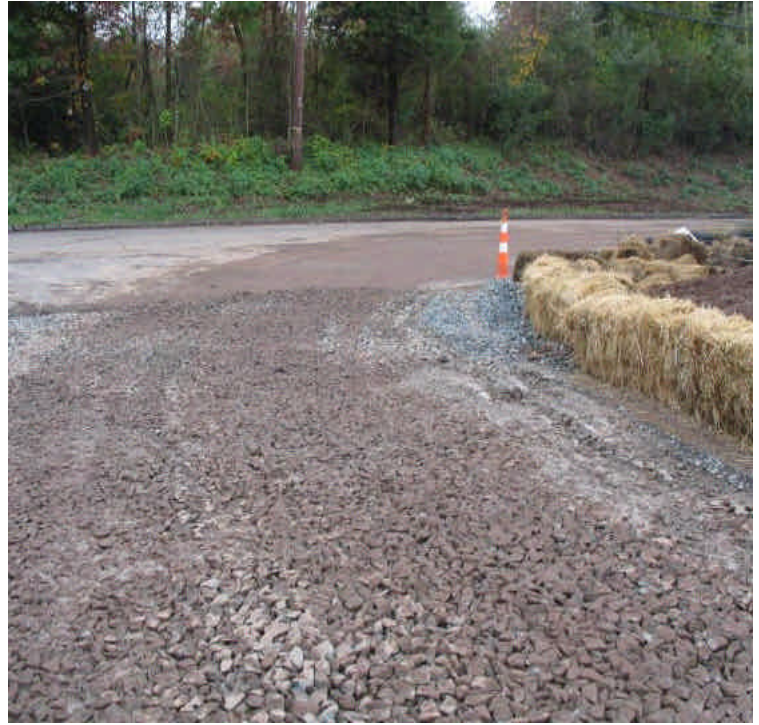
Areas of Inspection	Observation	Recommended Action	Corrected Action
Access roads and adjacent roadways	All truck traffic leaving the site is using stone entrance on east side. Sediment and dust have accumulated on Carpenter Lane. Sediment laden run-off was flowing from the entrance pad to Carpenter Lane. 10/12/06	Clean/refresh stone construction entrance. Continue to keep roadway clear of stone; Clean/sweep roadway regularly; clean gutter by hand. Continue to monitor stormwater leaving the site; replace and add more controls as needed. 10/12/06	Needs attention: Contractors are discussing improving/re-working the stone pad.
	Equipment has done some damage to the road surface. 8/24-10/12/06	Clean and repair road surface as needed. 8/24-10/12/06	Needs attention when feasible.
	Trucks have been entering the site from the new western driveway; no sediment or road damage was noted here. 10/12/06	Monitor road and erosion controls in driveway for sediment accumulation and damage; clean and repair as needed. 10/12/06	NA

Carpenter Lane has observable sediment tracking and the roadway should be swept regularly. The entrance pad should be cleaned and improved. This is planned in the near future.

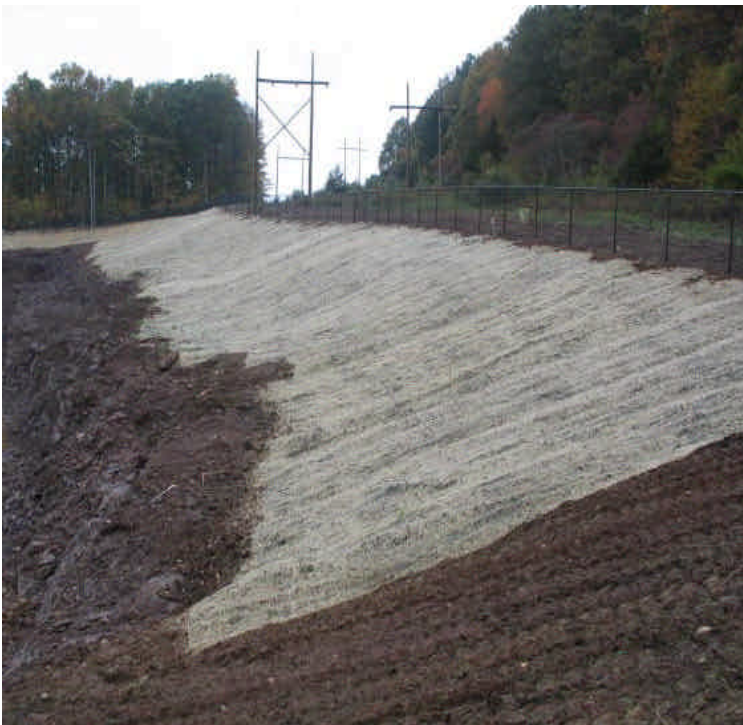
Erosion control mats were placed along the northern slopes. New perimeter fence is also installed.

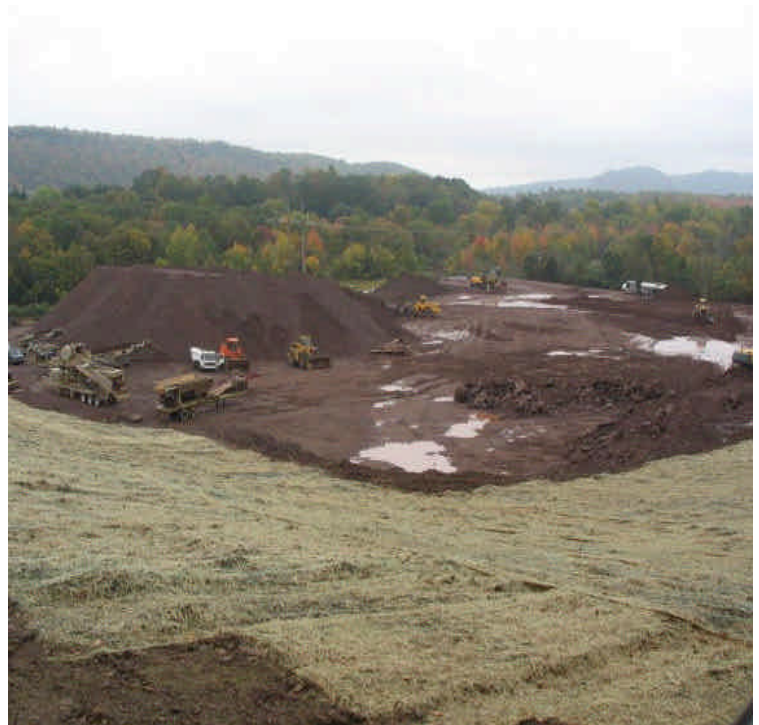
Entire site, looking from northwest to southeast.

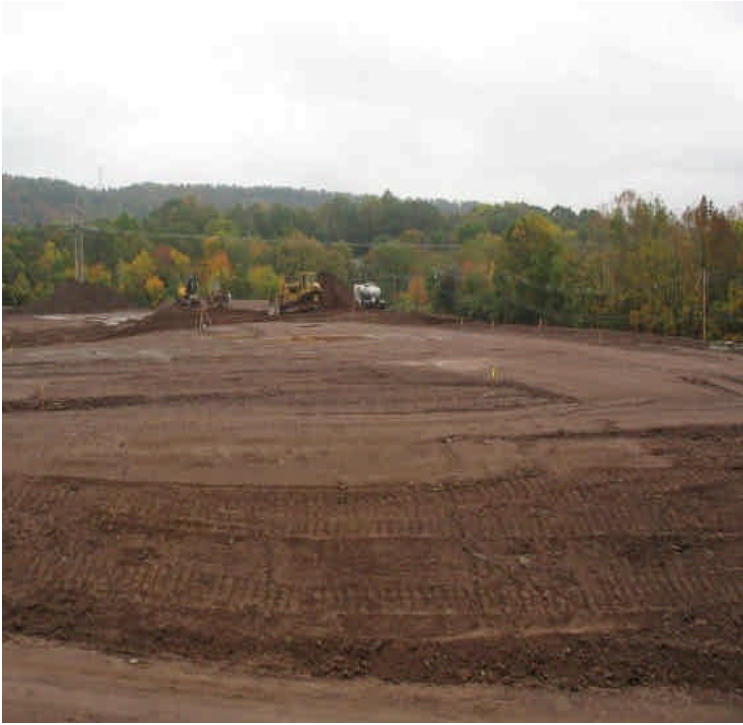
Final grading and installation of detention basins above the new retaining walls along Carpenter Lane.

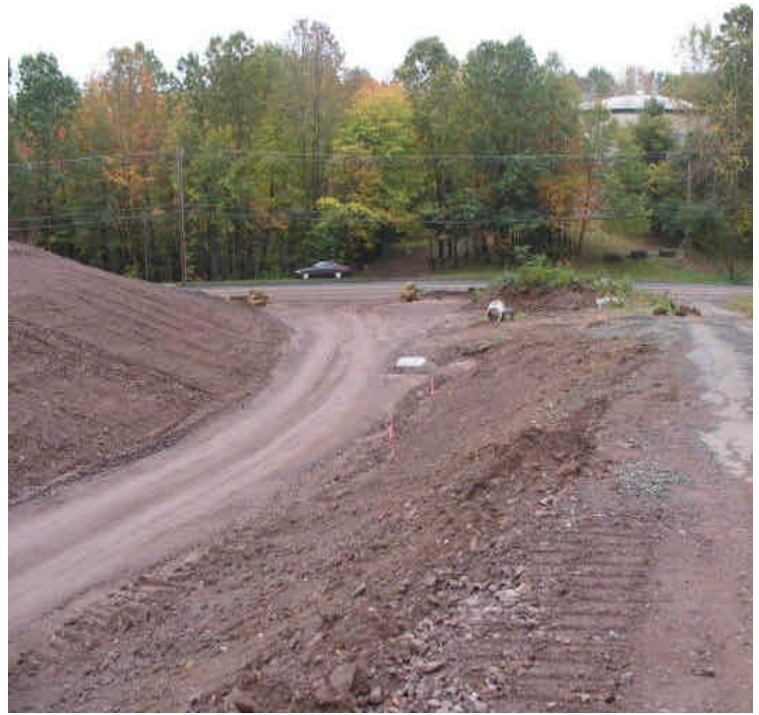
New site entrance near old Zolnik driveway.

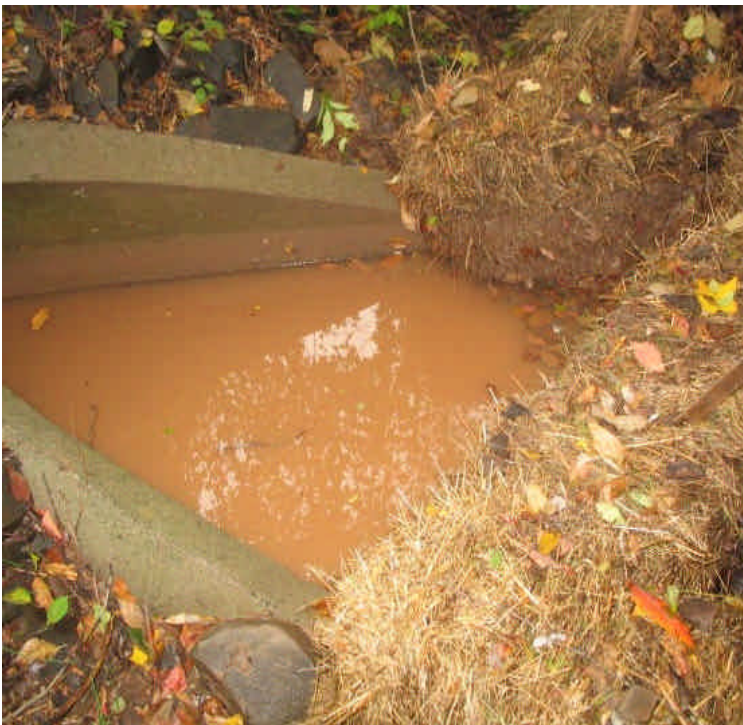
Areas of Inspection	Observation	Recommended Action	Corrected Action
<p>Erosion and sediment controls (continued)</p>	<p>Sediment-laden water remains in the pipe and highly turbid water was also present in the wetland. 10/5-10/12/06</p> <p>Haybales at the outlet drain across Carpenter Lane need to be replaced 10/12/06</p> <p>Current BMPs used to prevent sedimentation to the wetland need re-evaluation because sediment continues to enter wetland during rain events. Monitor new silt liners in CB's; consider other sediment and erosion control measures: haybales at outlet pipe are last line of defense and cannot effectively filter the existing sediment load. 10/5-10/12/06</p> <p>New CBs on site remain protected and covered with filter fabric. Fabric should be replaced as needed if obstructed by sediment. 10/12/06</p> <p>New grass growth was noted at southern site slope along Carpenter Lane. 10/12/06</p>	<p>Sediment should continue to be removed from the outlet pipe. Additional controls (new silt liners) are in place along the road; more may be needed to prevent turbidity in the wetland. Replace haybales. 10/12/06</p> <p>New methods to control sediment in storm water need to be evaluated and an effective solution established. Attention should be placed first to stabilization of exposed soils, including roadway soil tracking, then to additional drain inlet protection, flocculants, etc. Contractors are planning to re-work/improve the stone access which may help. 10/12/06</p> <p>Inspect and maintain CB protections as needed. 10/12/06</p> <p>Continue to seed any remaining areas soon – fall seeding should generally be completed by October 15th. 10/12/06</p>	<p>Needs attention.</p> <p>New CB inlet protection installed but still, Needs attention.</p> <p>NA</p> <p>NA</p>

Turbid water continues to be present in the storm drain outlet.

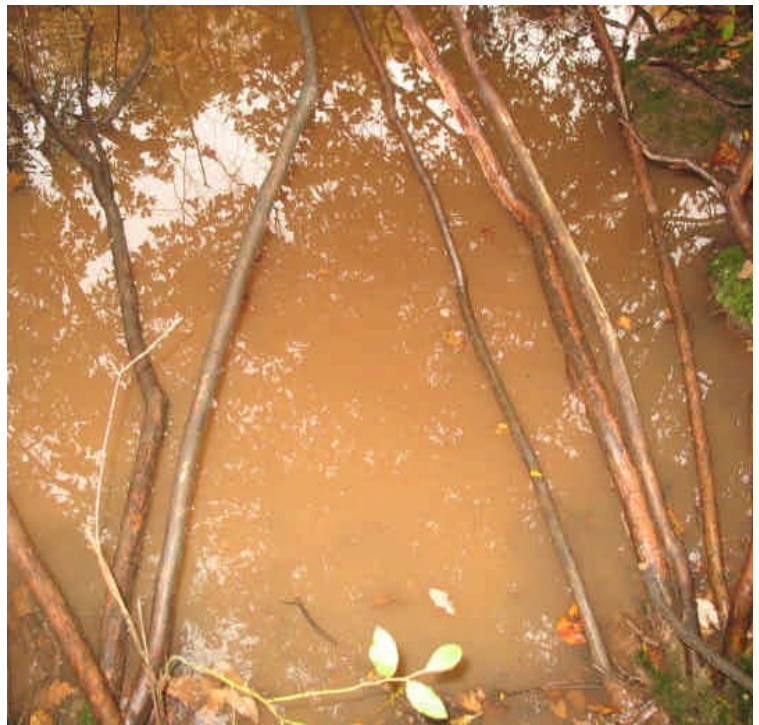
<p>Inland Wetland and Watercourse encroachment and mitigation</p>	<p>The wetlands across Carpenter Lane continue to receive additional sediment accumulation and highly turbid water since the last inspection. The outlet pipe contained standing turbid water. These turbidity events are too common; additional controls are needed to</p>	<p>Accumulated sediment in wetland does not warrant removal yet (It will need evaluation after sediment settles out). If more pumping is required on site, monitor pipe outlet to ensure sediment does not bypass haybales. New silt liners were added; more controls are needed</p>	<p>Needs attention.</p>

Wetland continues to receive turbid water from the outlet.
