**Docket No. 272 – Development and Management Plan Inspection**

**Beseck Switching Station Inspection**

**Date:** October 26, 2006

**Location:** Beseck Switching Station

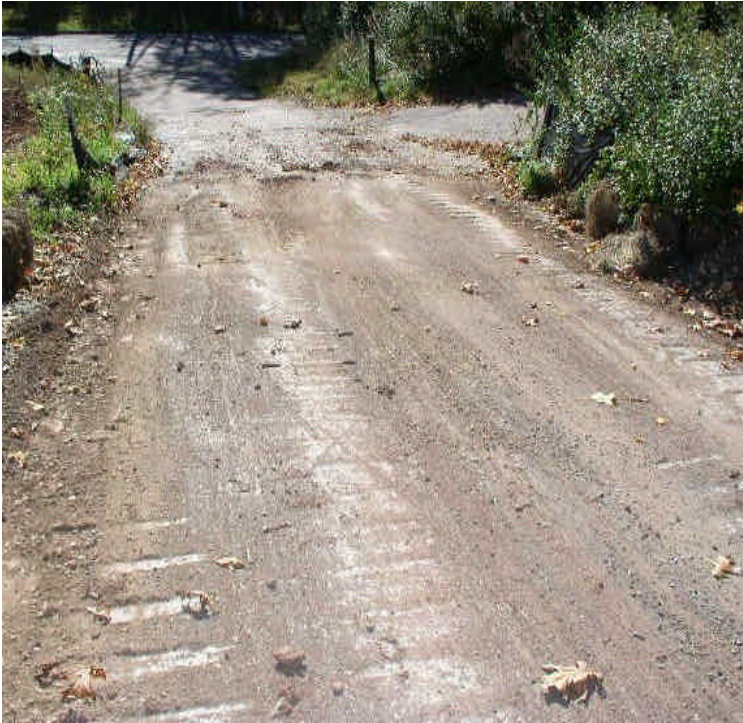
**Old Zolnik property entrance at Carpenter Lane. Haybales need to be placed across the driveway.**

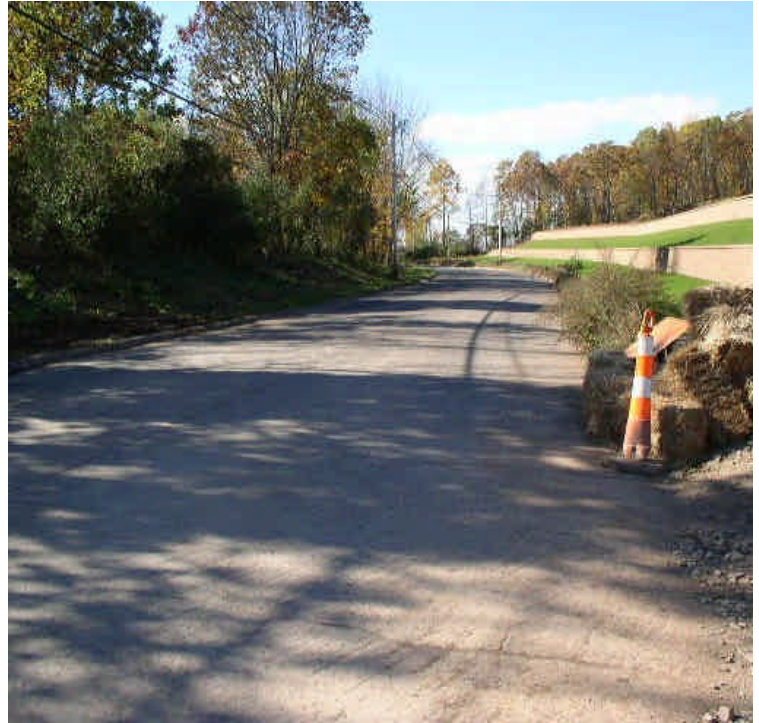
**Carpenter Lane has little sediment tracking, roadway should continue to be swept regularly. The stone entrance pad was cleaned. Entrance pad improvements are planned in the near future.**

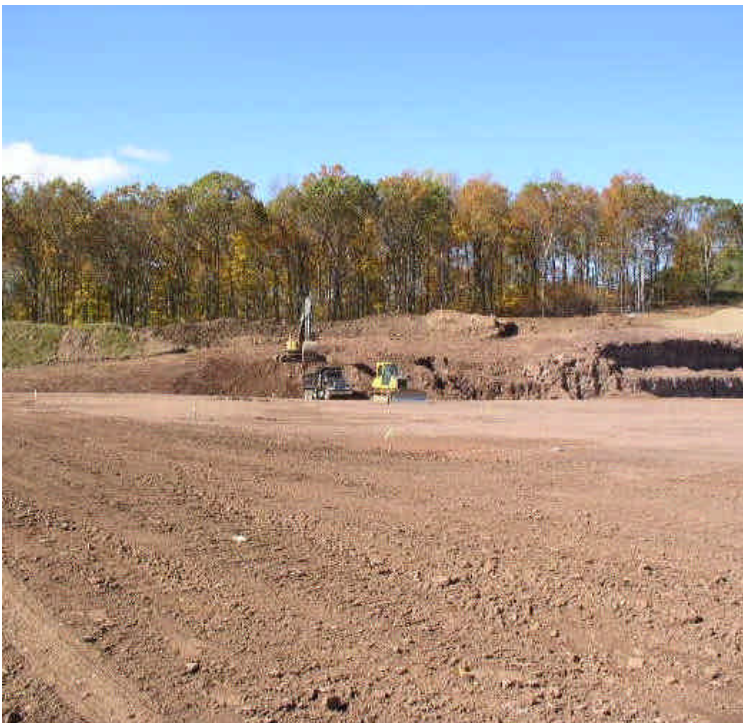
**Remaining soil removal and grading along the northwestern slope.**

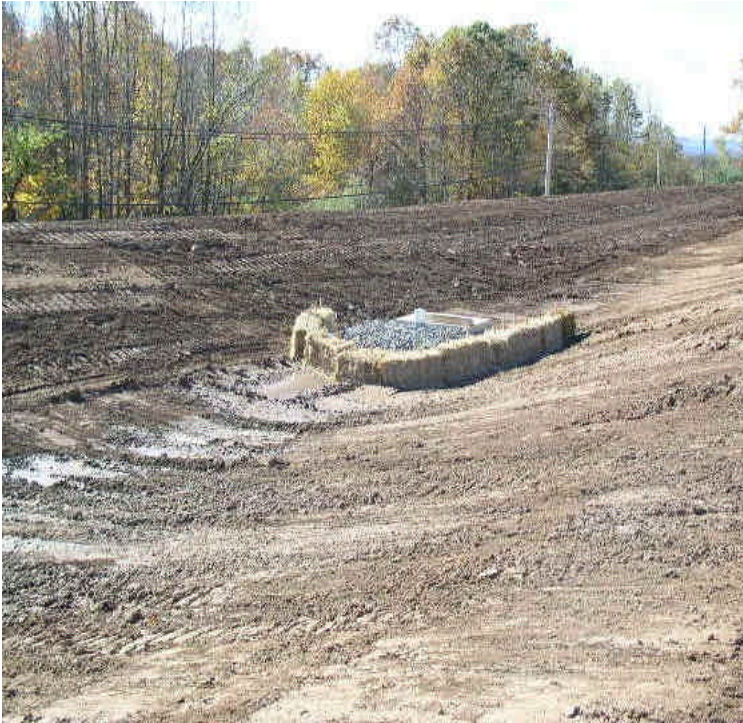
**Final grading and installation of detention basins above the retaining walls along Carpenter Lane. Controls were in place at the inlets.**

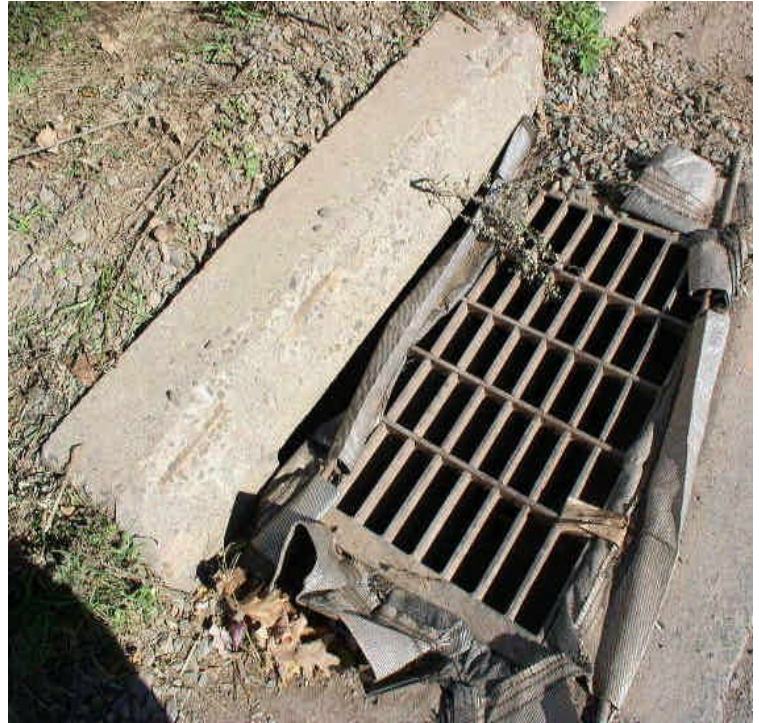
**View of CB inlet protection along Carpenter Lane; dams could be placed at the curb drop inlet portion of the basin to force water through the filter.**

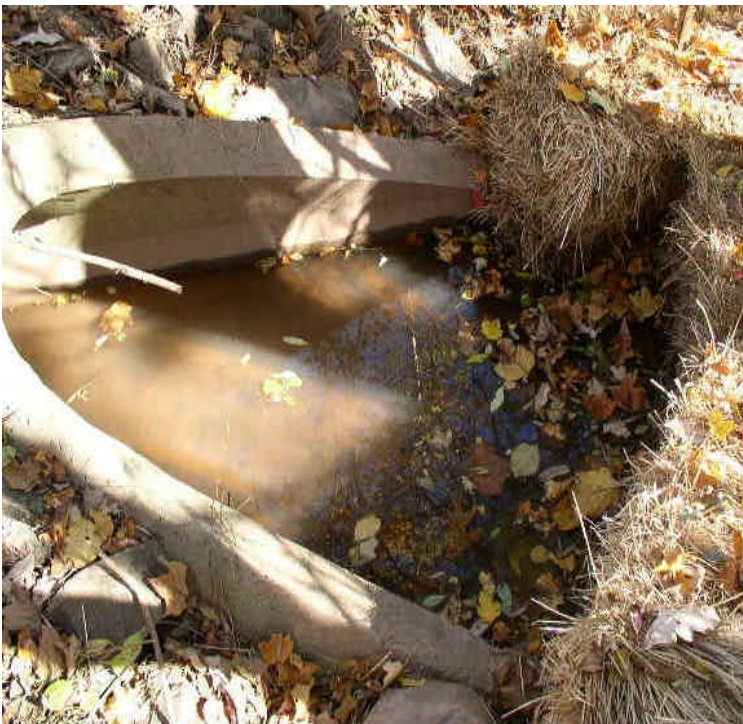
**Sediment continues to settle out in the bottom of the storm drain outlet. New haybales have been installed.**

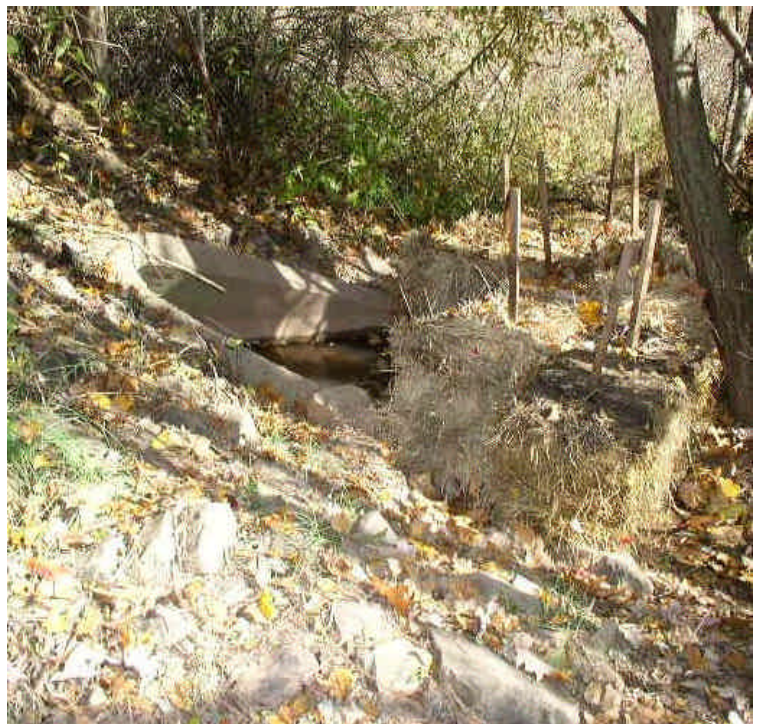
**View of haybale barrier at the storm drain outlet. No new sediment has entered the wetlands.**
