Docket No. 272 – Development and Management Plan Inspection

Scovill Rock Switching Station Inspection

Date: August 9, 2006

Location: Scovill Rock Switching Station

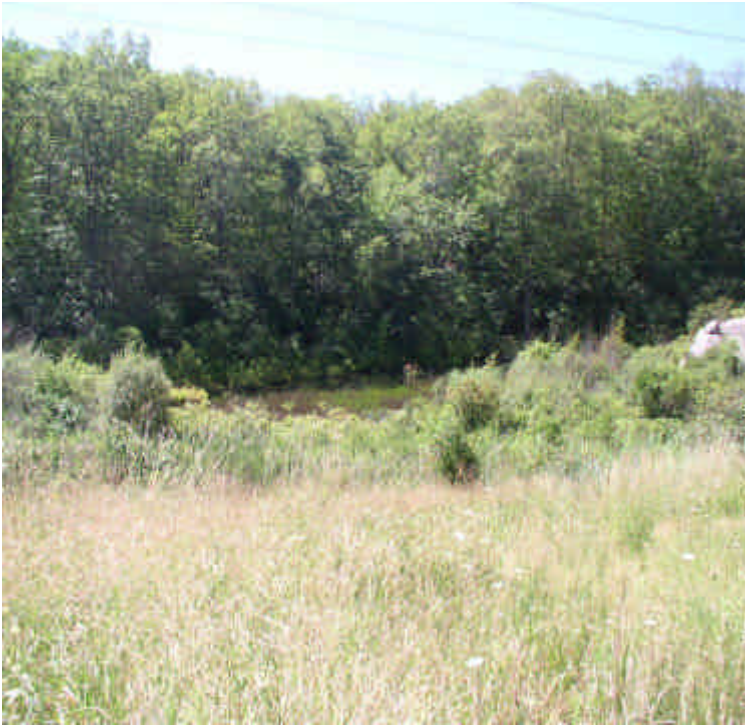
Looking from the southern fence at the vegetated buffer to a small pond, located on the south side of the site.

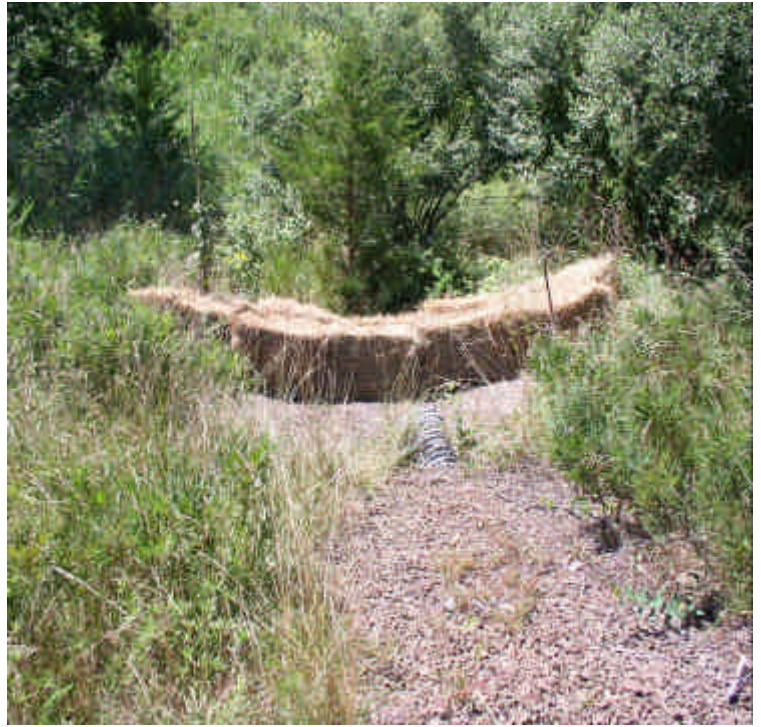
As discussed last week a double layer of haybales was installed at the 12" storm drain pipe. No	Monitor storm water when flowing to ensure haybales are working properly. 8/9/06	The controls were revised, haybales installed.

Storm water outfall pipe upgradient of wetland, south side of the site. Haybales were installed.

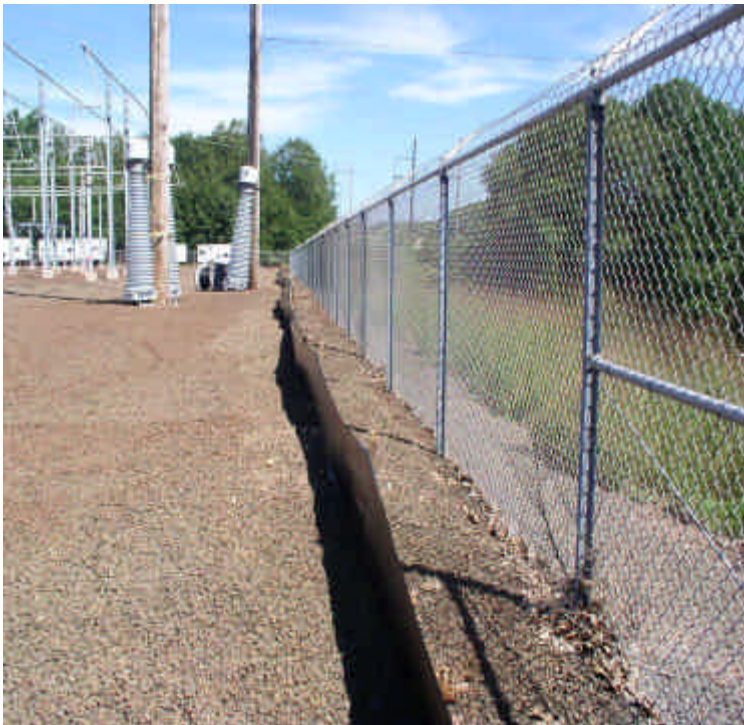
Silt fence installed along the eastern edge of the site.

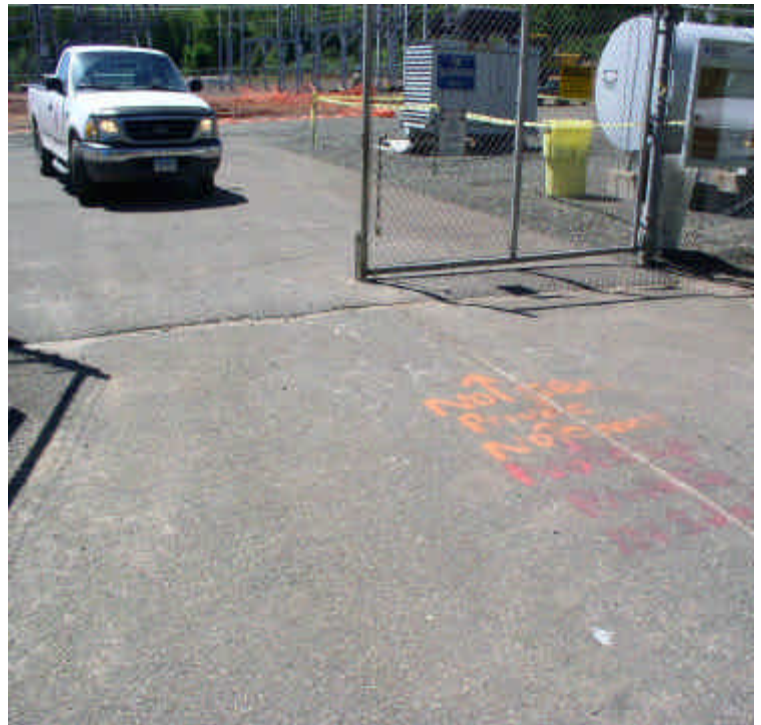
Entrance to the switching station with spill kit, north side of site.
