Docket No. 272 – Development and Management Plan Inspection

Scovill Rock Switching Station Inspection

Date: August 24, 2006

Location: Scovill Rock Switching Station

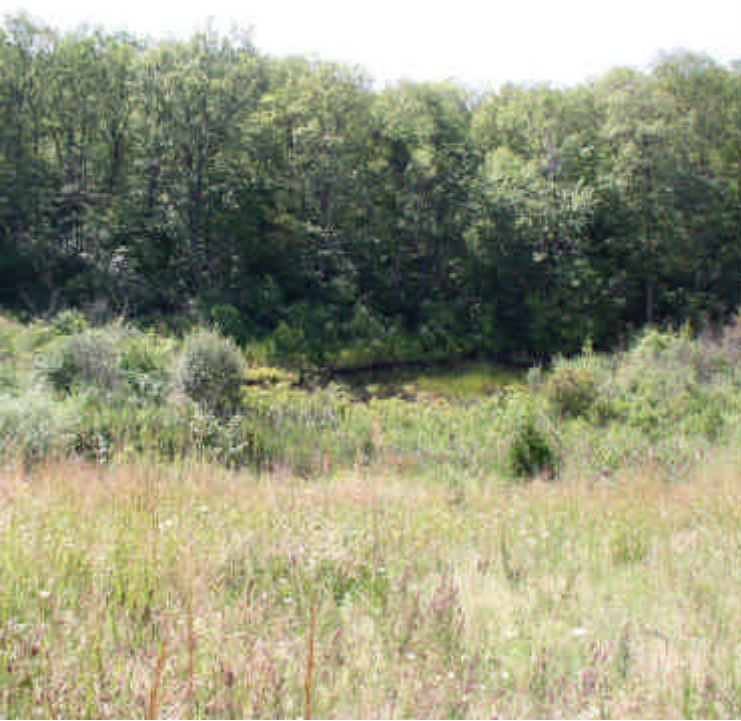
Looking from the southern station fence at the vegetated buffer to a small pond, located south of the site.

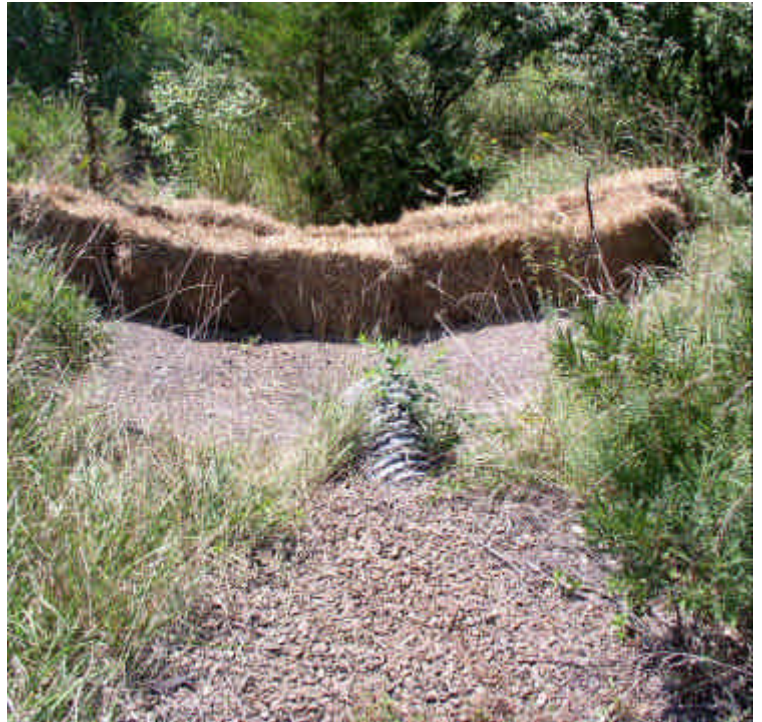
Storm water outlet pipe upgradient of the wetland, on the south side of the site. Controls are in place.

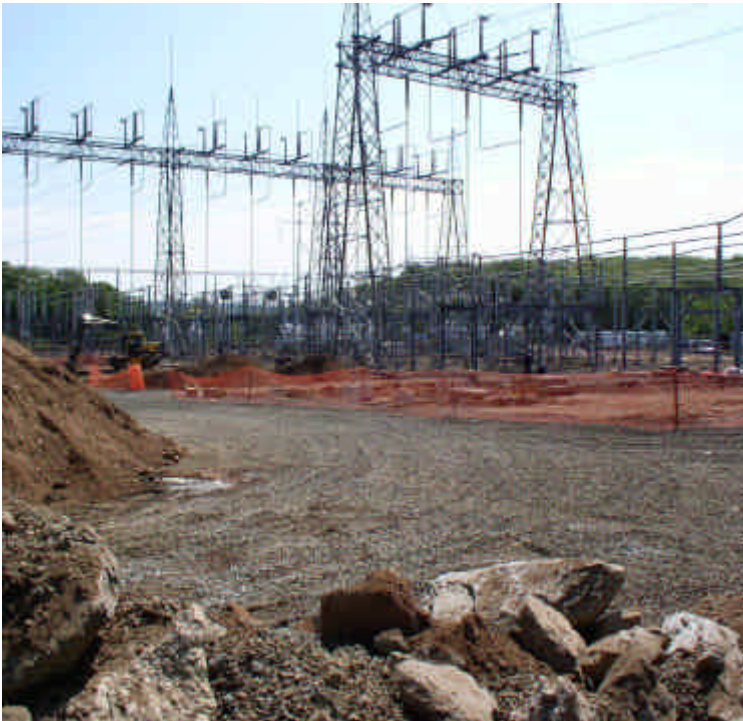
New foundations being installed in the yard. Small stockpiles remain contained.

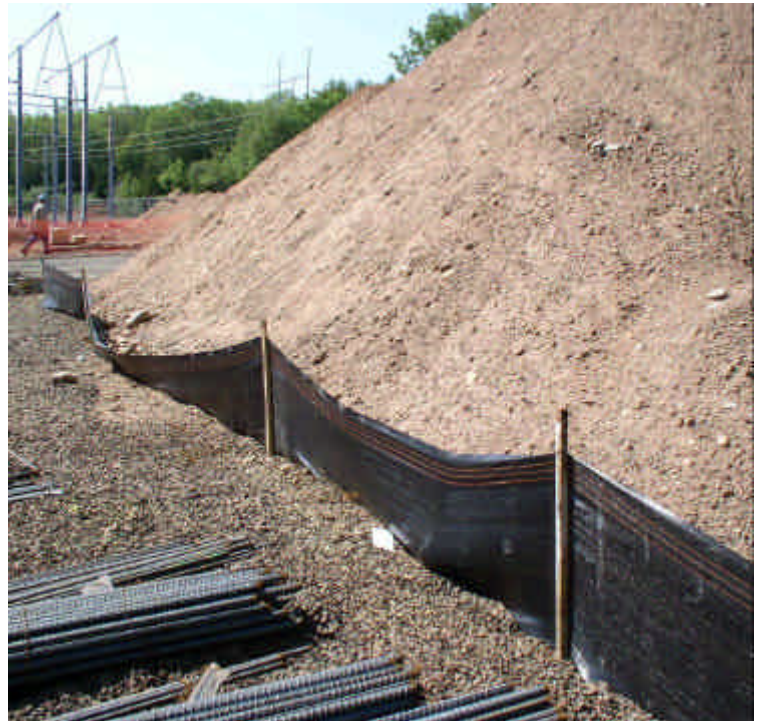
Silt fence added along stockpile at the northeast side of site; repair the section that came down and monitor. The section in disrepair is located well within the site.
