Docket No. 272 – Development and Management Plan Inspection

Scovill Rock Switching Station Inspection

Date: August 31, 2006

Location: Scovill Rock Switching Station

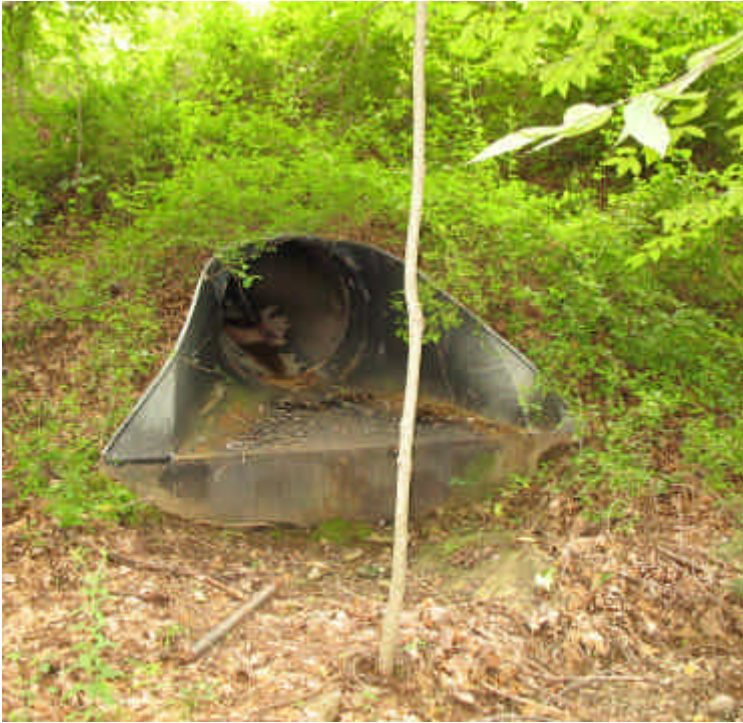
Existing culvert located under the access road to the switching station.

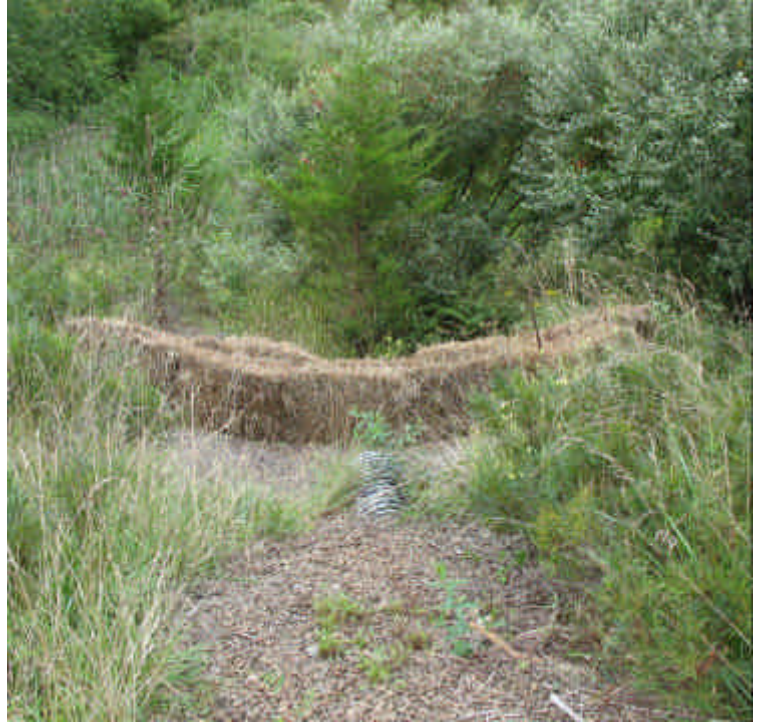
Storm water outlet pipe upgradient of the wetland, on the south side of the site. Controls are in place.

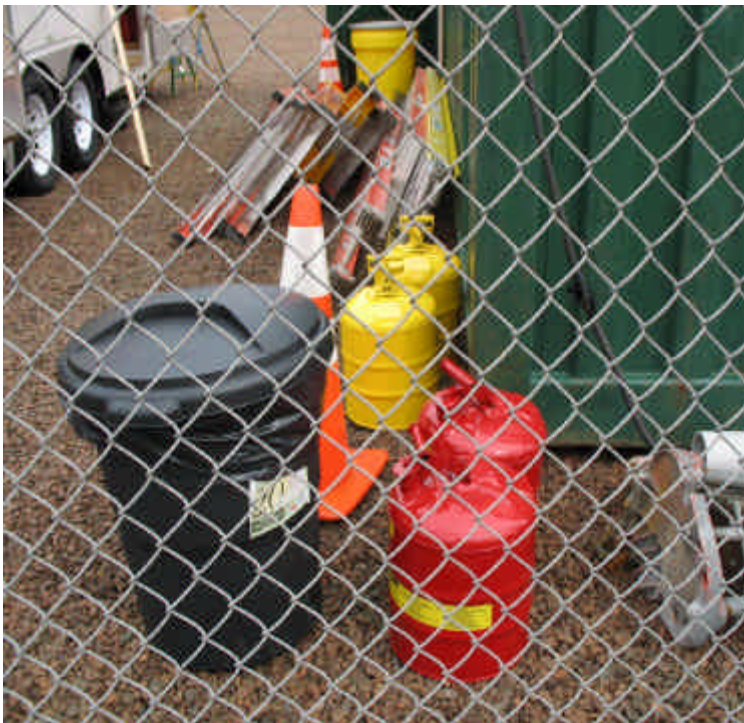
Gas containers located along the southern fence upgradient and in the vicinity of the storm drain pipe. These were reportedly moved away from the drain pipe on 9/1/06.

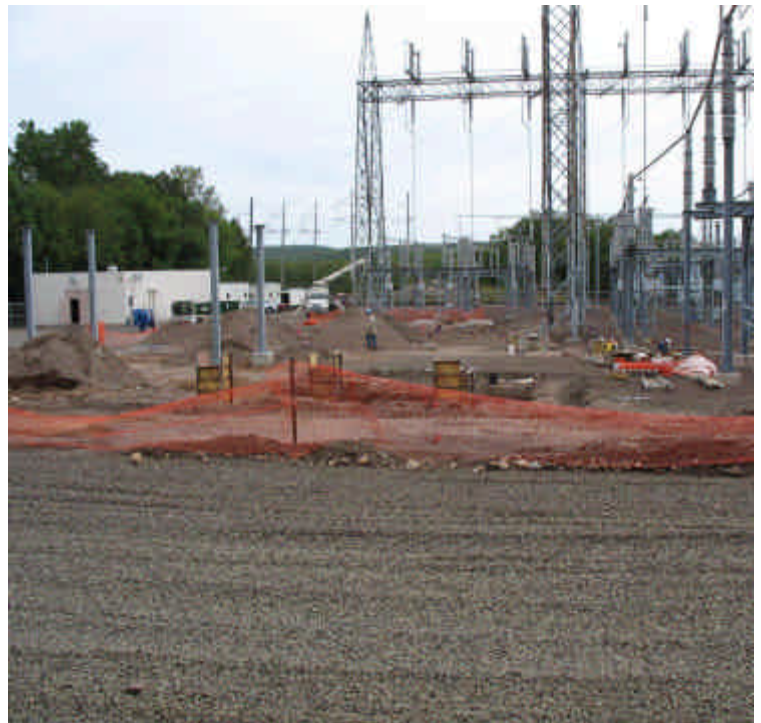
New foundations being installed in the yard. Small stockpiles remain contained.
