**Docket No. 272 – Development and Management Plan Inspection**

**Scovill Rock Switching Station Inspection**

**Date:** September 7, 2006

**Location:** Scovill Rock Switching Station

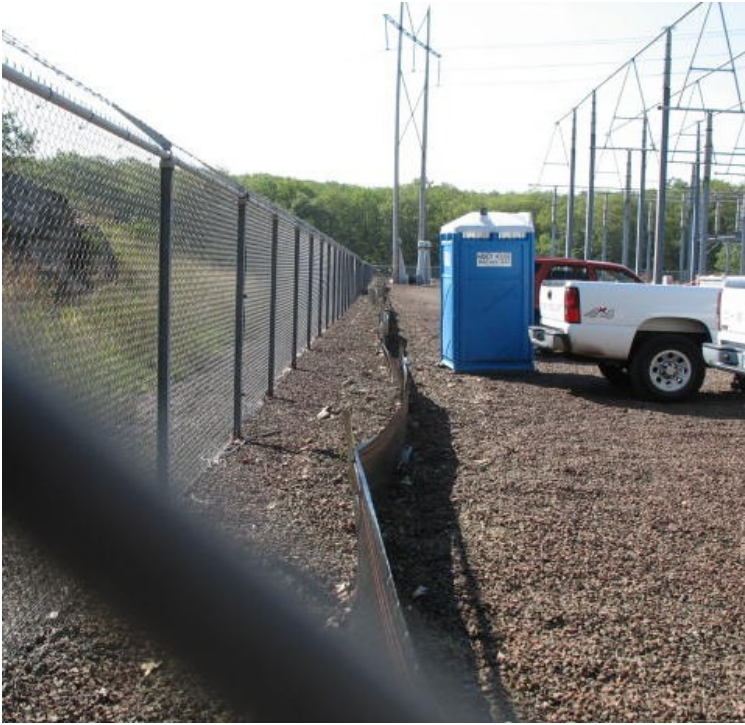
Silt fence along the eastern property looks good.

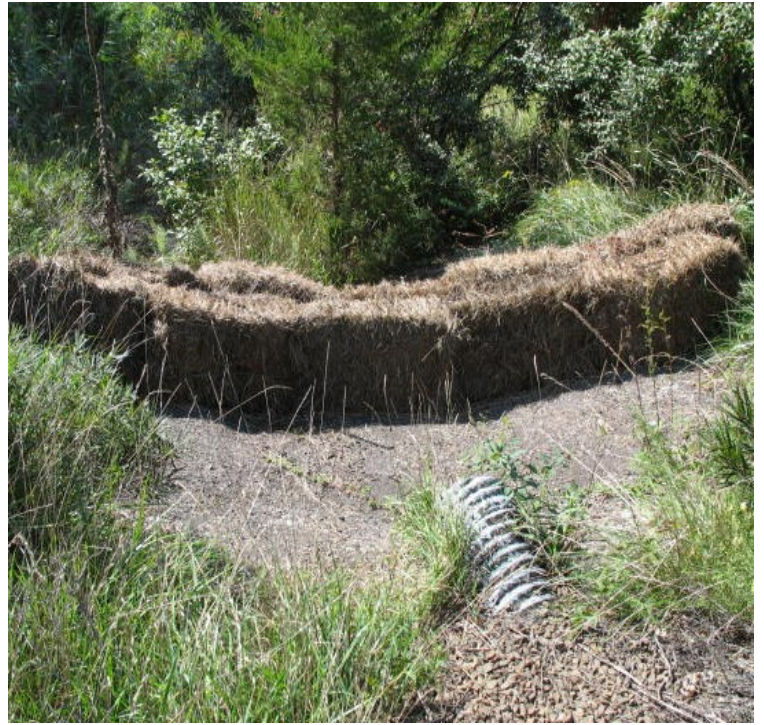
Storm water outlet pipe upgradient of the wetland, on the south side of the site. Controls are in place.

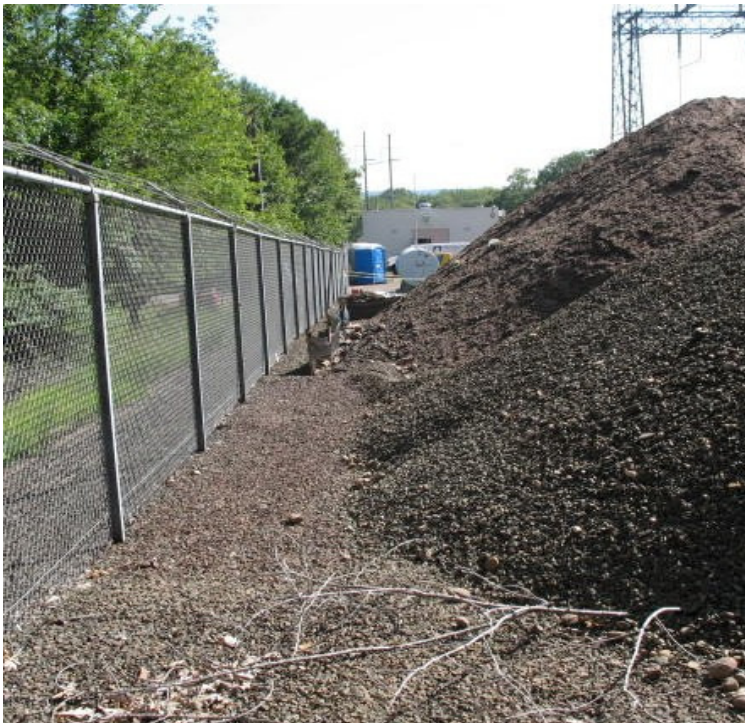
Silt fence located around the soil stockpile in the northwestern corner of the site looks good, soils contained.

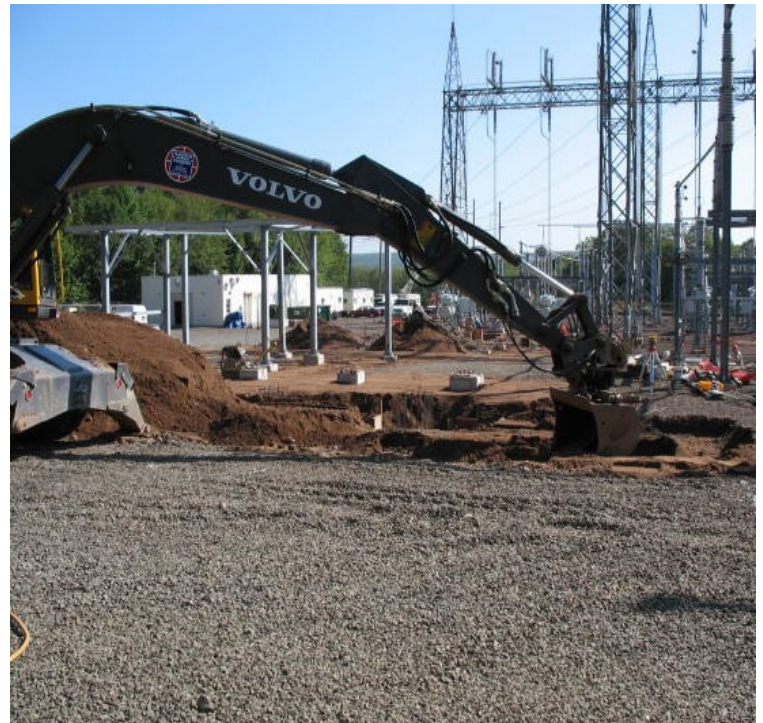
New foundations being installed in the yard. Small stockpiles remain contained.
