**Docket No. 272 – Development and Management Plan Inspection**

**Scovill Rock Switching Station Inspection**

**Date:** September 28, 2006

**Location:** Scovill Rock Switching Station

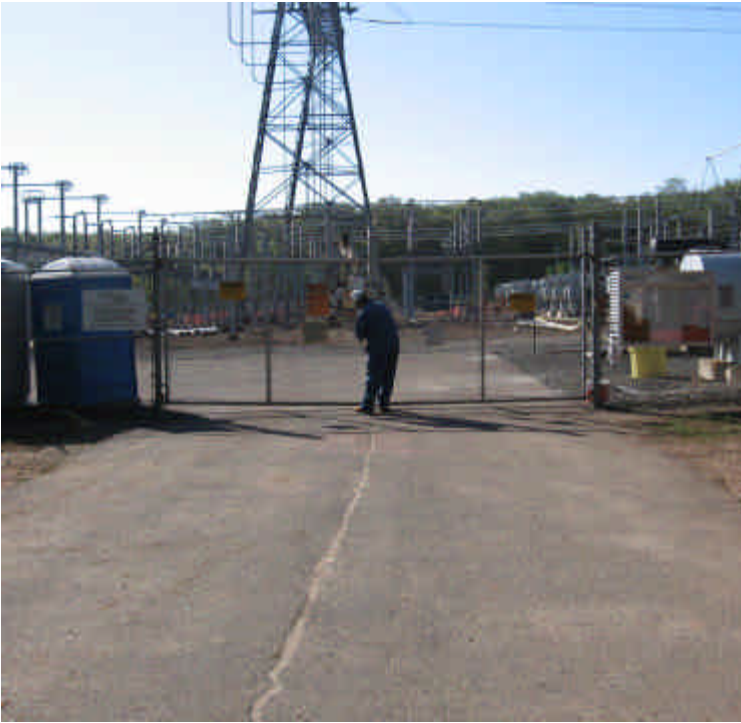
**Site entrance is clean and spill kits are available onsite.**

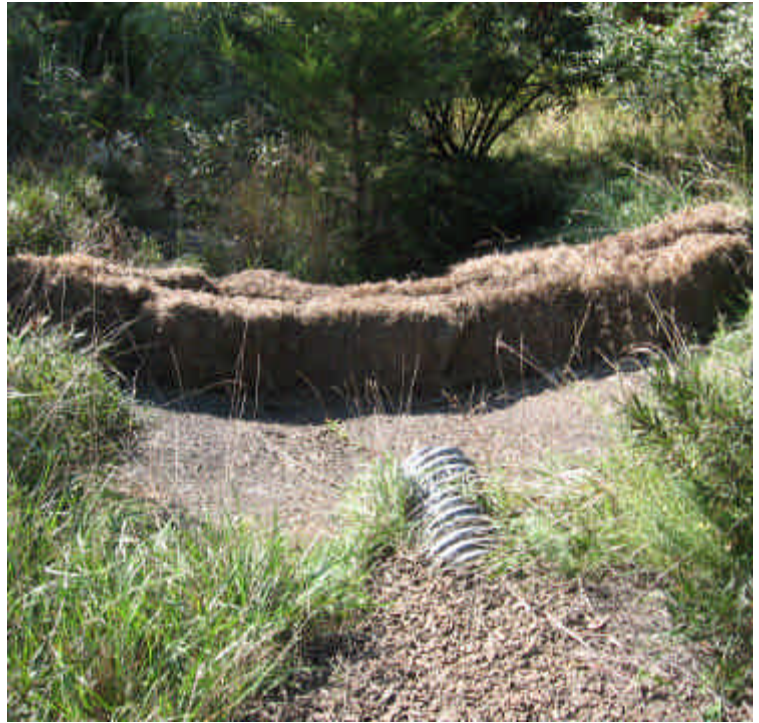
**Drain outlet controls remains secure.**

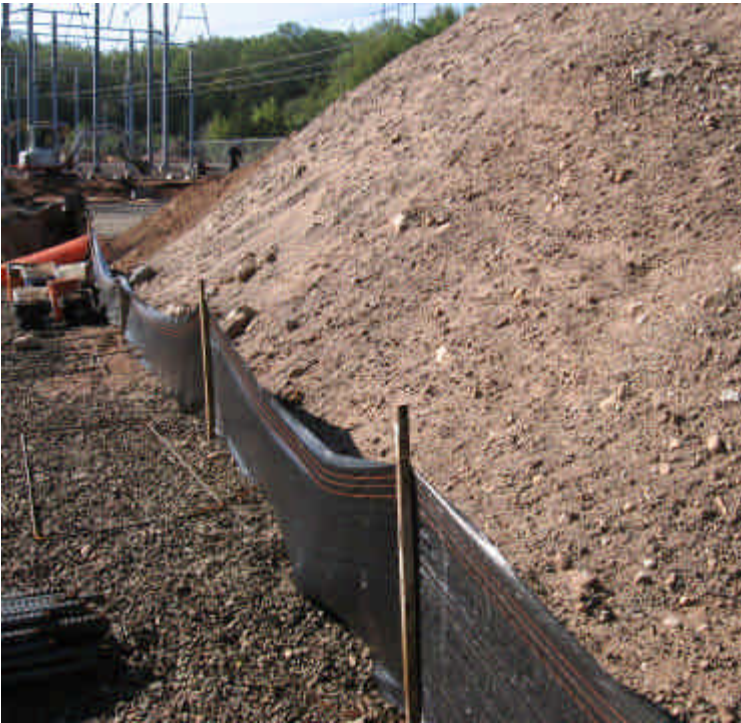
**Silt fence secure in northwestern corner of site.**

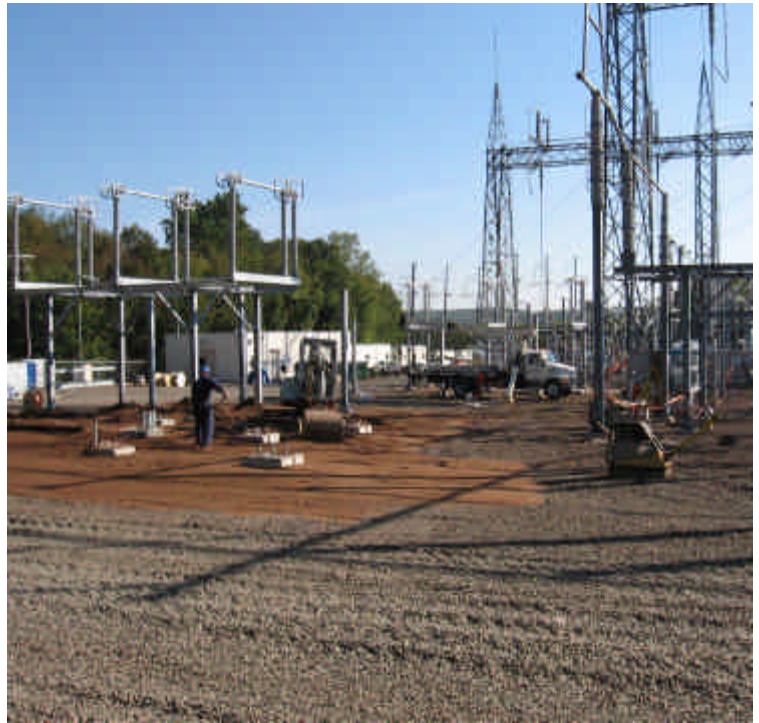
**New foundations being installed in center of yard. Area is contained**
