Docket No. 272 – Development and Management Plan Inspection

Scovill Rock Switching Station Inspection

Date: October 12, 2006

Location: Scovill Rock Switching Station

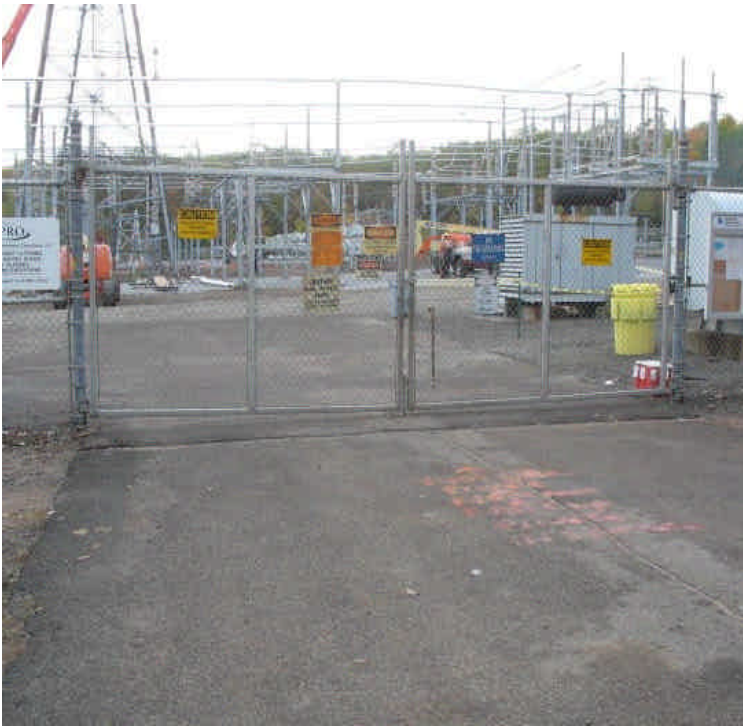
Site entrance, no new equipment spills or leaks, spill kits are onsite.

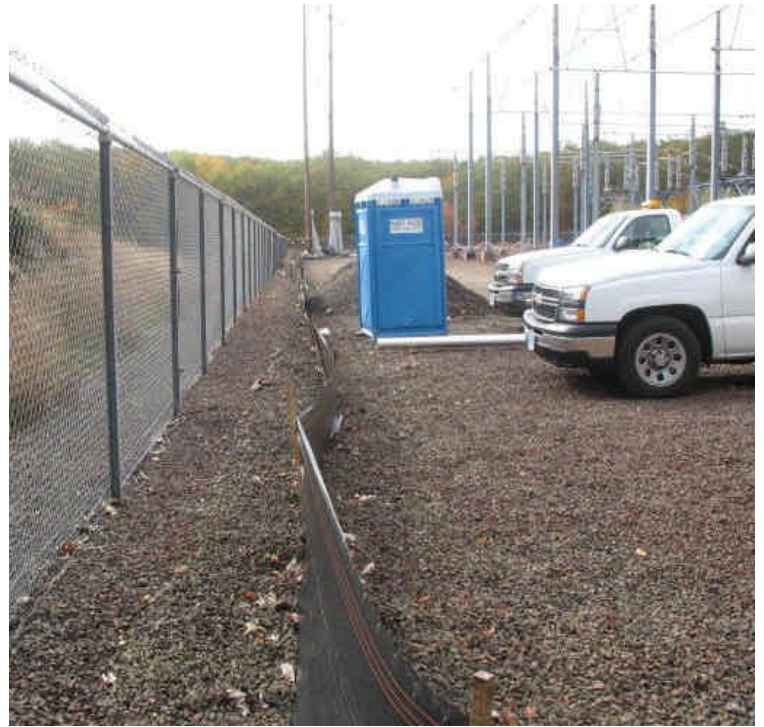
Silt fence along the eastern perimeter fence looks good.

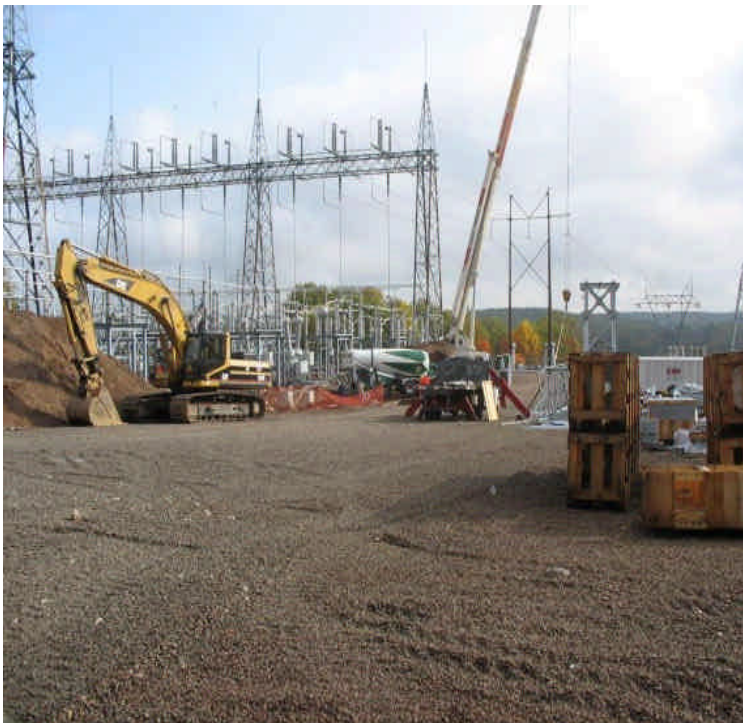
New excavations for foundations; stockpiles are internal to the yard and remain contained.

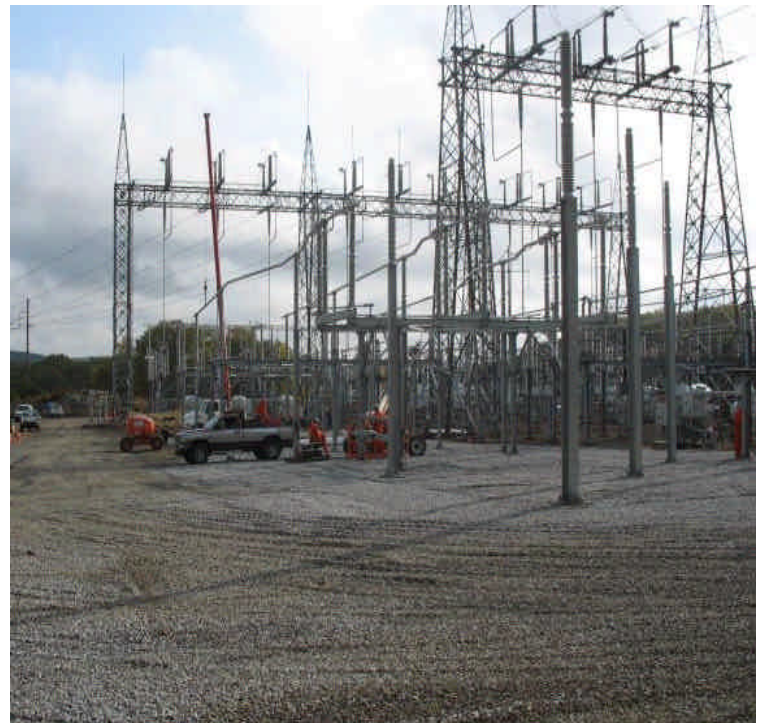
New foundations installed, these portions of the site are graded and stabilized.
