Docket No. 272 – Development and Management Plan Inspection

Segment 1a Inspection

Date: October 26, 2006

Location: Segment 1a – Scovill Rock Switching Station to Chestnut Junction, Oxbow Junction to Beseck Switching Station (excluding Royal Oak Bypass), Black Pond Junction to Beseck Switching Station

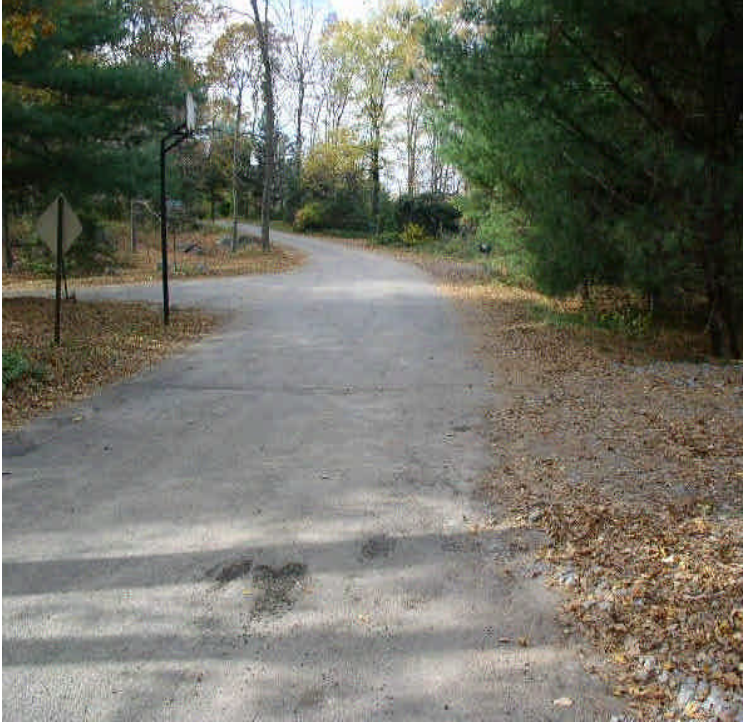
Tracking was not noted on Oxbow Road; the roadway was cleared of sediment.

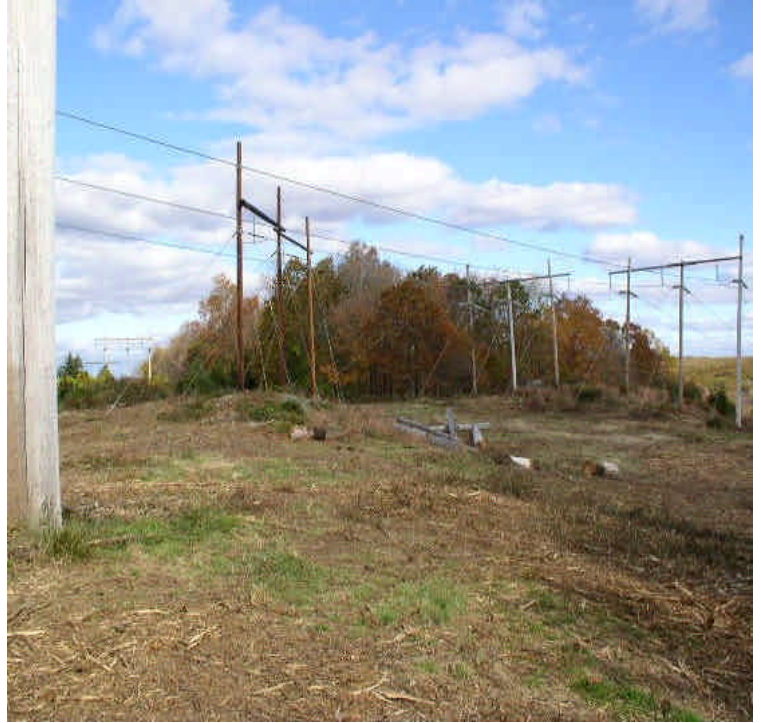
Pole installation complete at Oxbow Junction.

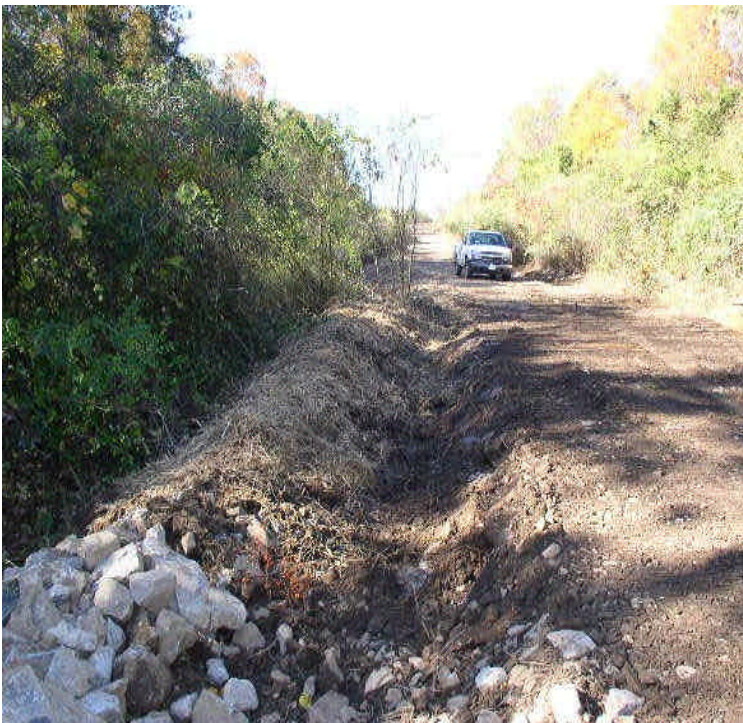
Completed access road off Black Walnut Dr with stormwater controls in place. A swale was installed and road slopes were temporarily stabilized with mulch.

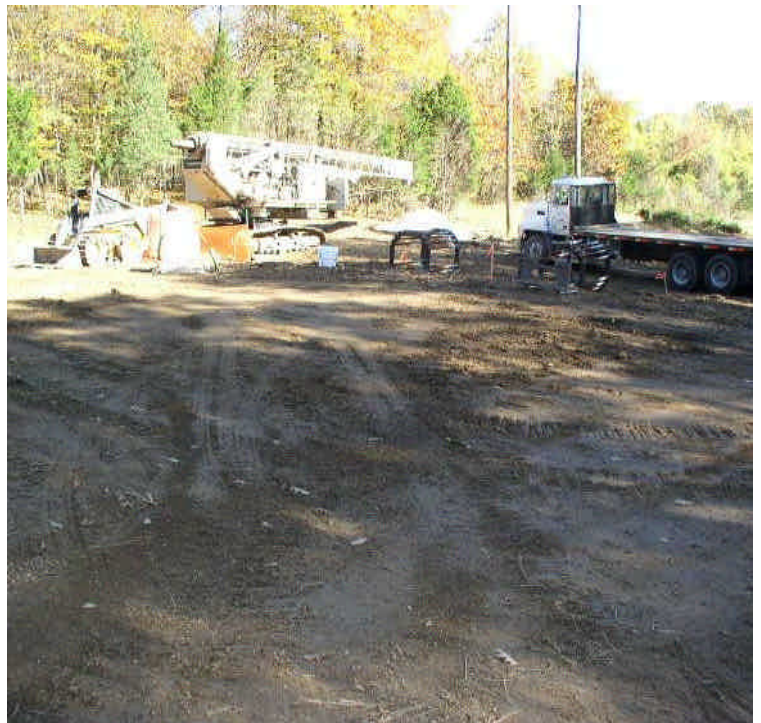
Drilling foundations off Black Walnut Dr.

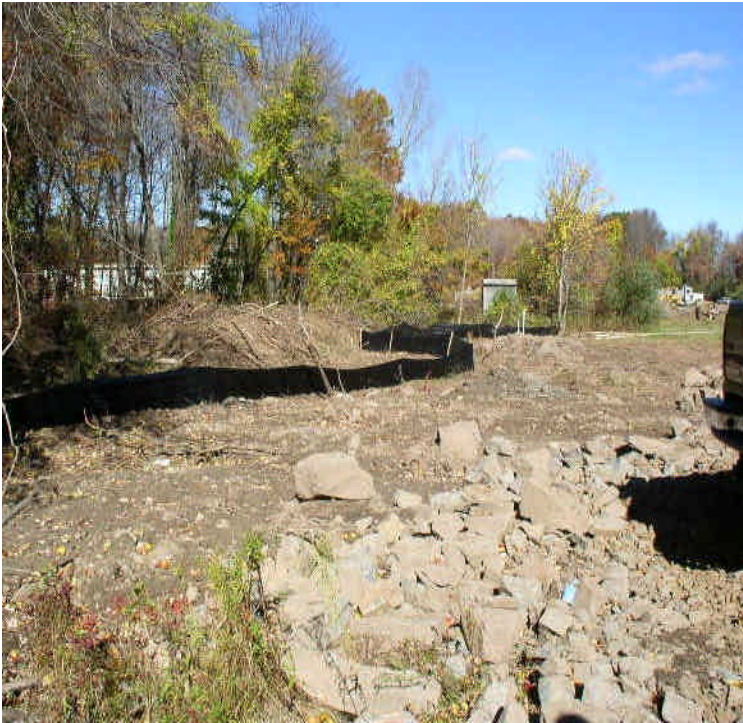
Silt fence installed at the contractor receiving yard & staging area.

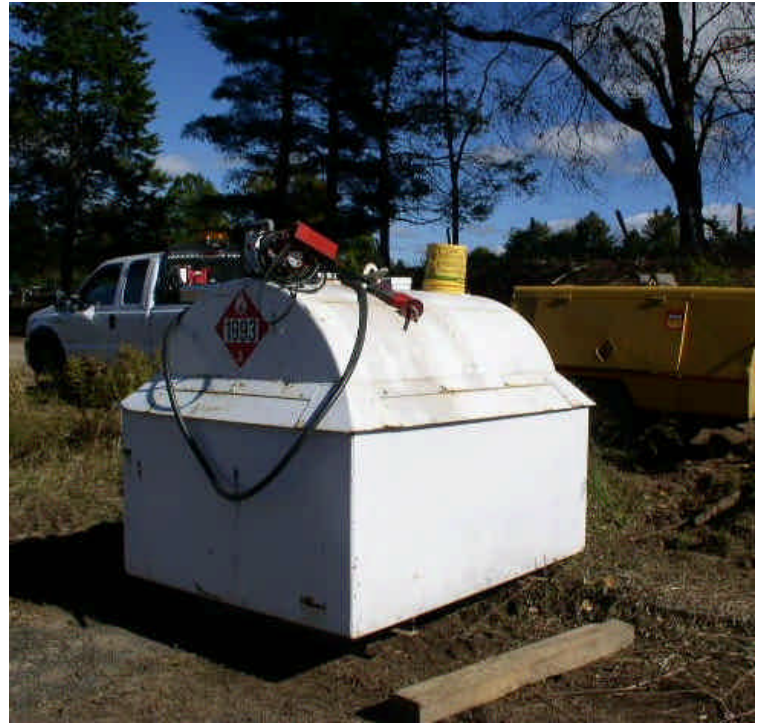
Areas of Inspection	Observation	Recommended Action	Corrected Action
	<p>of each day. 10/26/06</p> <p>Two refueling tanks have been brought onsite to fuel equipment. These tanks need spill kits and nozzle holsters to prevent dripping. Fuel was dripping from one nozzle during the inspection. 10/26/06</p>	<p>10/26/06</p> <p>Ensure spill controls are used during fueling. Consider installing spill control materials or containment on the ground near the tanks for added protection. Install nozzle holsters to keep them upright and prevent spills. 10/26/06</p>	<p>Needs immediate attention.</p>
<p>Additional Observations</p>	<p>NA</p>	<p>NA</p>	<p>NA</p>

Fuel was observed dripping from the nozzle of a refueling tank at the contractor yard. Controls/improved storage are needed as soon as possible.

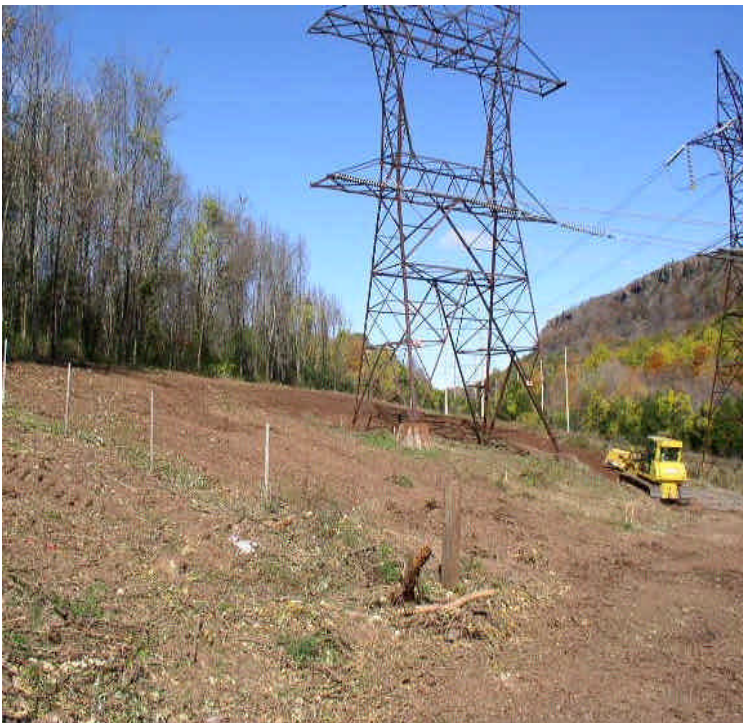
Grading and site preparation off Route 66 (Black Pond).

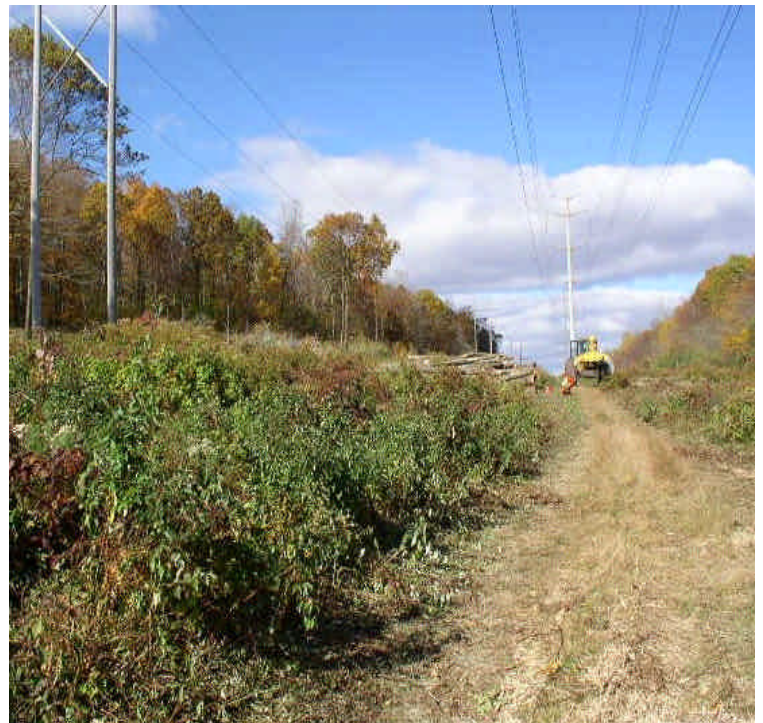
Tree clearing in the ROW, north of Beseck Switching Station.
