Docket No. 272 – Development and Management Plan Inspection

Segment 1a Inspection

Date: October 31, 2006

Location: Segment 1a – Scovill Rock Switching Station to Chestnut Junction, Oxbow Junction to Beseck Switching Station (excluding Royal Oak Bypass), Black Pond Junction to Beseck Switching Station

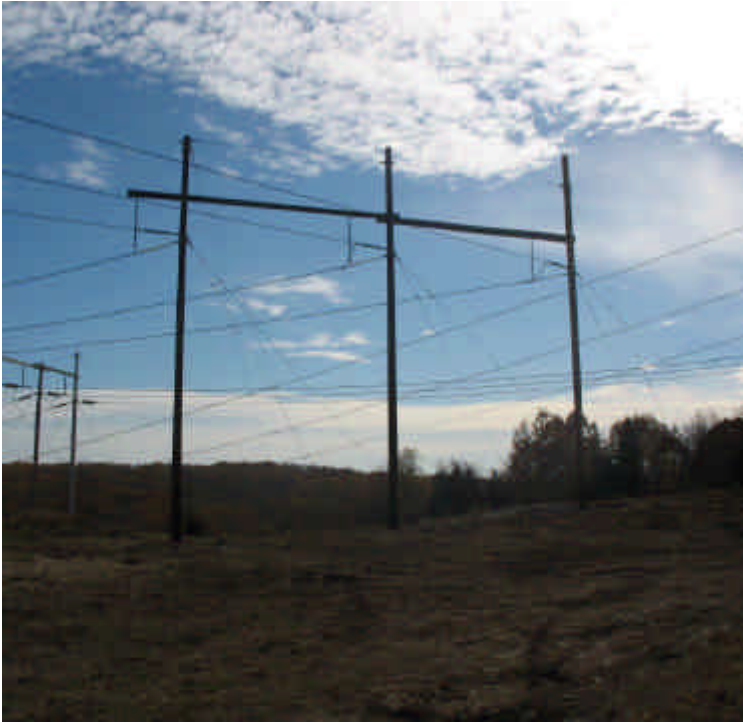
Pole installation complete at Oxbow Junction.

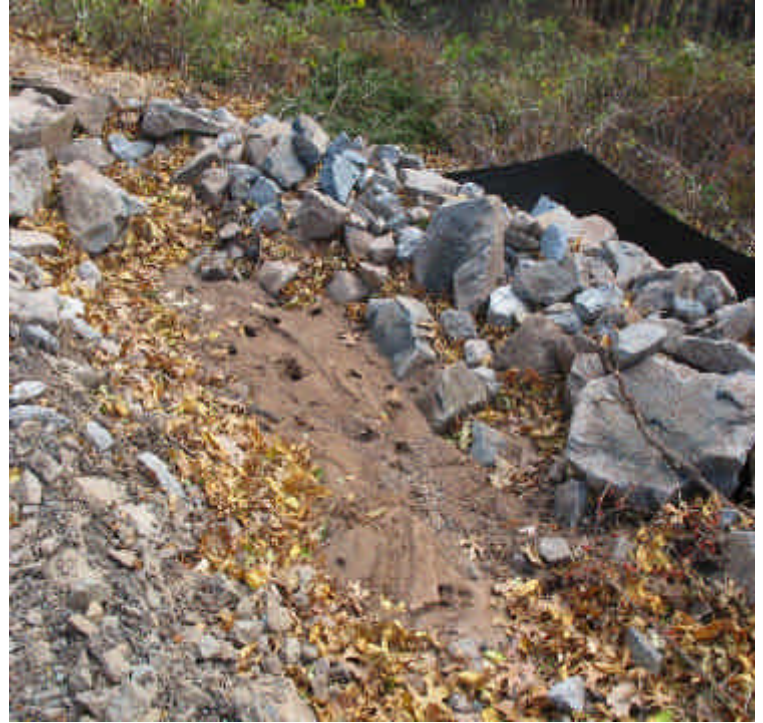
Sediment captured at the riprap sediment trap from the recently installed culvert/swale along Black Walnut Dr.

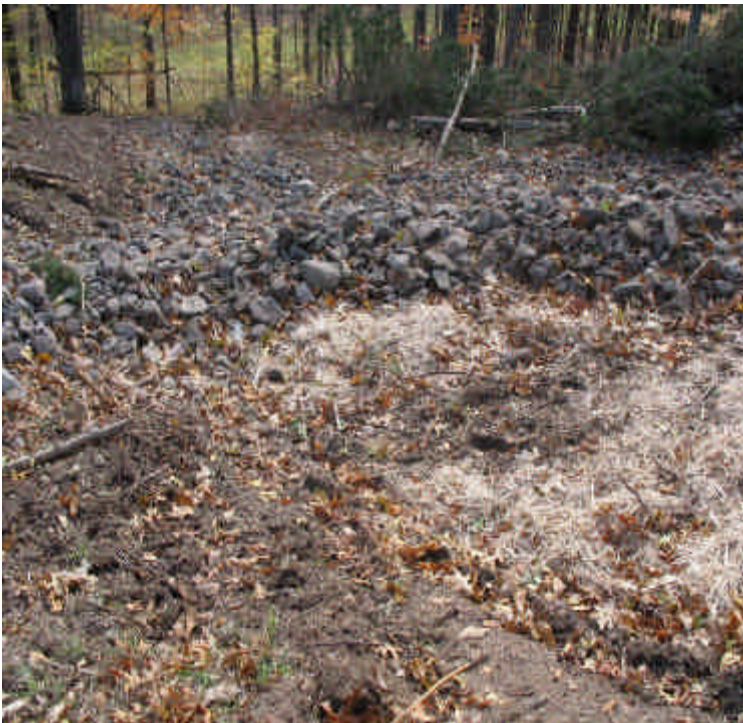
Mulch, check dam, and riprap installed at the end of the access road off Black Walnut Dr.

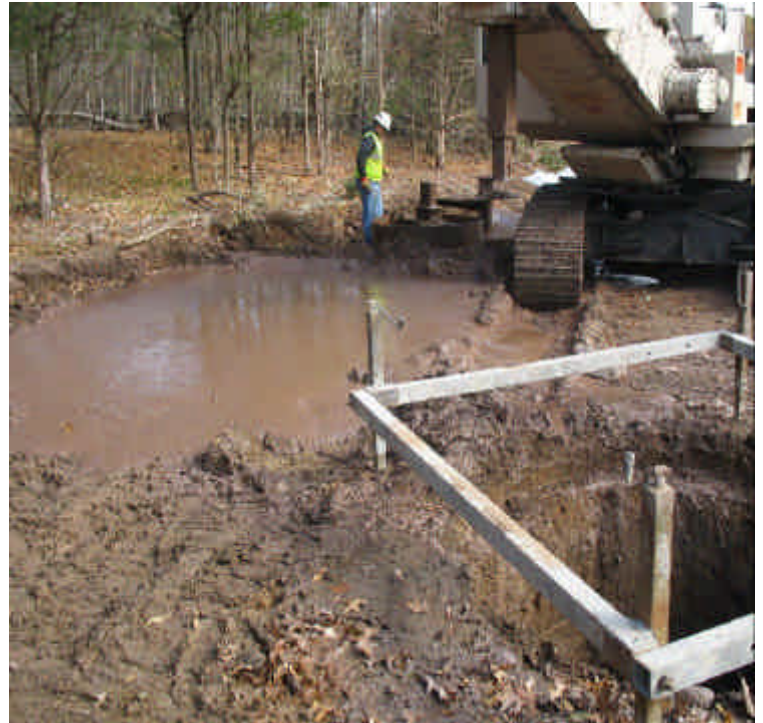
Dewatering	<p>Dewatering is being performed off Black Walnut Dr. The foundation excavation was being dewatered into a slurry pit as well as the concrete washout water. The slurry pit was being raked in order to dry out the mud quickly. 10/31/06</p>	<p>Caution should be taken not to exceed the holding capacity of the concrete washout area or the slurry pit. Additional controls (silt fence) could be used for further containment, as concrete will prevent water from filtering through the fabric. 10/31/06</p>	<p>Contained areas are being used for dewatering.</p>
Blasting	<p>No blasting is proposed at this time. 10/31/06</p>	<p>None 10/31/06</p>	<p>NA</p>
<p>Spills, soils and material storage</p> <p>Contractor Receiving Yard and Staging Area</p>	<p>Concrete washout area installed with fencing to protect the area. Concrete washout area will also be used for dewatering from the new drill holes. 10/31/06</p> <p>Spill controls move from site to site with the equipment. 10/31/06</p> <p>Materials are being stored and structures stored in</p>	<p>Maintain washout area and safety precautions. Caution should be taken not to overwhelm the washout area when used for dewatering. See dewatering section. 10/31/06</p> <p>Always use spill control materials when working on equipment and during refueling. Replace as needed. 10/31/06</p> <p>Continue to keep potential impact materials</p>	<p>Concrete washout area installed with fencing.</p> <p>NA</p> <p>Sanitary facility needs to be moved</p>

Slurry area from foundation drilling dewatering off Black Walnut Dr.

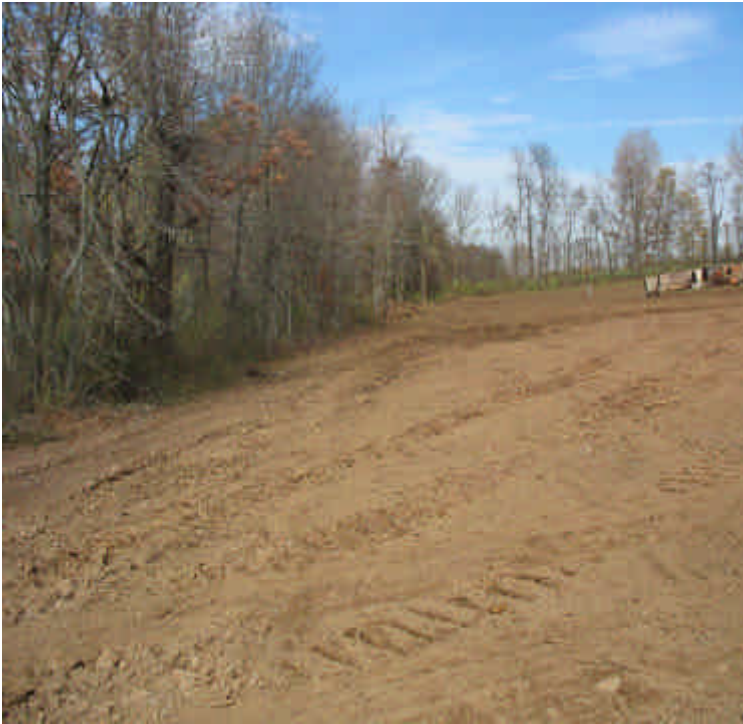
Silt fence installation needed above drainage ditch at the contractor receiving yard & staging area.

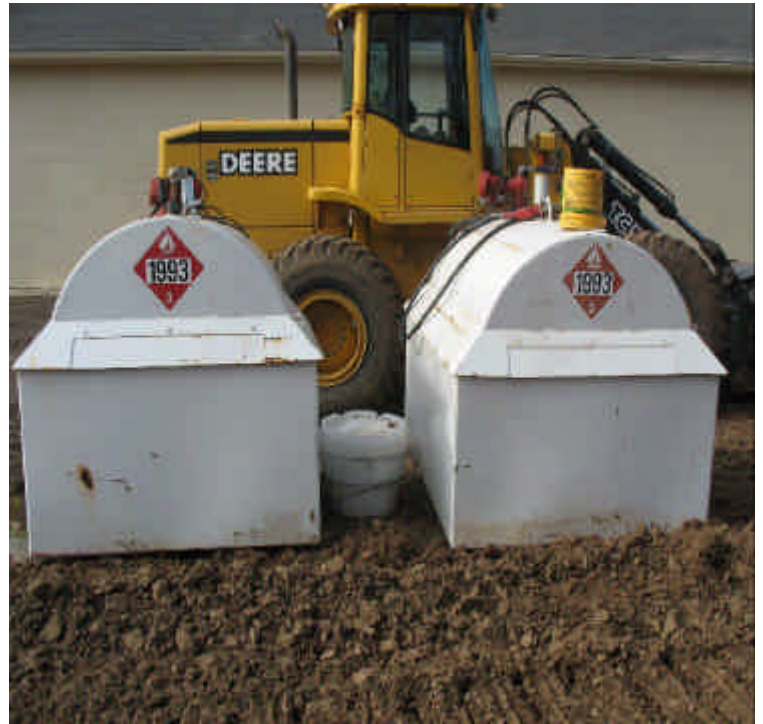
Fuel tanks were empty, nozzles turned up, and a spill kit was added the contractor yard until further containment can be constructed.

Areas of Inspection	Observation	Recommended Action	Corrected Action
Black Walnut Dr.	<p>and structures staged in this area. All stored materials, except the sanitary facility, are located approx 100 ft away from resource areas. 10/31/06</p> <p>Workers are using a large magnet to pick up small pieces of metal at the end of each day. 10/31/06</p> <p>The re-fueling tanks now have an adjacent spill kit and are empty until additional containment is in place. Nozzles were upright and no longer dripping but holsters will be needed. 10/31/06</p> <p>Some materials (structure components, equipment, etc.) are being stored here. These materials are located well away from any resource areas. 10/31/06</p>	<p>potential impact materials such as soils & fuel stored away from resource areas; move the sanitary facility. 10/31/06</p> <p>Continue to remove debris (including trash) from the site regularly. 10/31/06</p> <p>Ensure spill controls are used during fueling. Continue to install additional spill containment near the tanks for proactive control. Install nozzle holsters. 10/31/06</p> <p>Continue to store materials away from resource areas.</p>	<p>to be moved.</p> <p>Debris is being removed regularly.</p> <p>A spill kit was provided and tanks are empty. Continue to install proactive containment.</p> <p>NA</p>

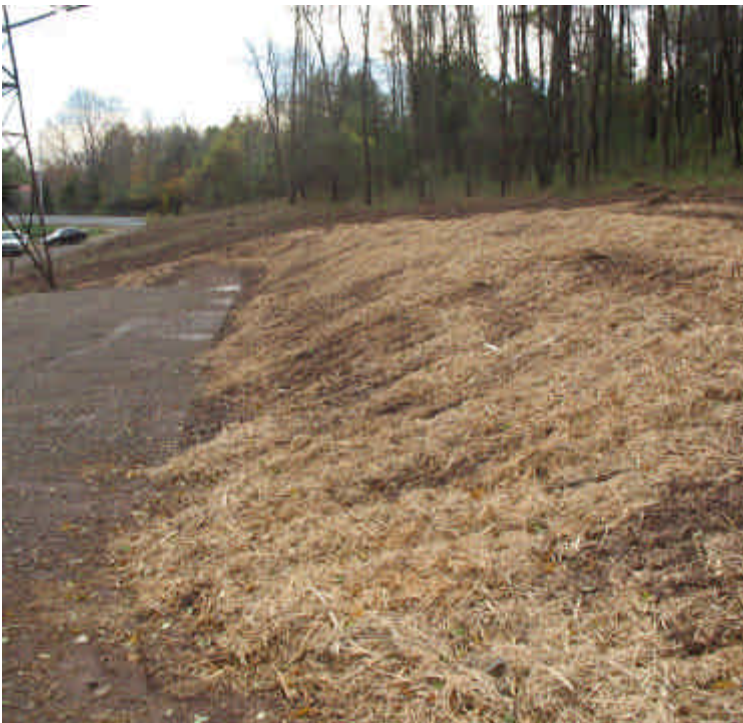
Mulch applied to most disturbed slopes off Route 66 (Black Pond).

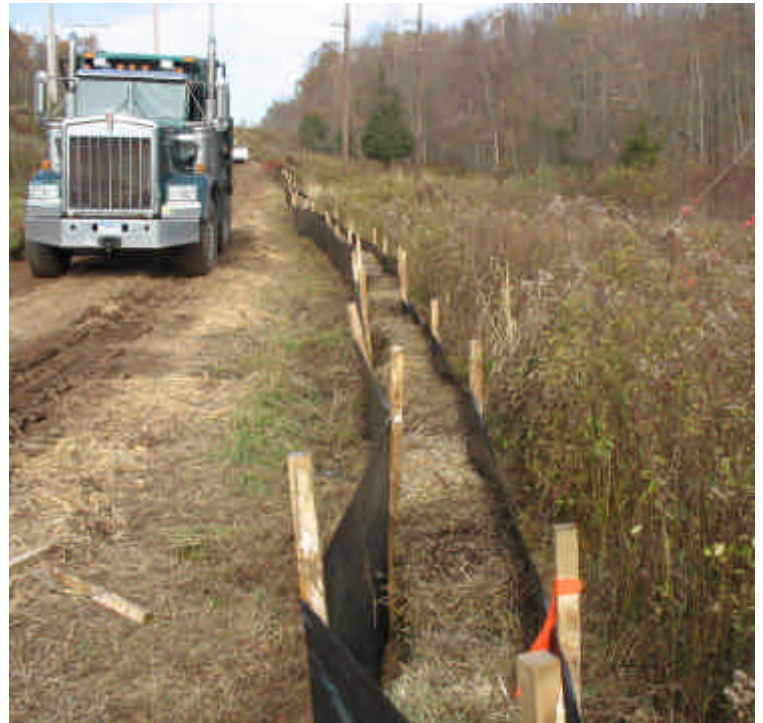
Silt fence/haybale barrier along the access road adjacent to the wetland near Beseck SS.
