Docket No. 272 – Development and Management Plan Inspection

Segment 2a Overhead Inspection

Date: August 24, 2006

Location: Segment 2a from Beseck Switching Station to Cheshire/Hamden Town Line

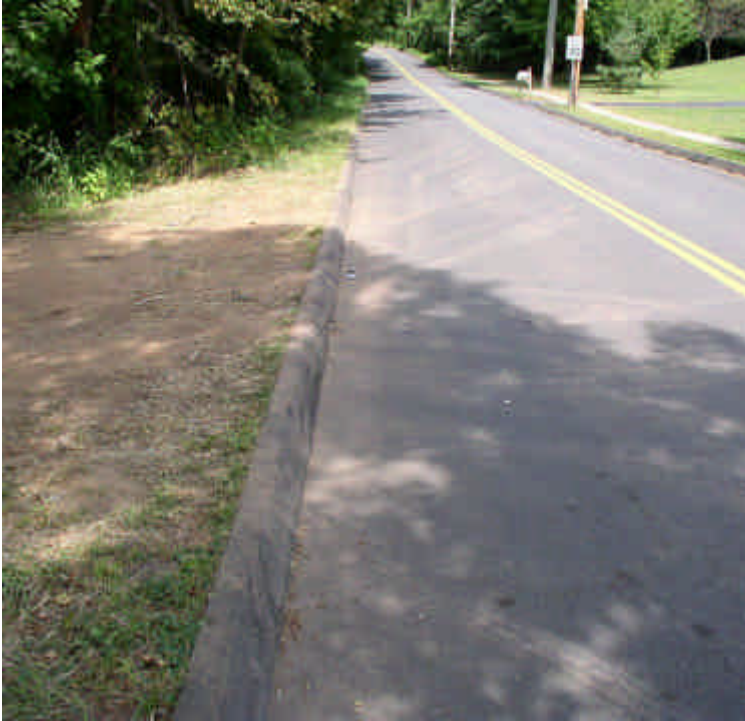
High Hill Road entrance to the ROW. Minimal tracking was noted.

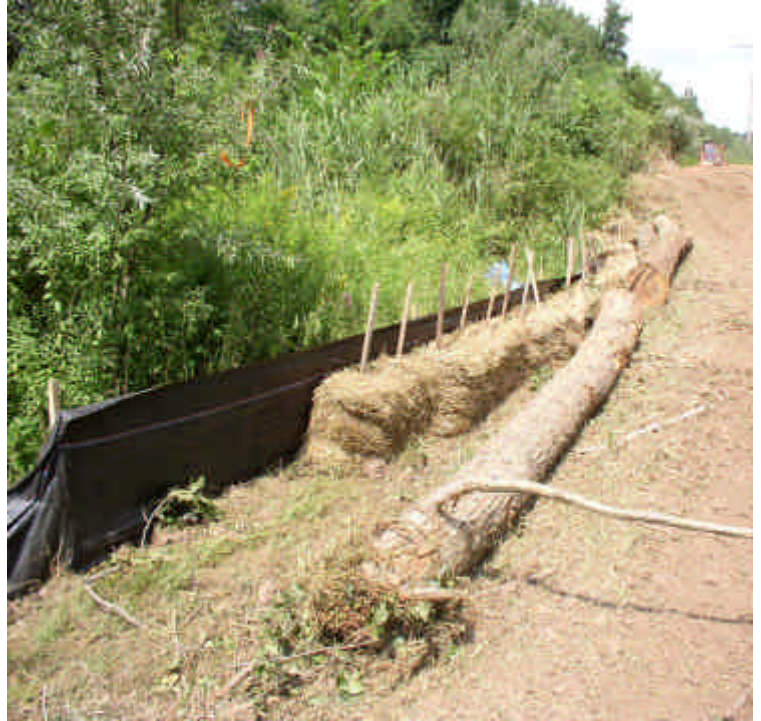
Erosion and sediment controls adjacent to the southern wetland.

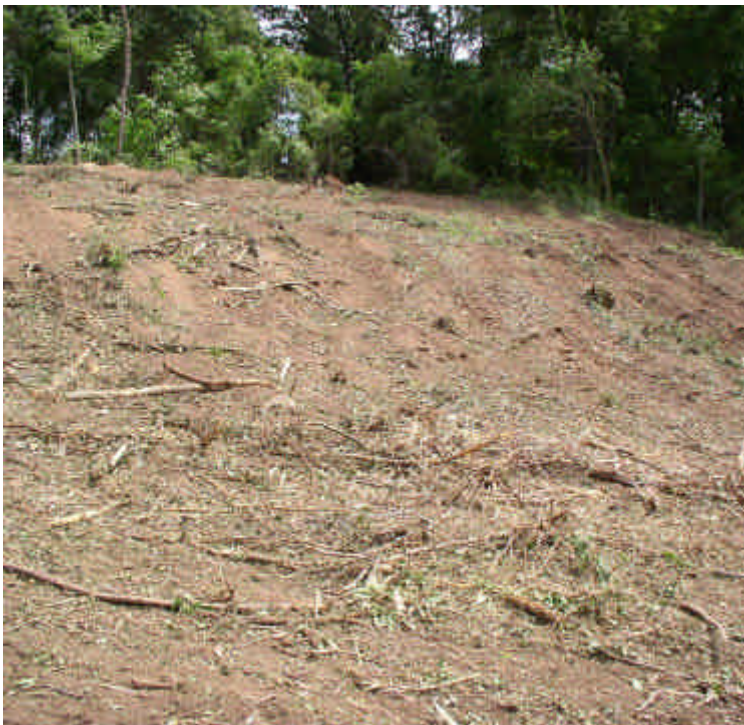
A fairly steep, exposed hill on site needs some stormwater controls to prevent erosion. 8/24/06	Several ideas for controls were discussed: mulch, wood chips, fiber mats, and water bars with grass seed are possible options. Retain as much vegetation as possible. 8/24/06	Needs attention.

Steep, exposed slope needs water bars and/or other erosion controls. Retain as much vegetation as possible to reduce disturbed sediment.

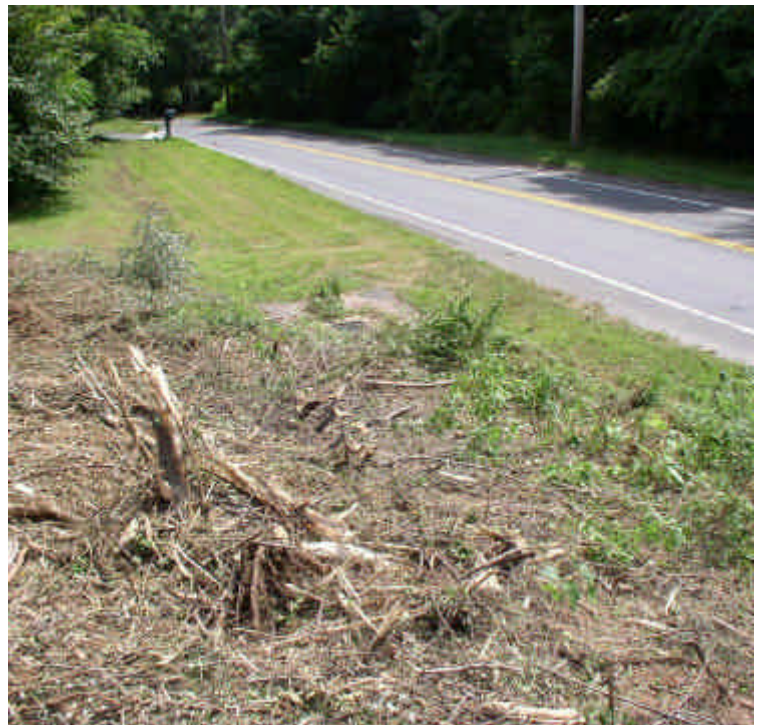
Haybales are needed around the catch basin along Route 68.
