Docket No. 272 – Development and Management Plan Inspection

Segment 2a Inspection

Date: September 7, 2006

Location: Segment 2a- Beseck Switching Station to Cheshire/Handen Town Line

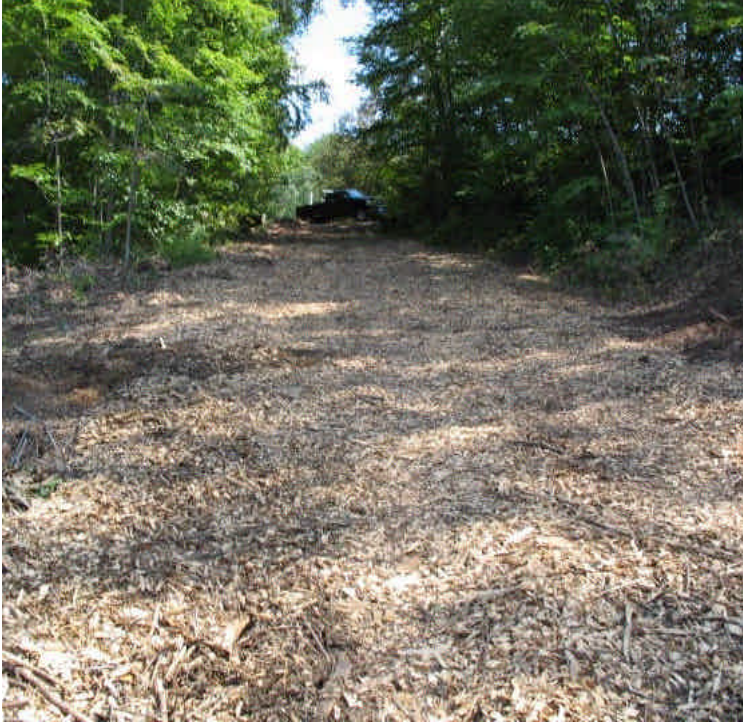
Entrance off High Hill Rd. Wood chips were placed to stabilize.

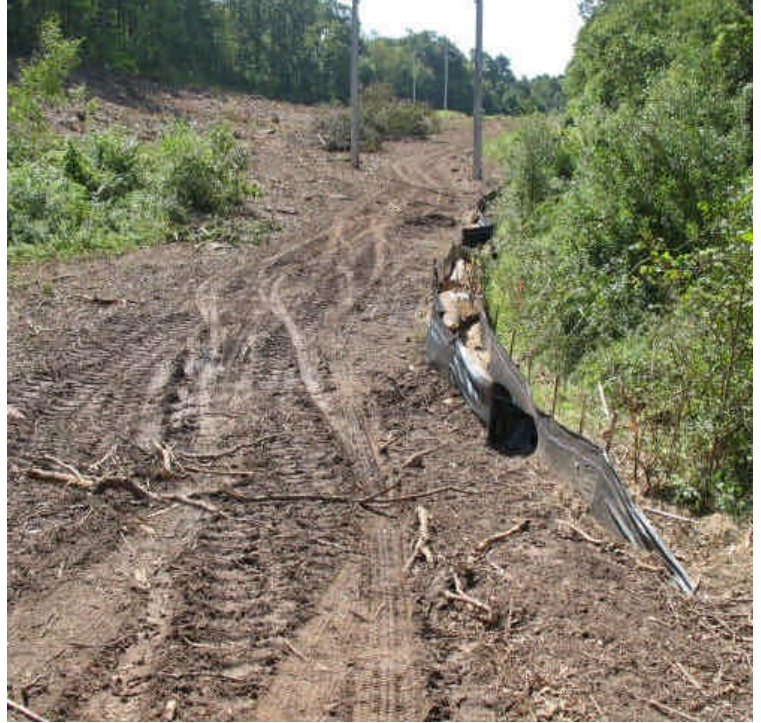
Erosion and sediment controls adjacent to the southern wetland at High Hill Rd.

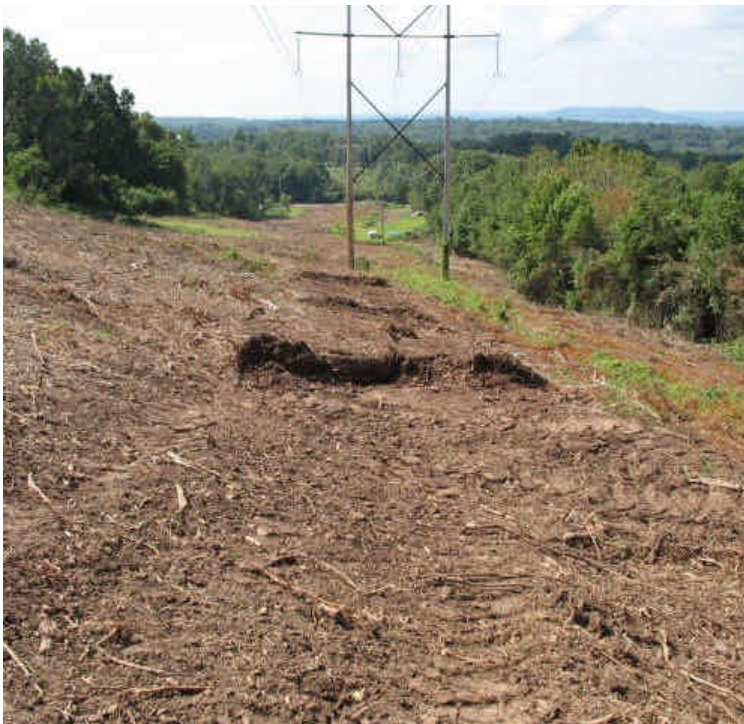
Water bars added between High Hill Rd. and Rt. 68.

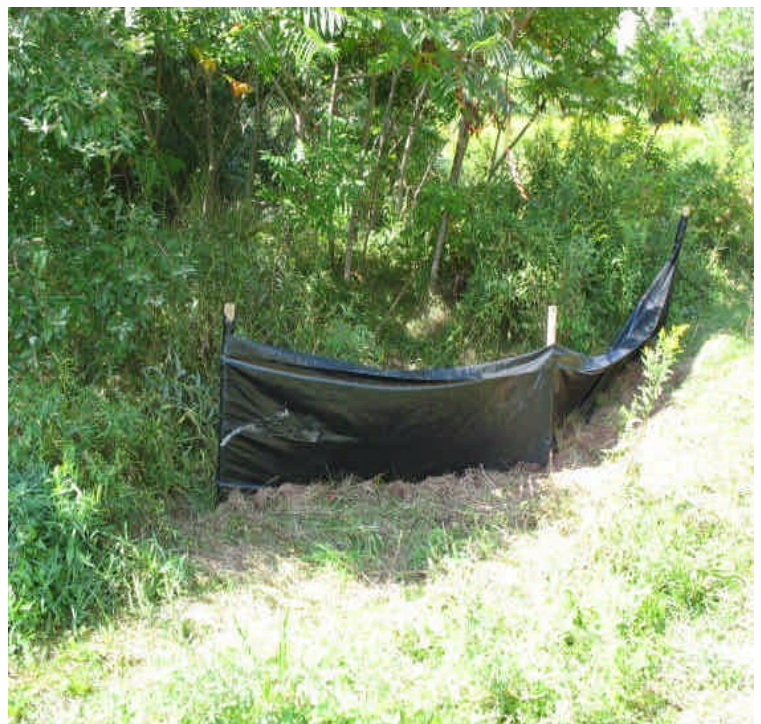
Silt fence and silt liner at catch basin inlet off Stony Brook Rd.

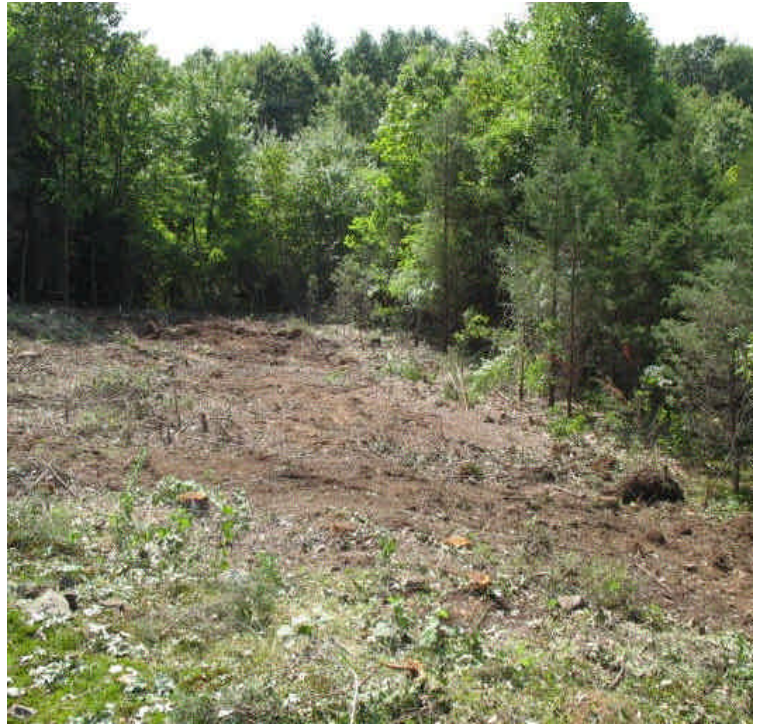
Right-of-way cleared, with vegetation left for erosion control, and 100' buffer maintained off South Turnpike.

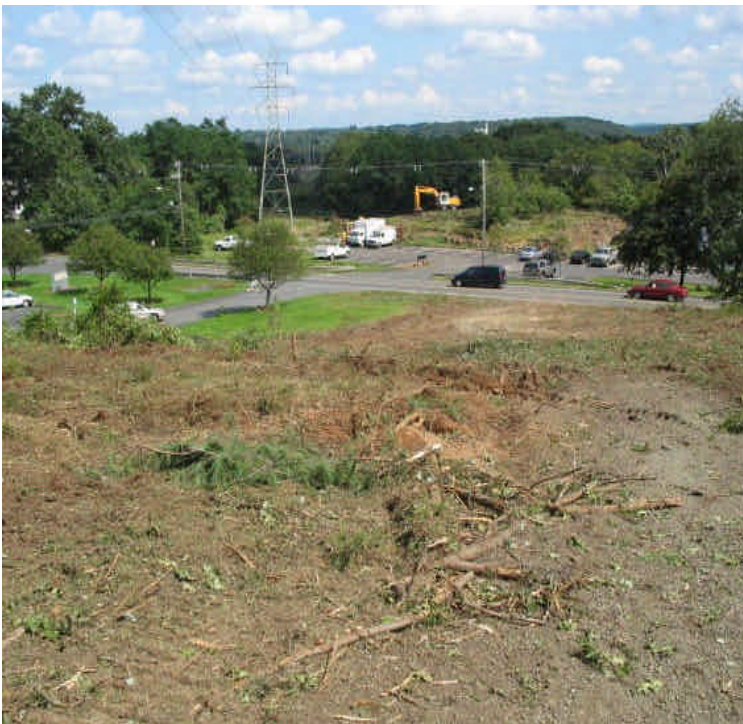
Recently seeded slope looking north over South Turnpike.

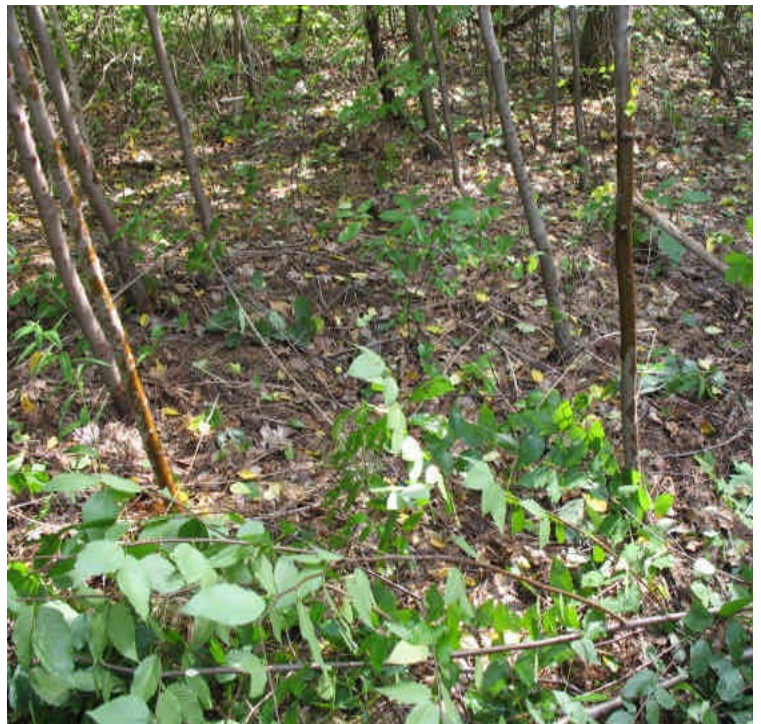
Hydraulic fluid spill (visible spots on woody stems) off Mansion Rd.

Areas of Inspection	Observation	Recommended Action	Corrected Action
Dewatering	Dewatering is not being performed at this time. 9/7/06	None	NA
Blasting	No blasting is proposed at this time. 9/7/06	None	NA
Spills, soils and material storage	Cleared trees and shrubs are being stockpiled and chipped on site. 8/24-9/7/06	Continue to keep all stockpiles set back from wetlands. 8/24-9/7/06	NA
	Spill control materials are being brought to sites. 9/7/06	Always use spill control materials when working on equipment and during refueling. Replace as needed. Also, park all machinery away from the wetlands. 8/24-9/7/06	NA
Williams Rd. to E. Center St.	The hydraulic fluid spill (less than 1 gallon) from last week in the Stony Brook Rd. section has been cleaned. 9/7/06	None. 9/7/06	Area has been cleaned.
Mansion Rd.	Less than 1 gallon of hydraulic fluid spilled when a hose broke on the Mansion Rd. section. Spill controls were used to contain most of the spill. Some fluid still remained to be removed. Spill was reported to Burns and McDonnell. 9/7/06	Continue to clean up any affected areas. Continue to use and restock spill kits as needed.	Spill kit used to absorb most of the spill. Remaining area should be cleaned.
