Docket No. 272 – Development and Management Plan Inspection

Segment 2a Inspection

Date: October 19, 2006

Location: Segment 2a – Beseck Switching Station to Cheshire/Hamden Town Line

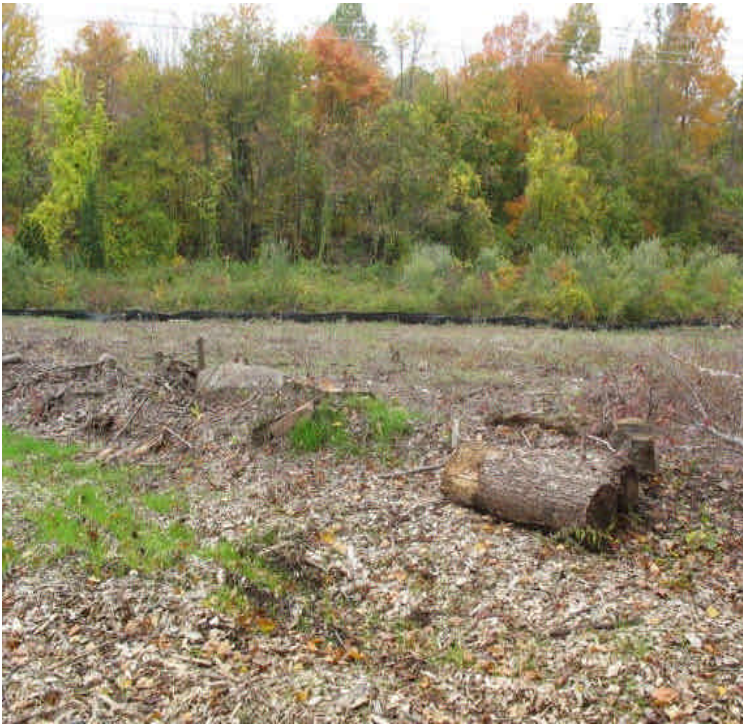
Silt fence off High Hill Rd.

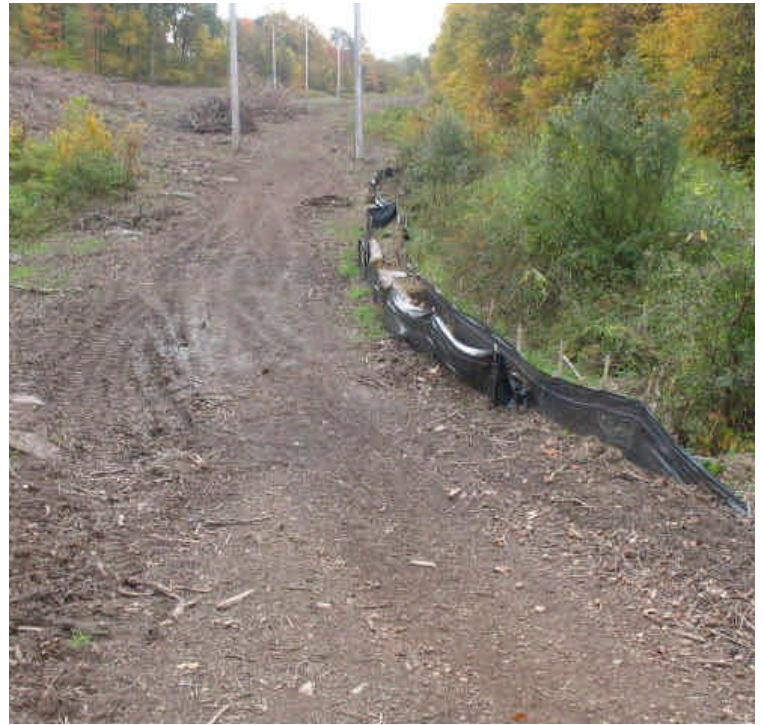
Silt fence above wetland off High Hill Rd.

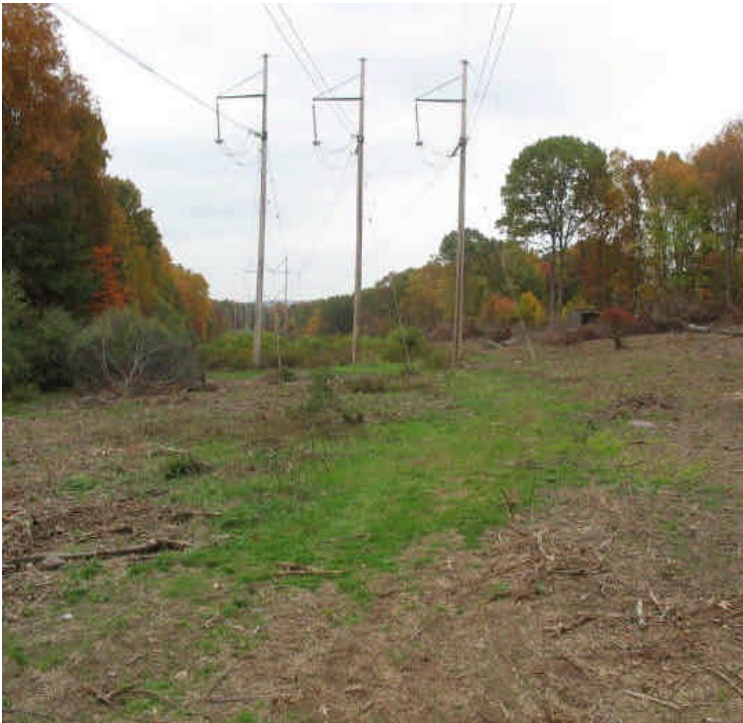
Grass growth off Stony Brook Rd.

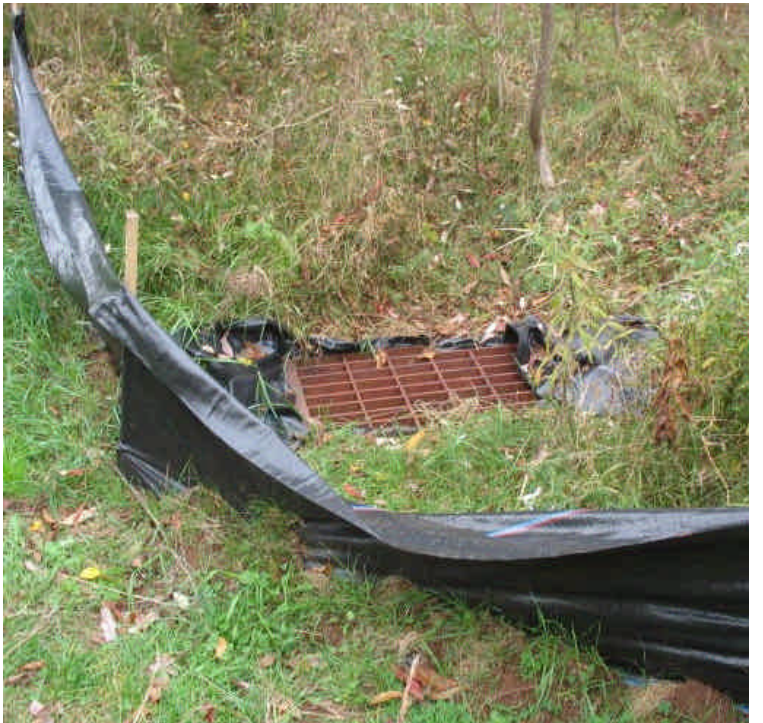
Catch basin controls in place off Stony Brook Rd.

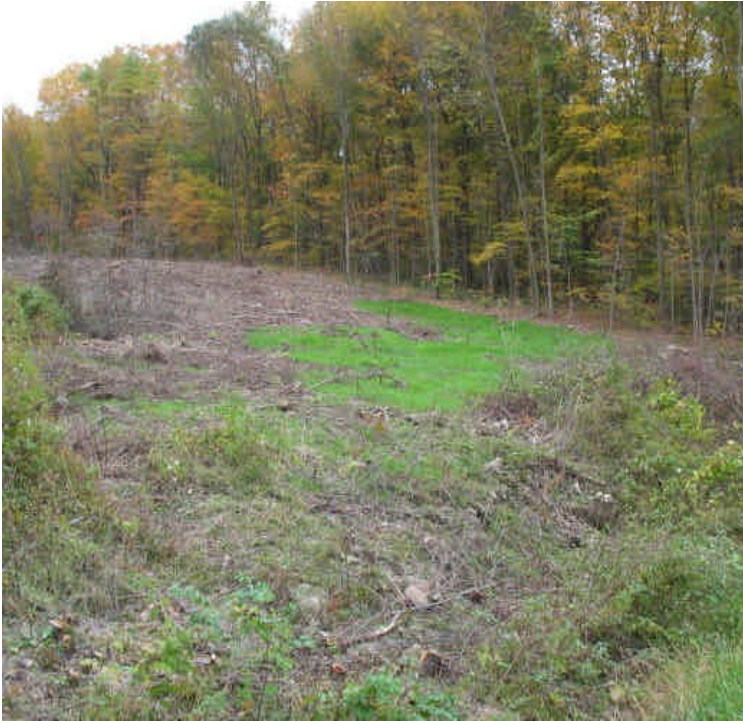
Increased grass growth noted off Mansion Rd.

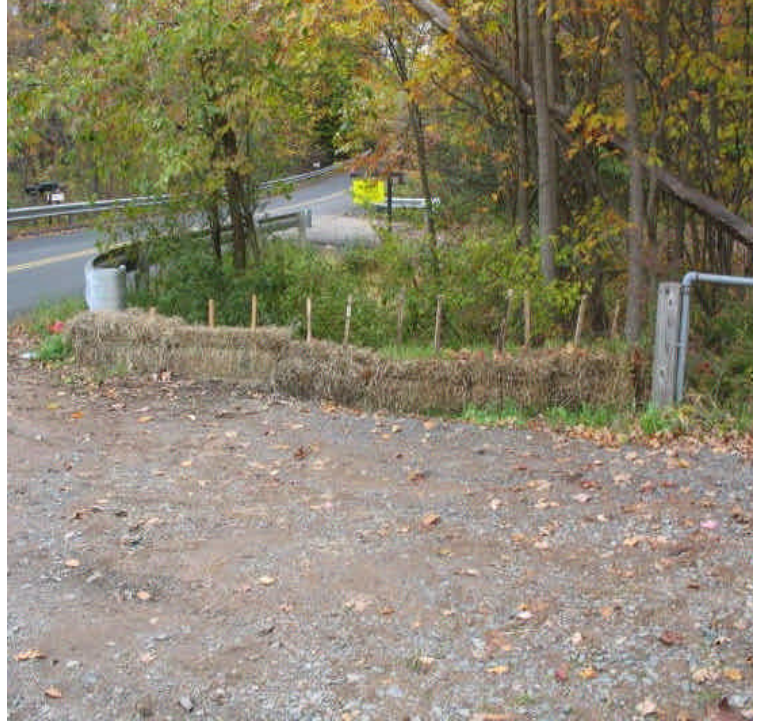
Extra haybales added to prevent runoff at Mansion Rd. entrance.

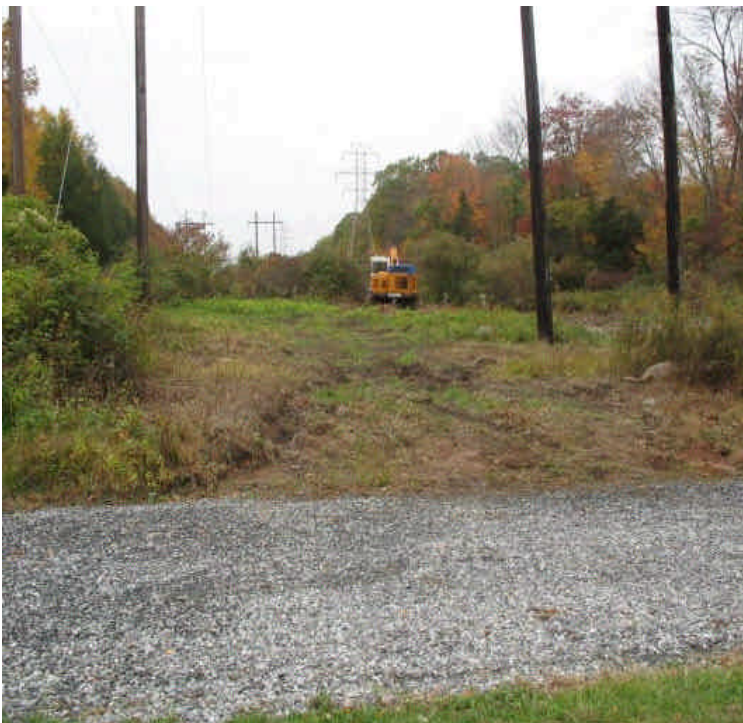
Old Farm Rd.	The piece of equipment parked off Old Farm Rd. appears to be leaking/dripping fuel and needs maintenance. Spill should be cleaned as soon as possible. 10/19/06	Check and maintain equipment regularly. Clean spill and fix equipment to stop gas leak. 10/19/06	Needs attention
Additional Observations	NA	NA	NA

Equipment off Old Farm Rd. has been leaking/dripping fuel.

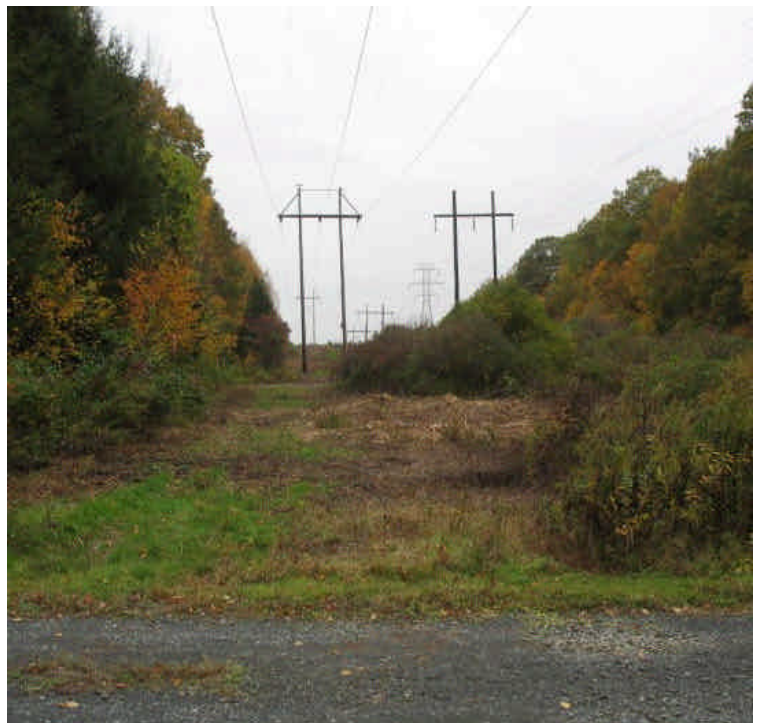
Vegetation left in place for stabilization off Old Farm Rd.
