Docket No. 272 – Development and Management Plan Inspection

Segment 4a Underground Line

Date: August 3, 2006 – Initial inspection

Location: Singer Substation to Fairfield/Westport Town Line

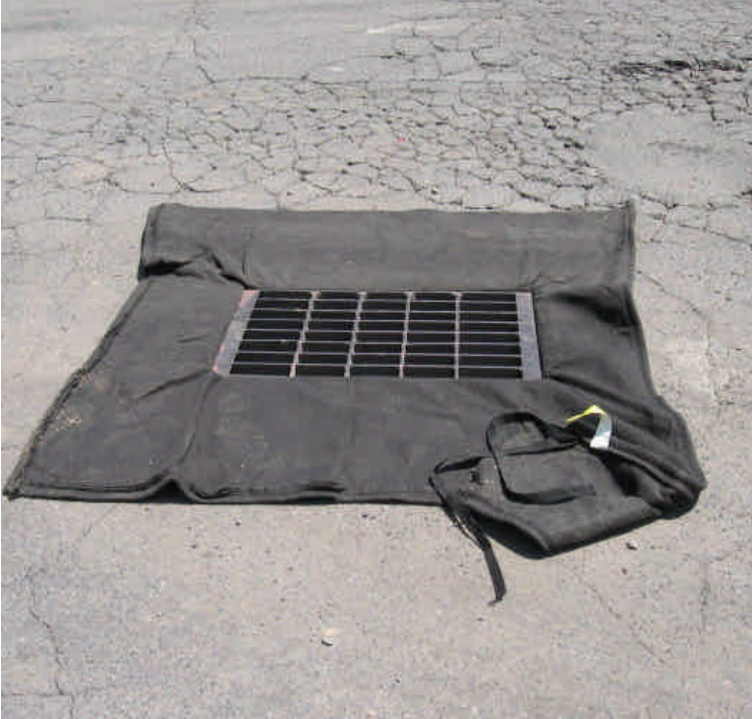
Catch basin with filter fabric located adjacent to construction area within the parking lot.

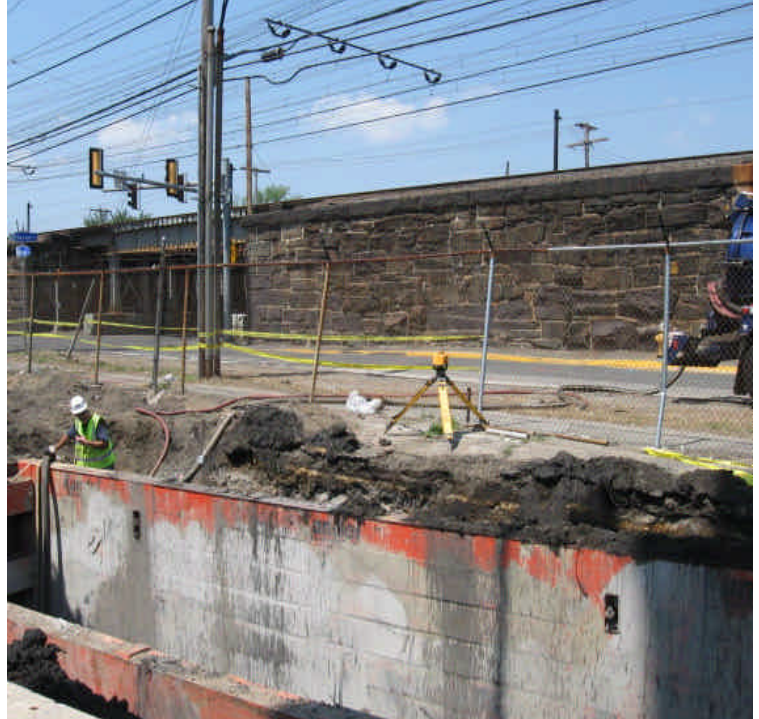
Vault opening within parking lot with a vacuum truck parked on Railroad Avenue removing water from the excavation.

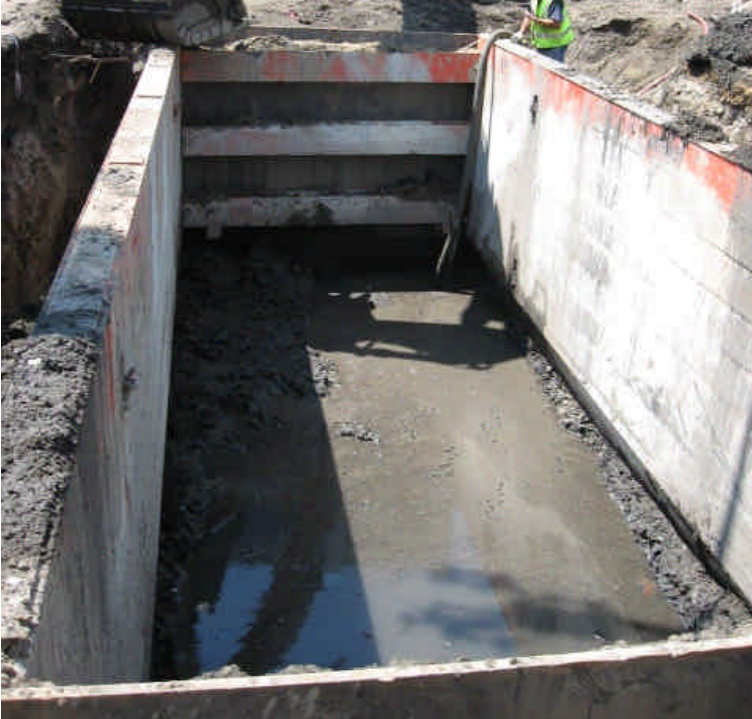
Open trench being dewatered and prepared for vault installation.

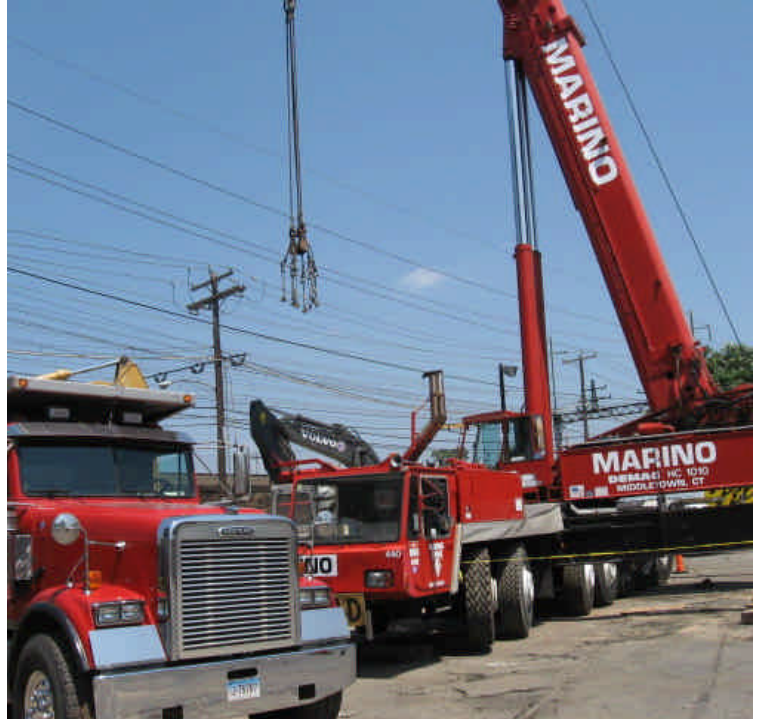
Overview of equipment in place for the vault construction.

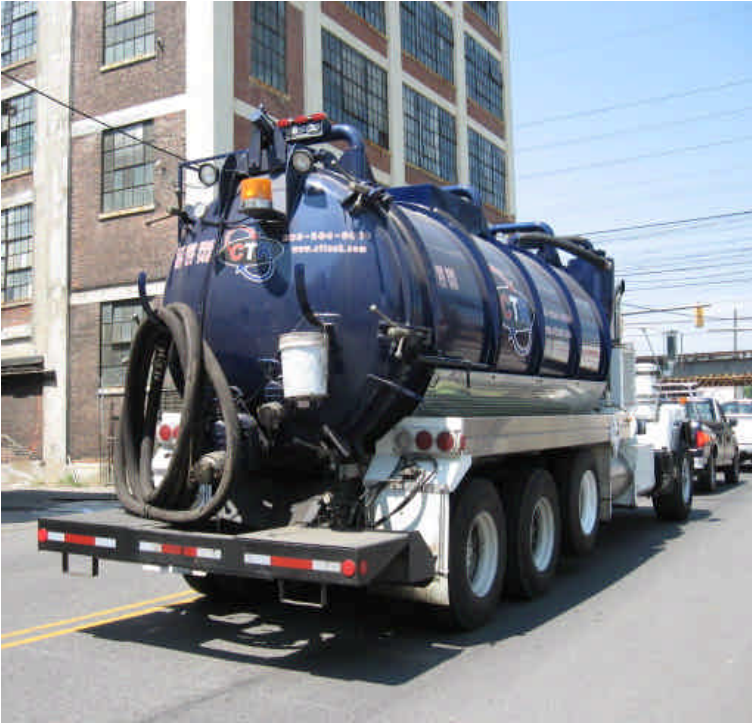
Vac truck returning to the site for dewatering the excavation

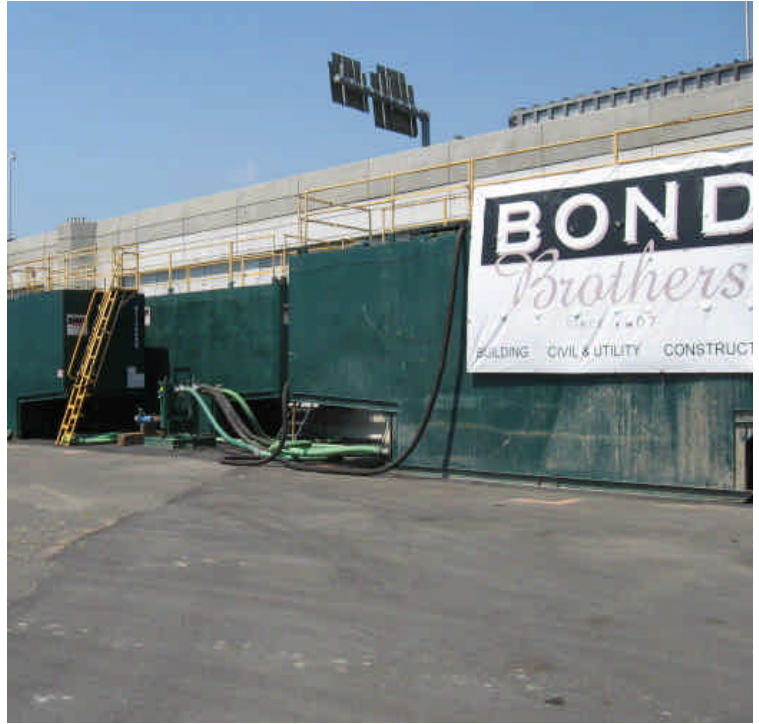
Frac tanks located at the contractor's storage area. These serve as holding, settling and filtration tanks for dewatering

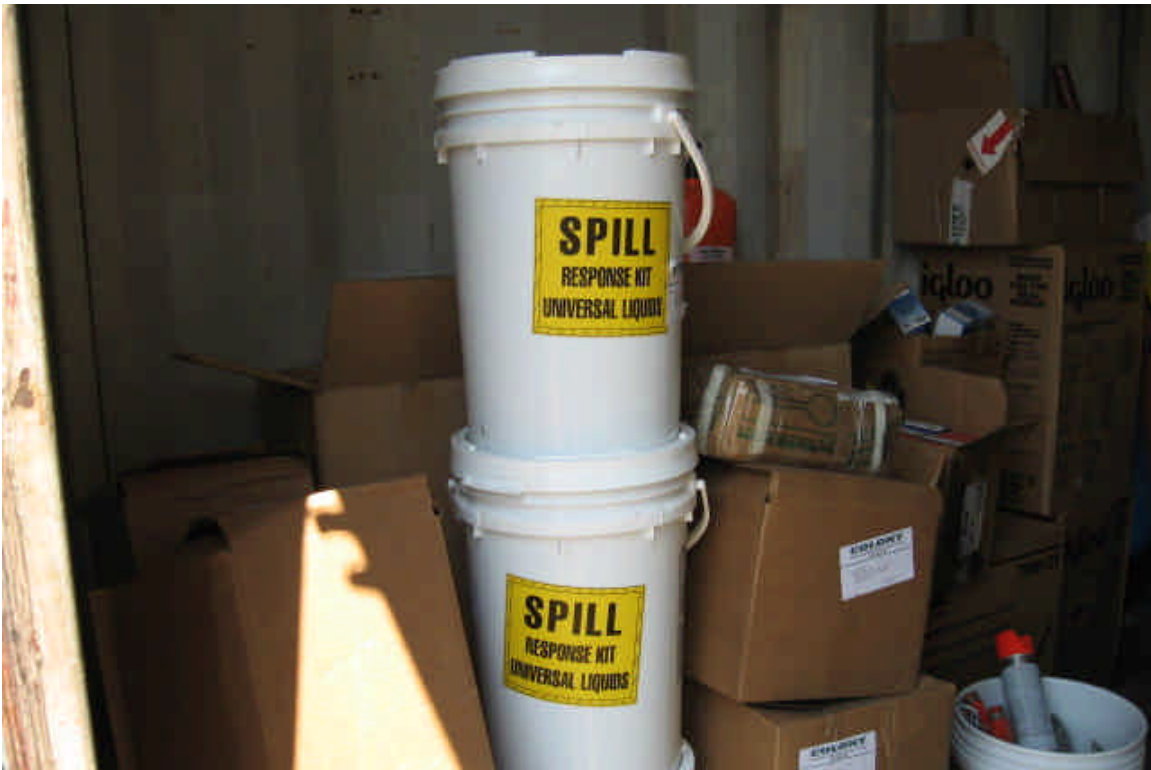
View of the spill kits stored at the contractor yard. These will be available for the equipment on site.
